R26DY

IMPORTANT SAFETY RECALL

SUBJECT: R26DY: Electric Vehicles May Shut Down

R26DY – Electric Vehicles May Shut Down

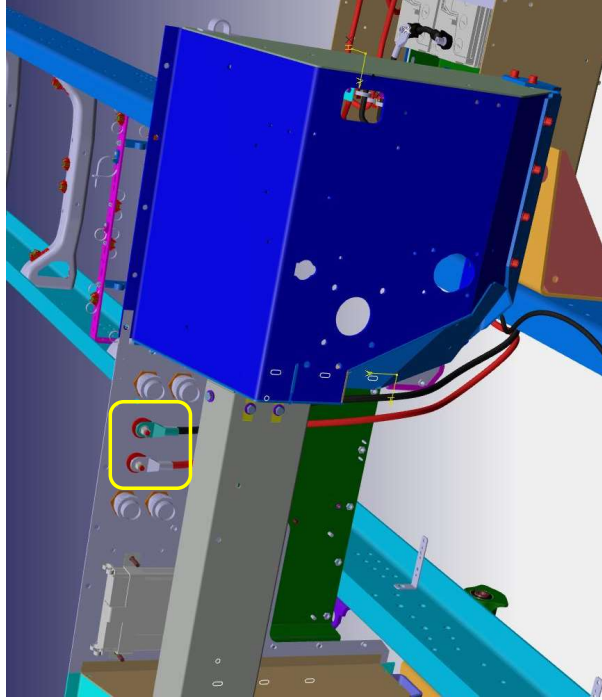
1. Remove negative battery cable from 12v Battery bank and secure.
2. Replace both positive and negative DCM pass through studs. (See Figure 1 & 2)
3. Service locations highlighted in Figures 4 - 7. Any connections/components found to have any thermal stress MUST be replaced.
4. Clean/prep connection(s) per Figure 3, and torque per legend on Page 2.

1. Replace both DCM pass through studs & nuts on the firewall on CV platforms.
2. Inspect all defined connection points and torque to defined values.

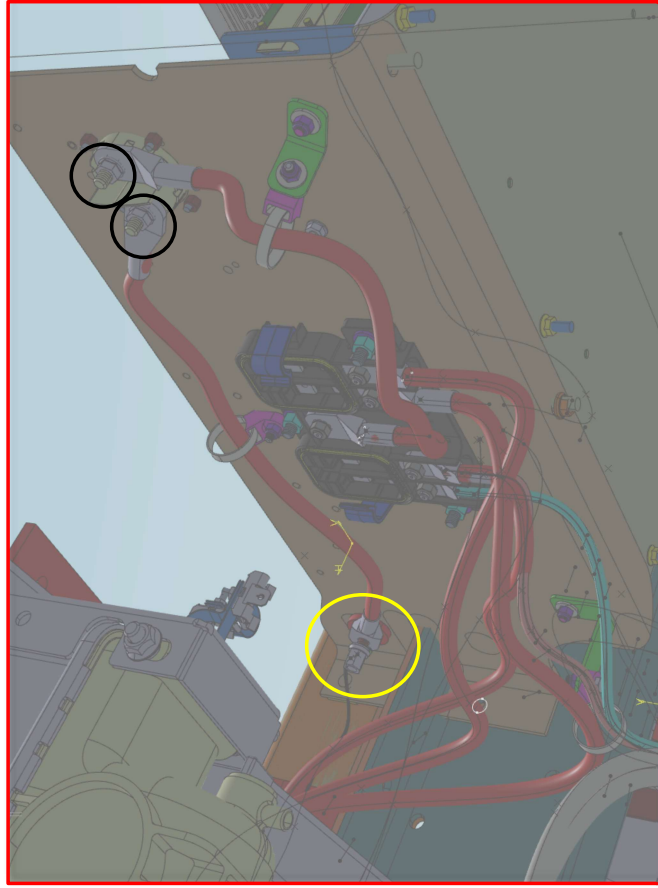
Figure 8

1. Remove negative battery cable from 12v Battery bank and secure.
2. Service locations highlighted in Figures 8 - 12. Any connections/components found to have any thermal stress MUST be replaced.
3. Clean/prep connection(s) per Figure 3, and torque per legend on Page 2.

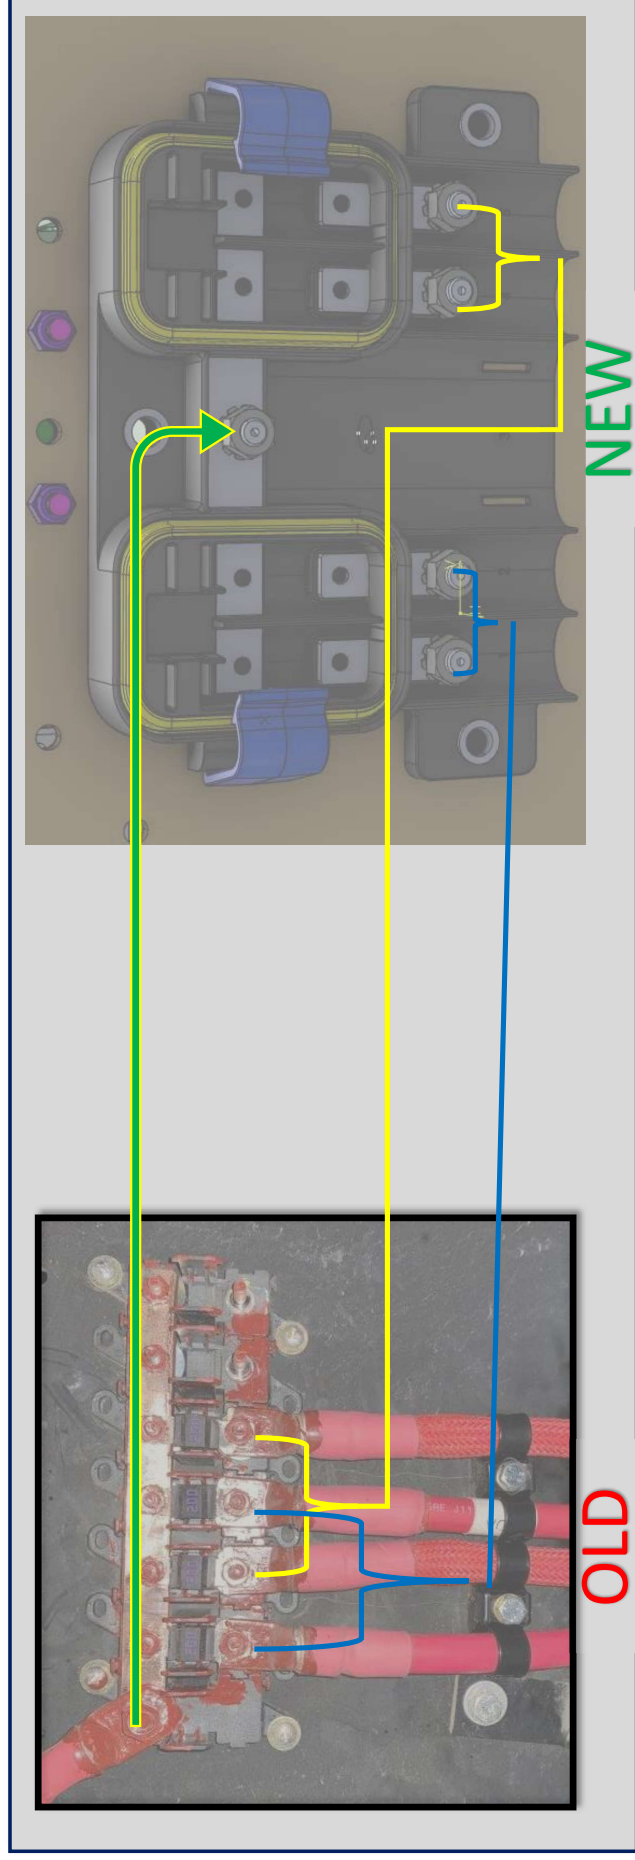
1. Remove battery negative cable and secure.
2. Remove all chassis cables from original BPDA and prep per Figure 3
3. Remove BPDA assy and install new BPDA per Figure 12
4. Torque connections on new BPDA per Figure 6
