SUBJECT: SAFETY RECALL OF 2026 MB TOURRIDER COACHES

Ref.: NHTSA recall reference # 26V-063
DCNA Bulletin # **TI 72.40U26365A**

TI No.: 72.40U26365A

TITLE: **External emergency valve not working**

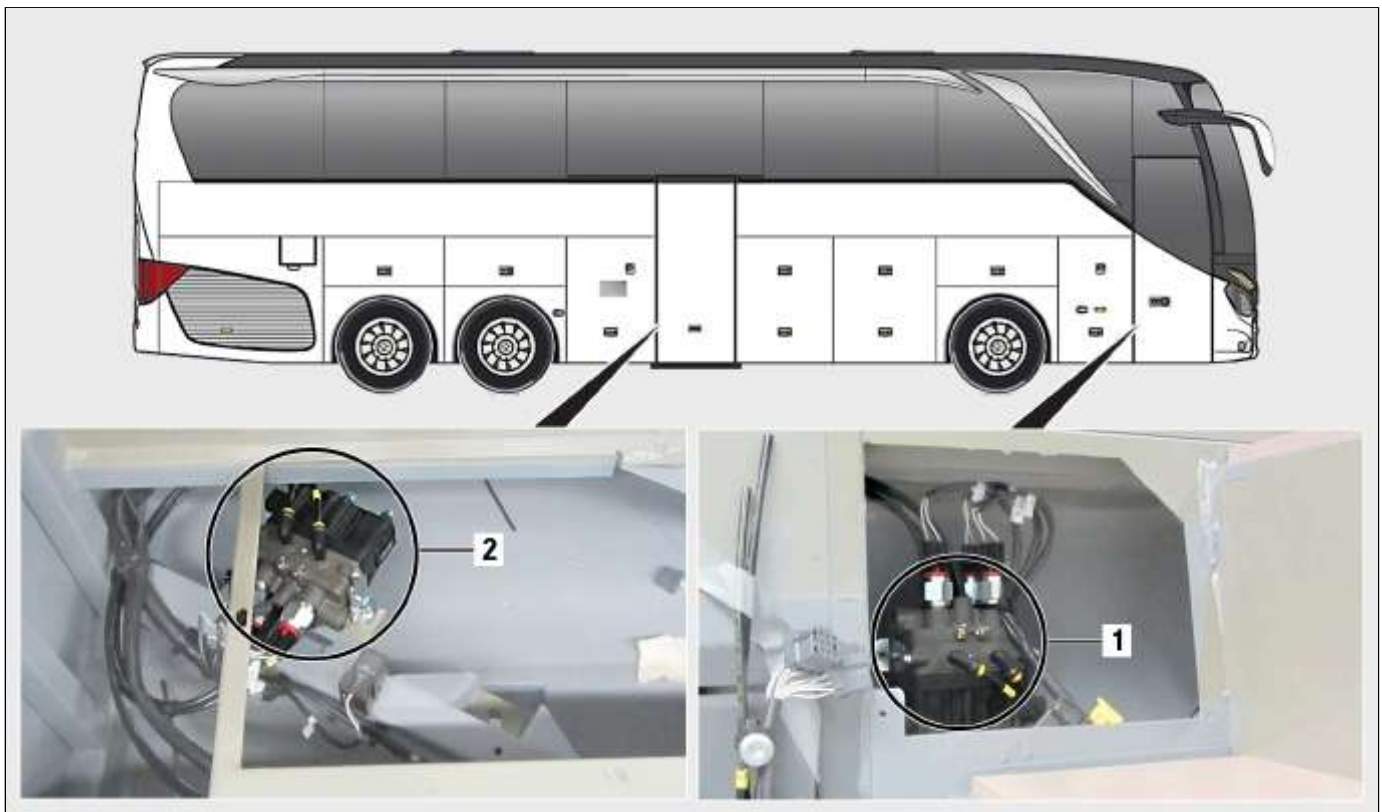
M72.40-0046-75

Overview of installation locations

1 Door valve of front door

The door valve of the front door (1) is fitted behind the cover on the left-hand side of the entrance.

2 Door valve of centre door

The door valve of the centre door (2) is fitted under the second step.

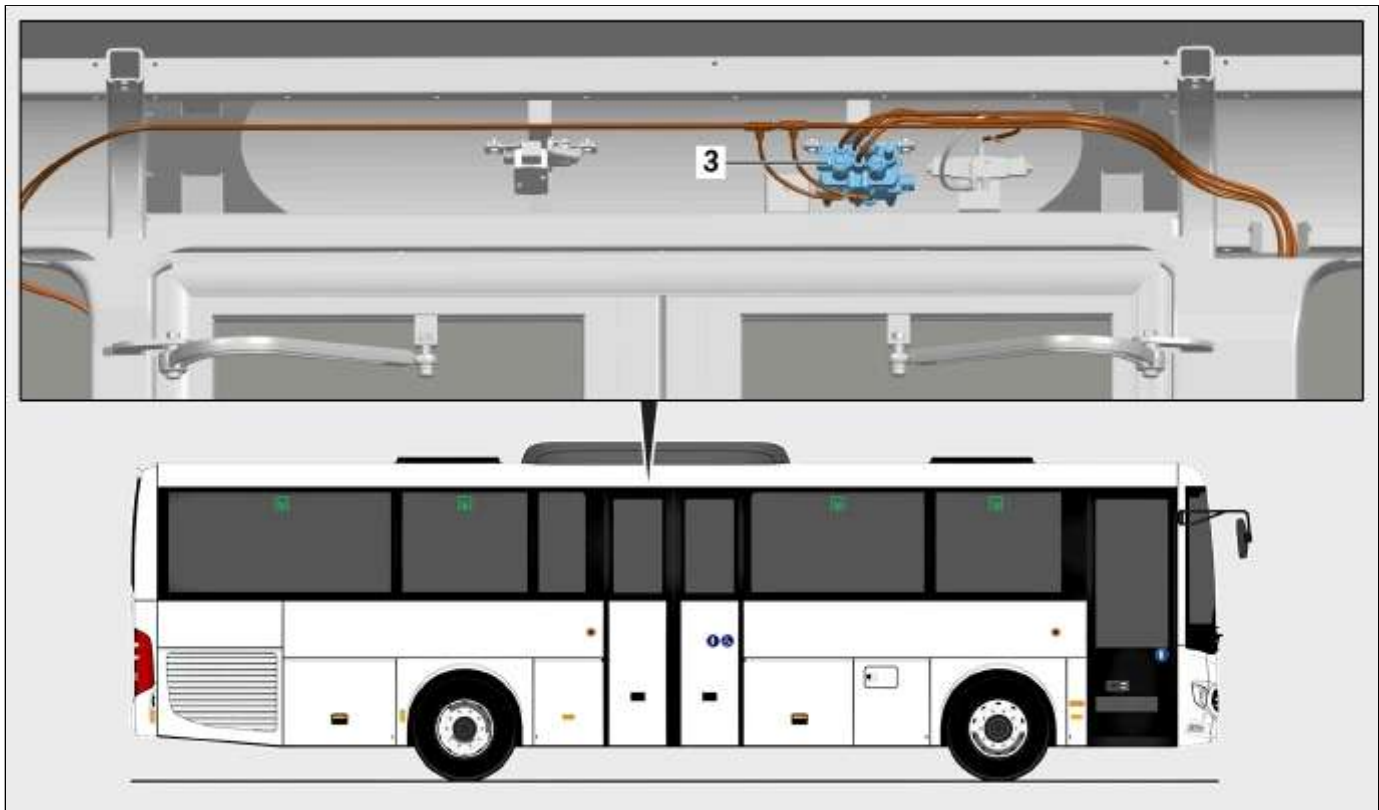
M72.40-A024-75

Installation location, double-leaf door

3 Above the door, in ceiling area

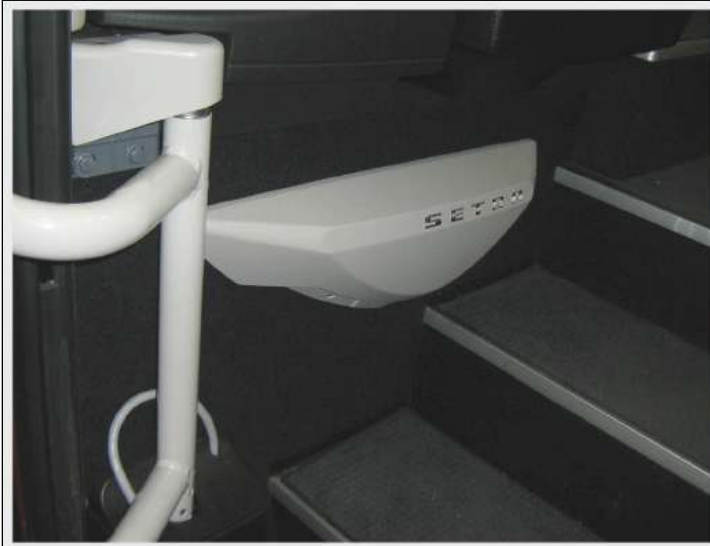
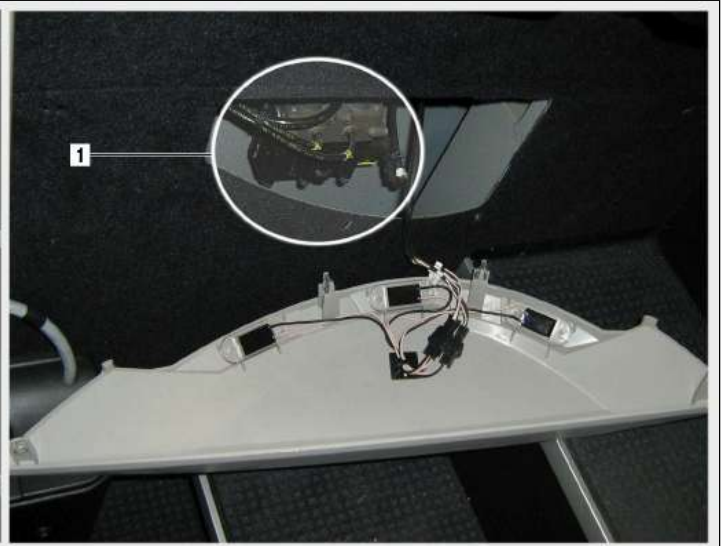
M72.10-0219-78

Door control valve of passenger door 1

1. Remove or fold open the cover in front of door control valve **(1)**.

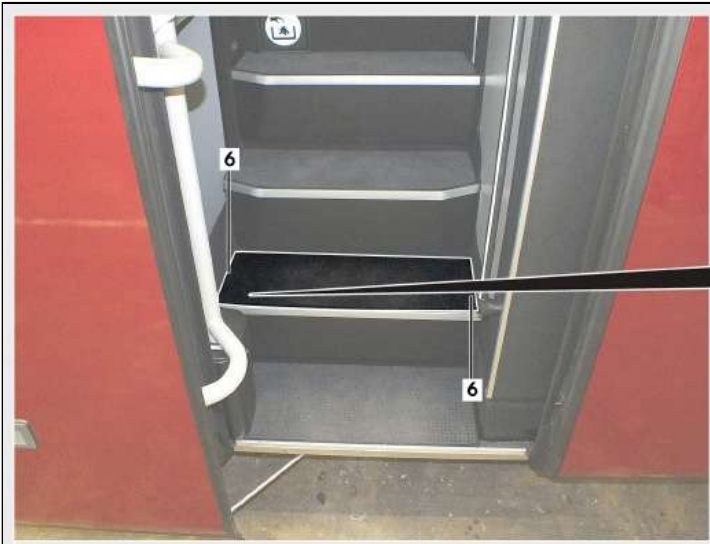
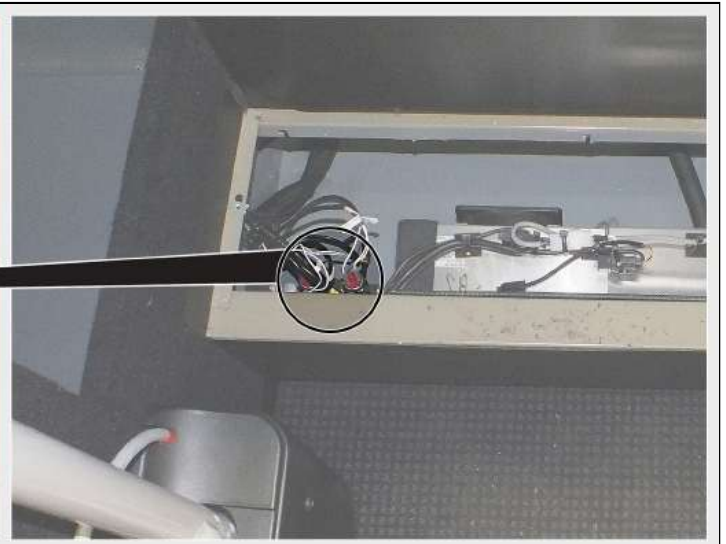
M72.40-0042-78

Door control valve of passenger door 2

1. Unscrew screws **(6)** and remove the step cover.

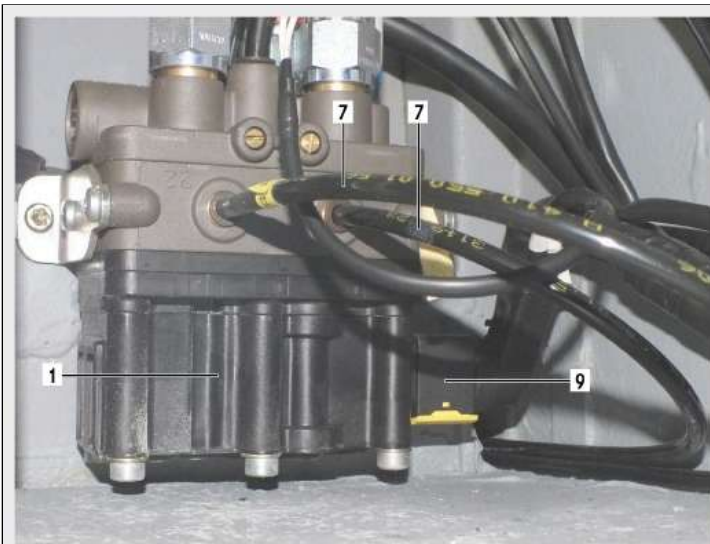
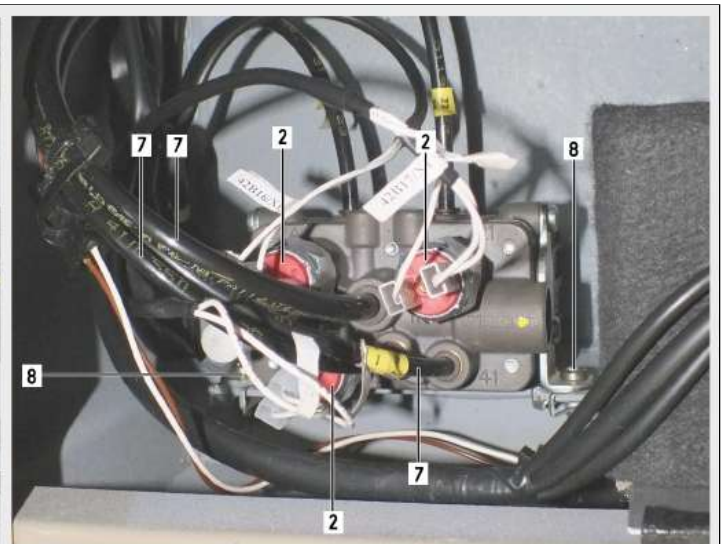
M72.40-0043-78

Removing the door control valve

1. Label and disconnect electrical **(2)** and pneumatic **(7)** lines.
2. Unscrew screws **(8)**.
3. Release and disconnect electrical connection **(9)**.

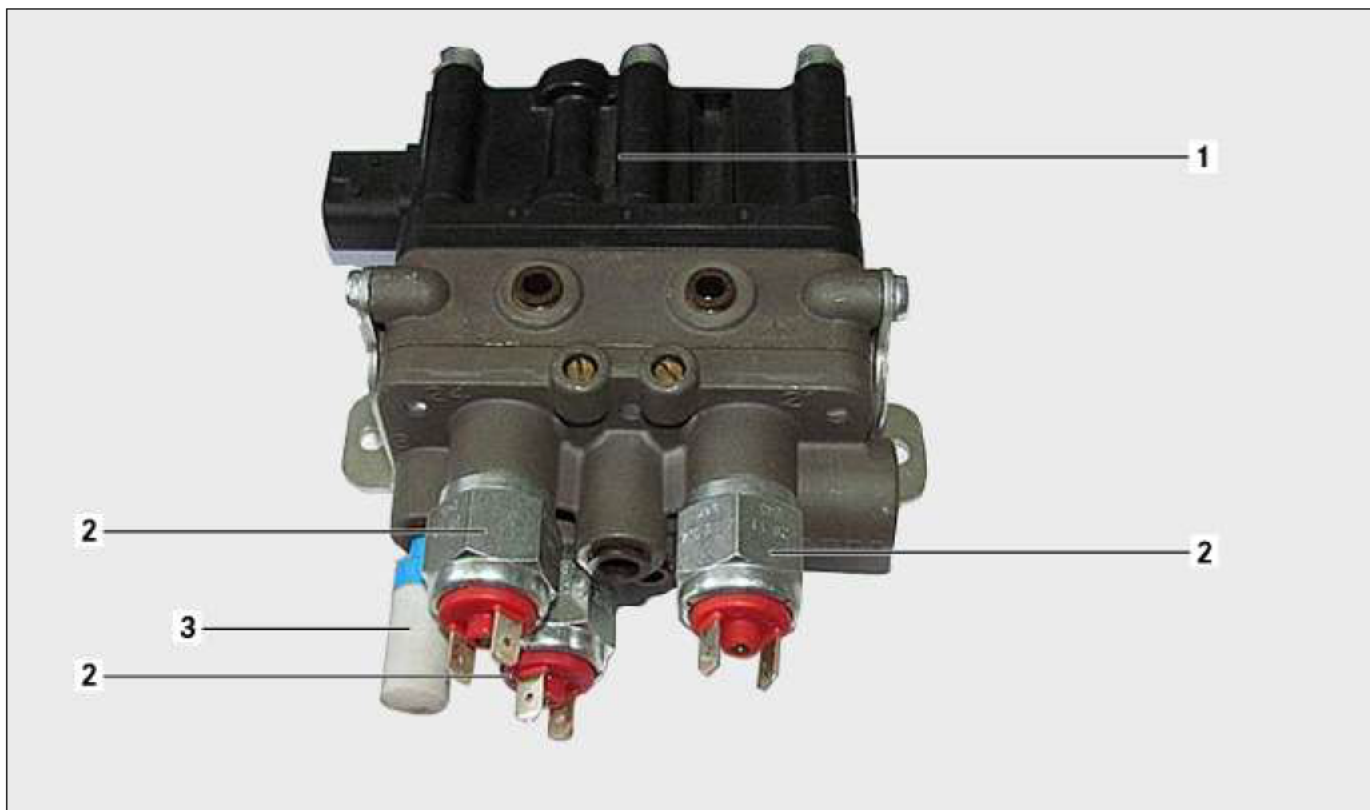
M72,40-0037-75

Converting attachment parts, in the event of door control valve replacement

1. Remove pressure switches **(2)** and fit them to new door control valve **(1)**.

Pressure switch to door control valve

30 Nm

Replace sealing rings with new ones.

2. Remove silencer **(3)** and fit it to new door control valve **(1)**.

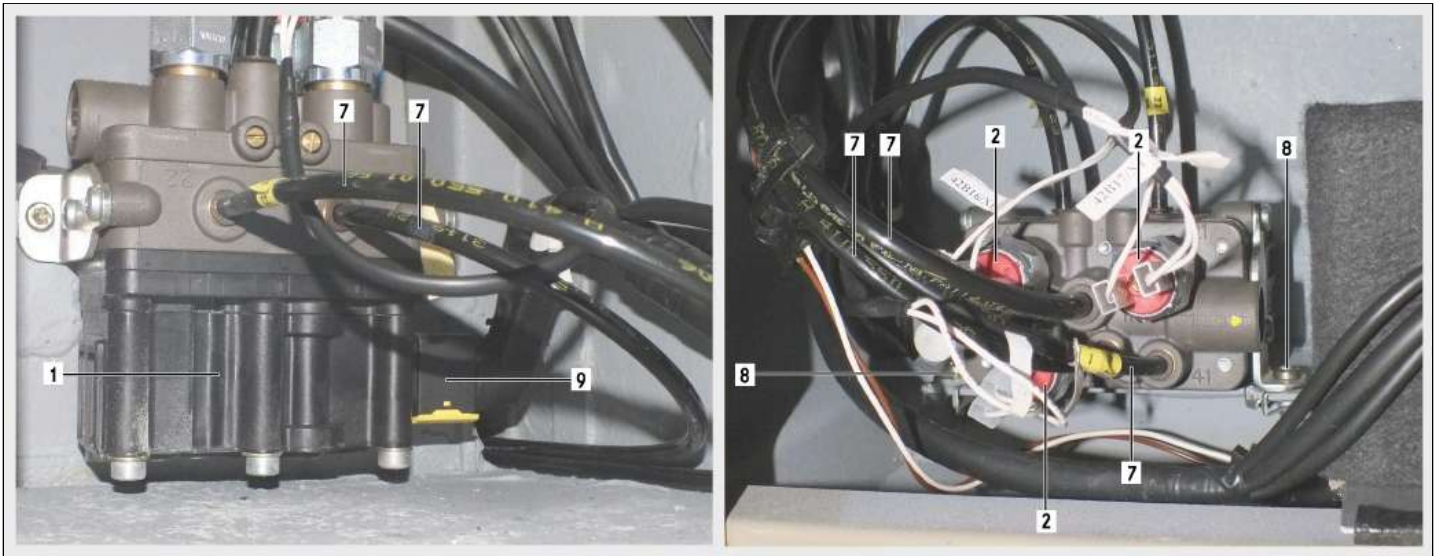
M72.40-0043-78

Fitting the door control valve

1. Note: [Routing of lines](#)
2. Establish and engage electrical connection **(9)**.
3. Fasten door control valve **(1)** in place using screws **(8)**.
4. Connect pneumatic lines **(7)** to door control valve **(1)**.

Observe the markings, do not misconnect pneumatic lines **(7)** under any circumstances.

5. Connect the electrical lines to the connections of pressure switches **(2)**.

6. Switch on the on-board power supply using the battery isolating switch.
7. Charge the auxiliary consumers circuit with compressed air at the test port or run the engine.
8. Adjust end position damping.

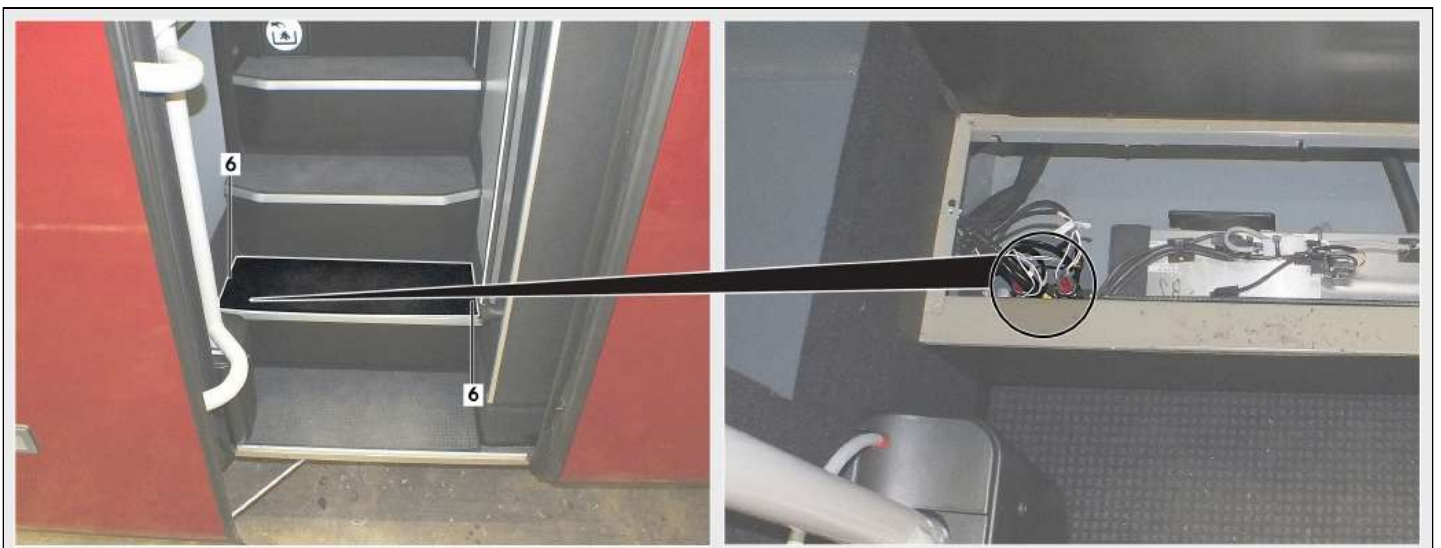
M72.40-0042-78

Door control valve of passenger door 2

1. Secure the step cover using screws **(6)**.

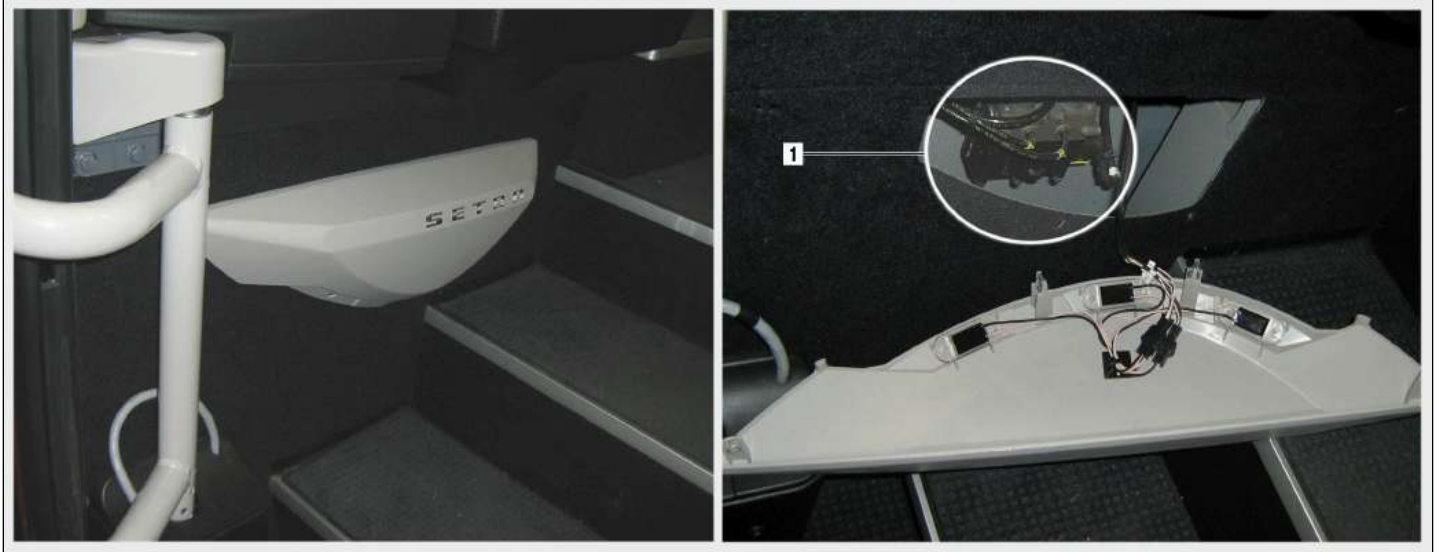
M72.10-0219-78

Door control valve of passenger door 1

1. Fit or fold closed the cover in front of door control valve **(1)**.
