SAFETY RECALL D113 CLAIM REQUIREMENTS

Defender

- 26MY Defender 110 with 3<sup>rd</sup> row

## SAFETY RECALL D113 PICTURE EXAMPLES

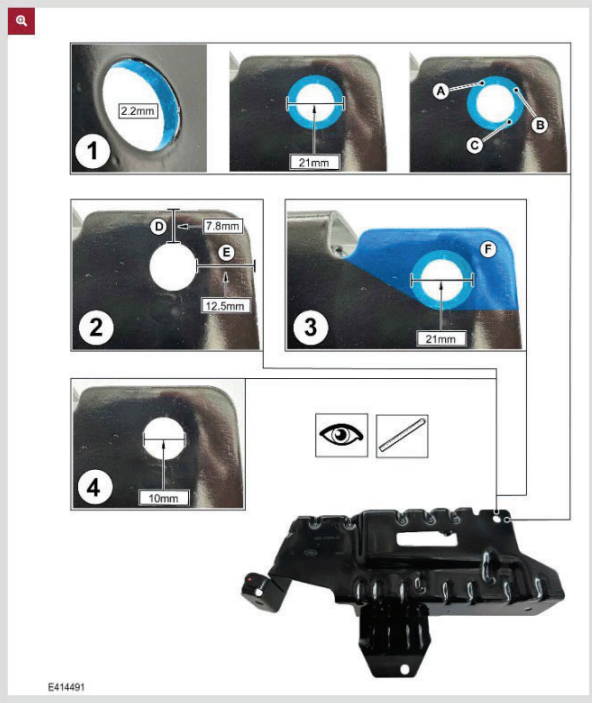
E414491

1. Using the images provided for reference, measure the thickness of the third row seatbelt anchor bracket. There must be a **minimum** thickness of 2.2 mm within the 21 mm perimeter around the drilled hole. Also, specifically measure the thickness of the areas marked A, B, and C. The deviation in thickness across points A, B, and C **MUST NOT** exceed 0.5 mm.

2. Measure from the edge of the drilled hole to the edge of the third row seatbelt anchor bracket, in the areas shown.
  - D) There **MUST** be a **minimum** of 7.8 mm from the edge of the drilled hole to the edge of the third row seatbelt anchor bracket, in the area shown.

- E) There **MUST** be a **minimum** of 12.5 mm from the edge of the drilled hole to the edge of the third row seatbelt anchor bracket, in the area shown.

3. Visually inspect the wider area of the third row seatbelt anchor bracket shown as Dark Blue in the illustration and marked F. Inspect for any incidental damage caused during steps 9 to 12. Any incidental damage present **MUST NOT** reduce the thickness of the third row seatbelt anchor bracket to less than 2.2 mm in the area shown.

4. Measure the diameter of the drilled hole. The diameter of the drilled hole **MUST** measure between 10 mm - 10.5 mm.

If **1 or more** of the below requirements cannot be achieved, a new third row seatbelt anchor bracket **MUST** be installed, continue to quarantine the vehicle and await a further communication. Do **NOT** install any third row seatbelt anchor bracket which does not meet **1 or more** of the below requirements.

Clear pictures of each measurement must be taken. That means 7 pictures per bracket, 14 pictures per vehicle/claim.

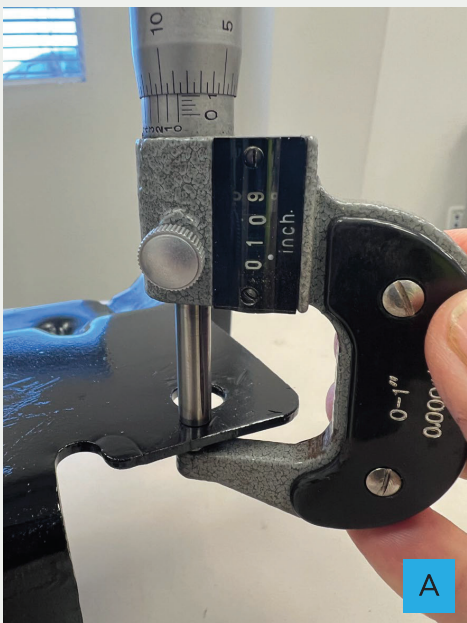
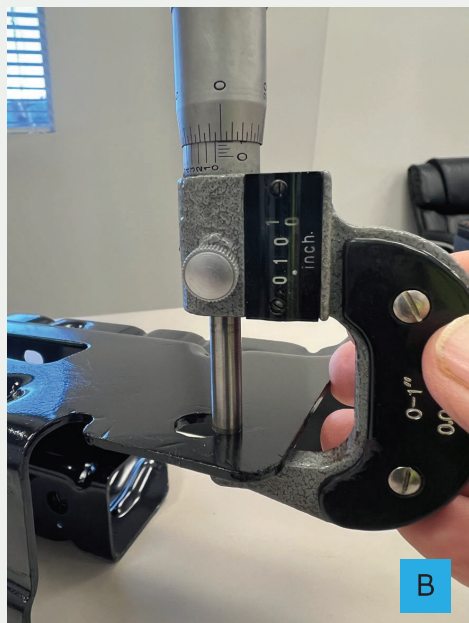
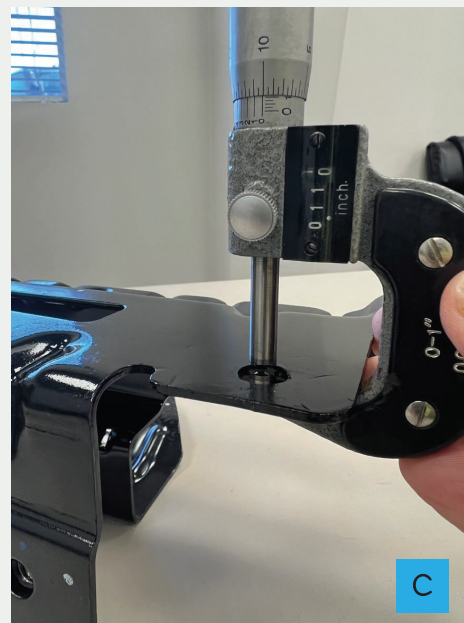
## Step 1

1. The thickness of the bracket must be confirmed at 3 points around the hole.
2. A picture of each measurement/ point must be taken.
3. A micrometer works better for this measurement than a caliper.
4. The minimum allowable thickness is 2.2mm (0.0866 inches).

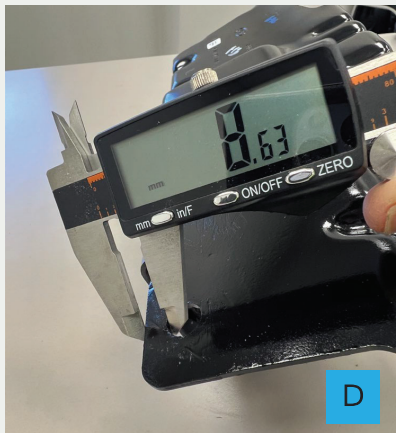
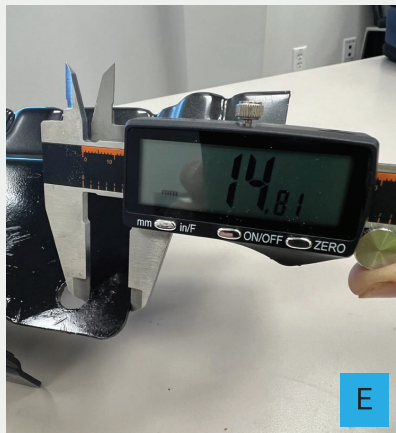
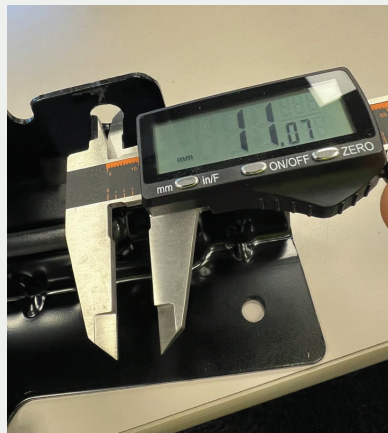
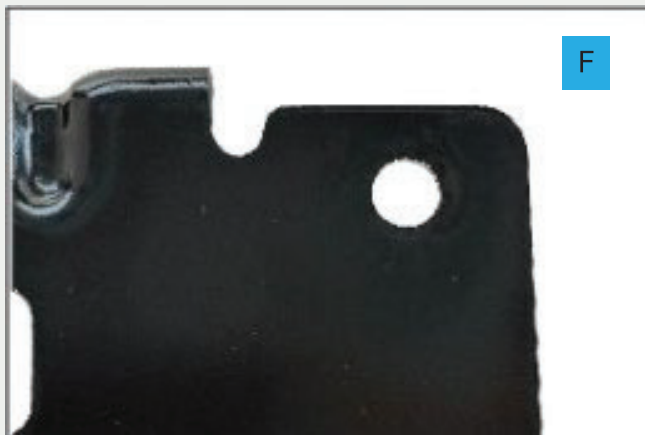
## Steps 2, 3 and 4

1. The distance of the hole to the edge of the bracket must be measured to each edge as shown, The minimum distance for measurement **D** is 7.8mm (0.307 inches).
2. The distance of the hole to the edge of the bracket must be measured to each edge as shown, The minimum distance for measurement **E** is 12.5mm (0.492 inches).
3. A clear picture of the surface around the stud hole must be taken to prove that there isn't any gouges/ cut marks in the bracket. Photo **F**
4. Measure the size of the hole in the bracket and confirm it is between 10 – 10.5mm (0.393 – 0.413 inches).

Any bracket that fails any of the minimum measurement steps, the bracket must be replaced.
