RRC-72-26-001-1: Inspect 2nd Row Seat Belt Fastener, R1T

Document Type	Safety Recall Bulletin
Date	January 9, 2026
Affected Region(s)	USA, Canada
Affected Model(s)	R1T
Model Year(s)	2022-2026
Approximate Build Dates	September 2021-May 2025

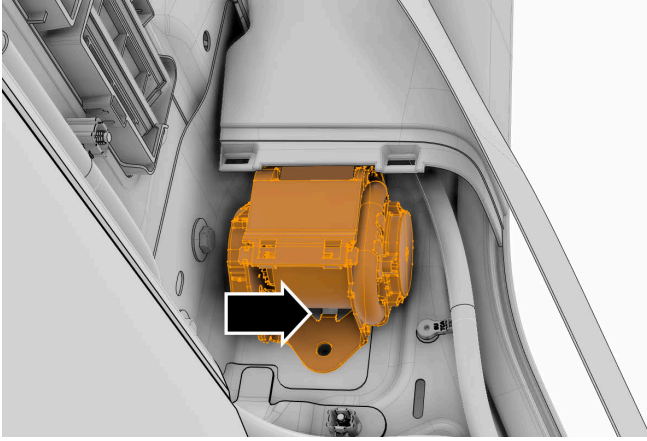
5. Check that the tab on the retractor is within the slot shown.

- If the tab on the retractor is not within the slot: Replace: Seat Belt, 2nd Row (refer to service manual procedure 721030010).
