IMPORTANT SAFETY RECALL

NHTSA Safety Recall# 26V-016
TRANSPORT CANADA# 2026-011

SUBJECT: Campaign # 201 – Water Tank Heating Pads

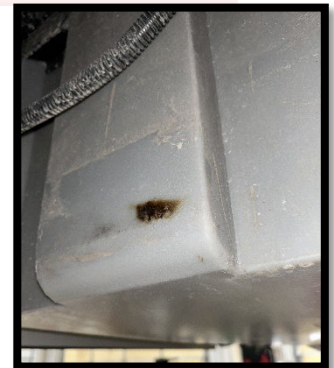
EXAMPLE

Before proceeding with the remedy, you must take at least three (3) clear photos of the damage present. These images must clearly show the specific area of thermal damage on the vehicle's tanks or removed *Thermaheat Pads*, including:

- The front & back side of the affected ThermaHeat heating pad(s) & area of damage on the pad(s).
- Evidence of any thermal damage to the tank surface where the ThermaHeat pad was adhered to.

- **If signs of thermal damage are present:** Retain the affected ThermaHeat pad(s) for return.
- **ThermaHeat Pads Return:** Even if only one pad shows signs of a thermal event, **all** ThermaHeat pads on the vehicle must be returned using the provided label included in the remedy kit.
- **If no signs of thermal damage are present:** Follow standard disposal procedures for the removed pads.

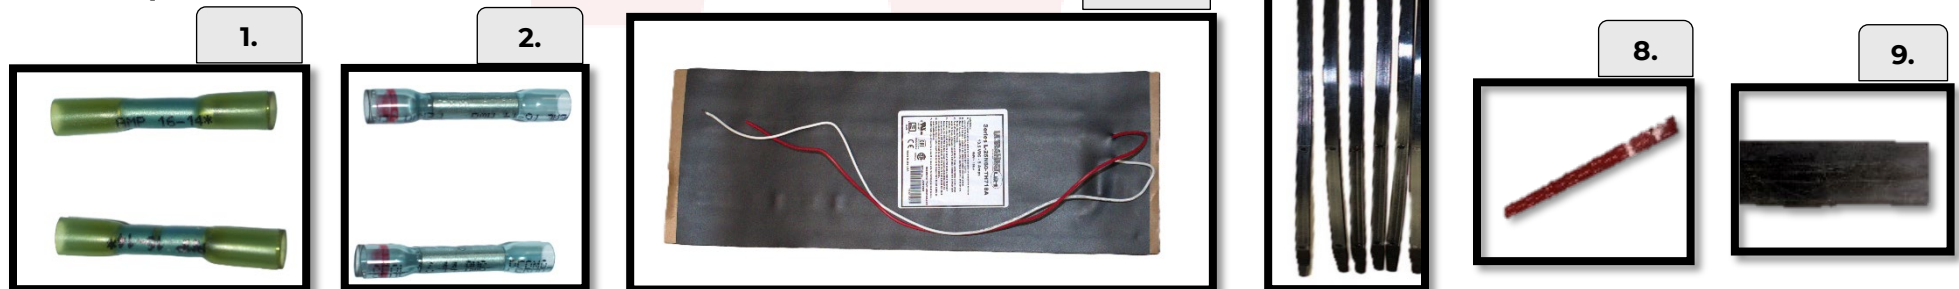
Part/s Required:

1. 16-14 AWG SPLICE-BUTT - 326467-01-000 (2) for **Red Positive** wire. (One per Pad)
2. 16-14 to 22-18 AWG SPLICE - REDUCER - 326905-01-000 (2) for **White Negative** wire. (One per Pad)
3. HEATING PAD - 364953-01-000
 - (2 needed per 322RS/324GG/326FE)
 - (3 needed per 328MB)
4. TIE-WIRE-14IN - 008343-02-000 (5)
5. CONVOLUTED CONDUIT - 041953-09-000 (2FT)
6. NUT-HEX-SER FLG LK 5/16-18 - 000D39-05-00B (4)
 - (4 needed per 322RS/326FE/328MB)
 - (2 needed per 324GG)
7. NUT-HEX W/NYLON LOCK - 000D29-06-00B (3)
 - (3 needed per 322R/322M - all other floorplans will not need to use these extra parts)
8. VHB TAPE, DBL COATED - 076322-23-000 (2FT)
9. SEAL-WIPE - 115075-03-000 (2 FT)

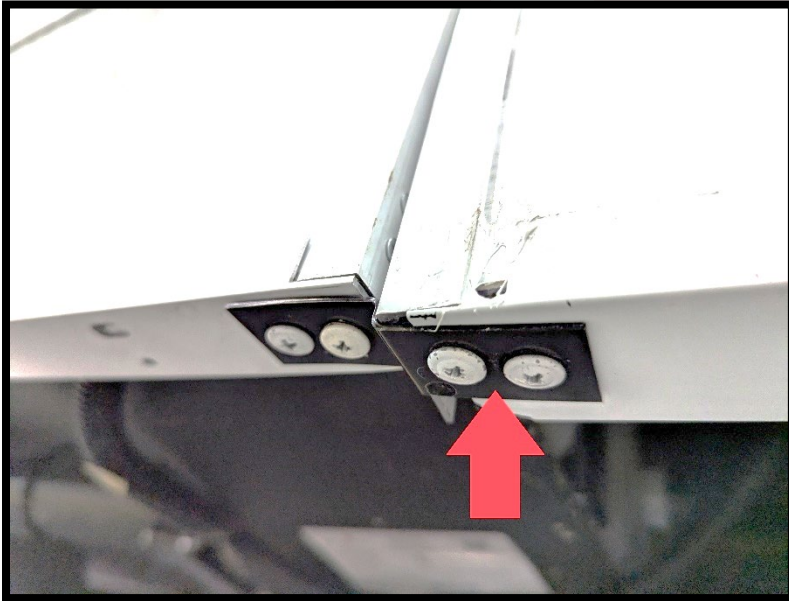
Figure 3

- A. Use a screw gun to remove the plate screws on each end of the passenger side compartment door behind rear wheel to allow door to open. (Figure 3)
- B. Use duct tape to tape the door to the sidewall securely to keep it open during rework. Duct Tape needs to be installed on fiberglass to avoid decal damage. (Figure 4)

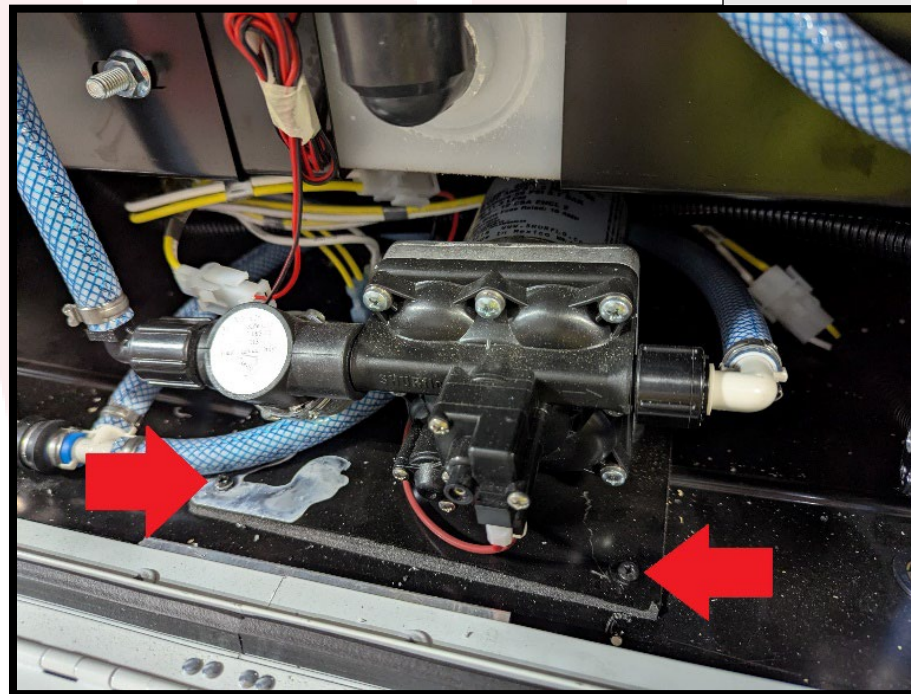
Figure 7

- A. Open the passenger side rear compartment door and use a screw gun to remove the two water pump screws holding the water pump plate to the compartment. Keep and set the screws aside for reinstallation further down in the process. Carefully remove the water pump from the compartment taking special care not to kink any of the flexible water lines. (Figure 7)
- B. Find an object to set the water pump on that is close to the outside of the compartment door opening to allow the water lines to remain connected on the pump while the rework is occurring. The fresh tank heat pad is now accessible to remove.

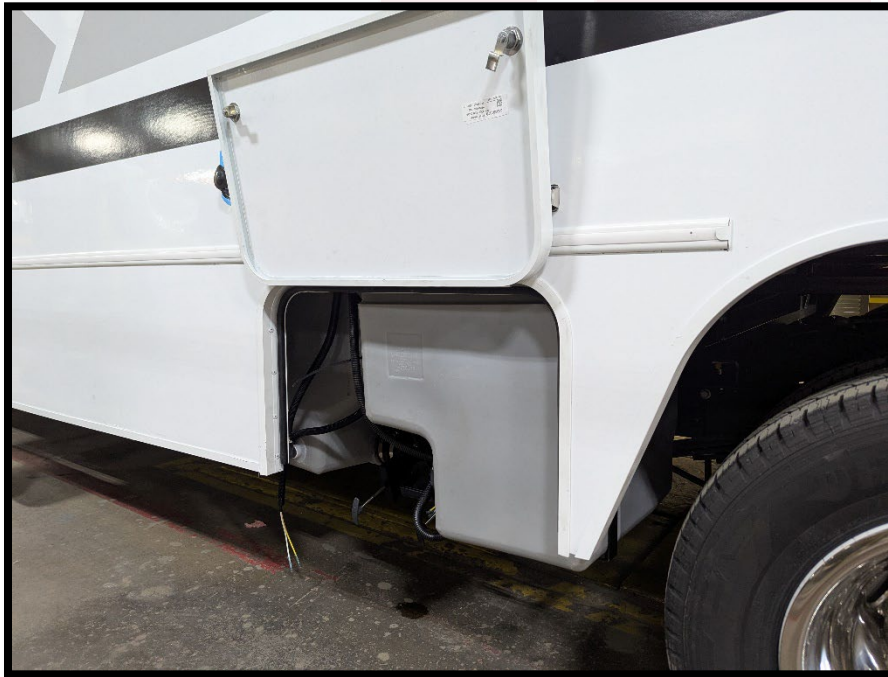
Figure 8

- A. Open the driver's side drainage compartment door to get access to the holding tanks. (Figure 8)
- B. Use a 5/16" socket and wrench to remove the two hex nuts holding the outboard grey tank strap to the floor frame assembly. This is the strap where one of the new heating pads will be installed under and should be the only one to be removed. (Figure 9)
- C. Remove the tank strap and set aside for use later. The hex nuts that were removed should NOT be reused and should be thrown away. The holding tank heat pads are now accessible to remove.

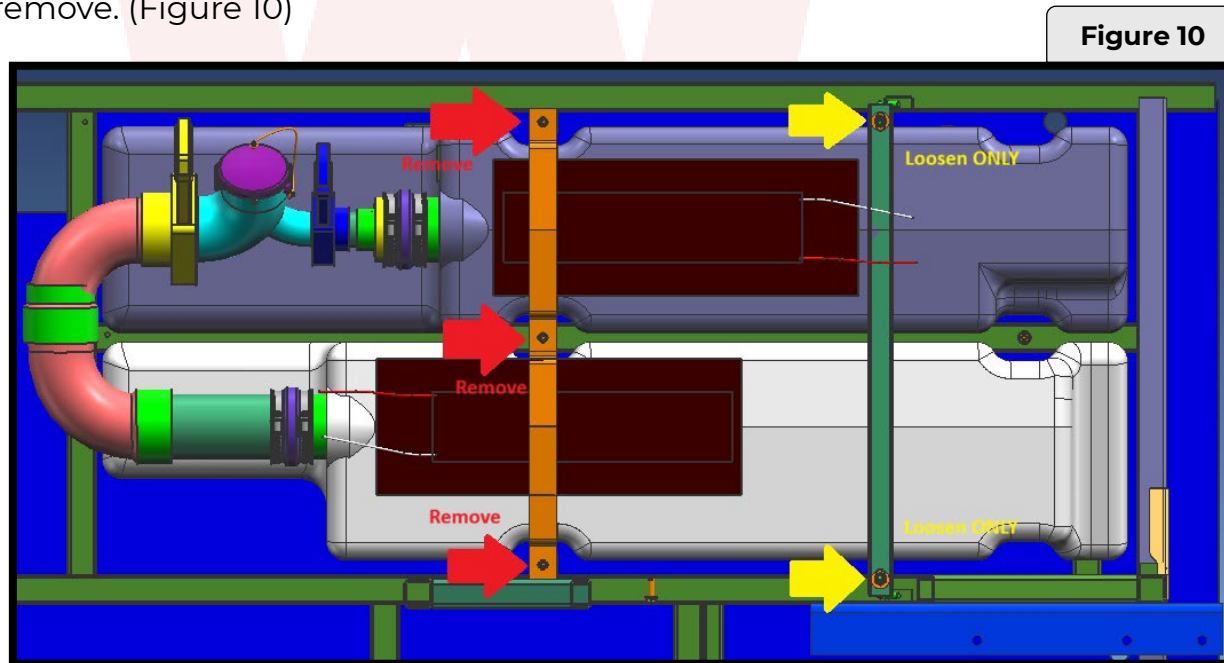
- A. Use a 5/16" socket and wrench to remove the two hex nuts (Red Arrows) holding the grey tank strap to the floor frame assembly. Also remove the hex nut (Red Arrow) holding the black tank strap to the floor frame assembly. These are the straps the new heating pad will be installed under.
- B. Remove these two tank straps and set aside for use later. The hex nuts that were removed should NOT be reused and should be thrown away.
- C. On some models, the two nylon nuts on the J-bolts (Yellow Arrows) holding the channel may also need to be loosened to get access to remove the old heat pad from under it. Use a 3/8" socket and wrench to loosen these nuts, but **do not** fully remove the channel assembly, keep the tank in place. The holding tank heat pads are now accessible to remove. (Figure 10)

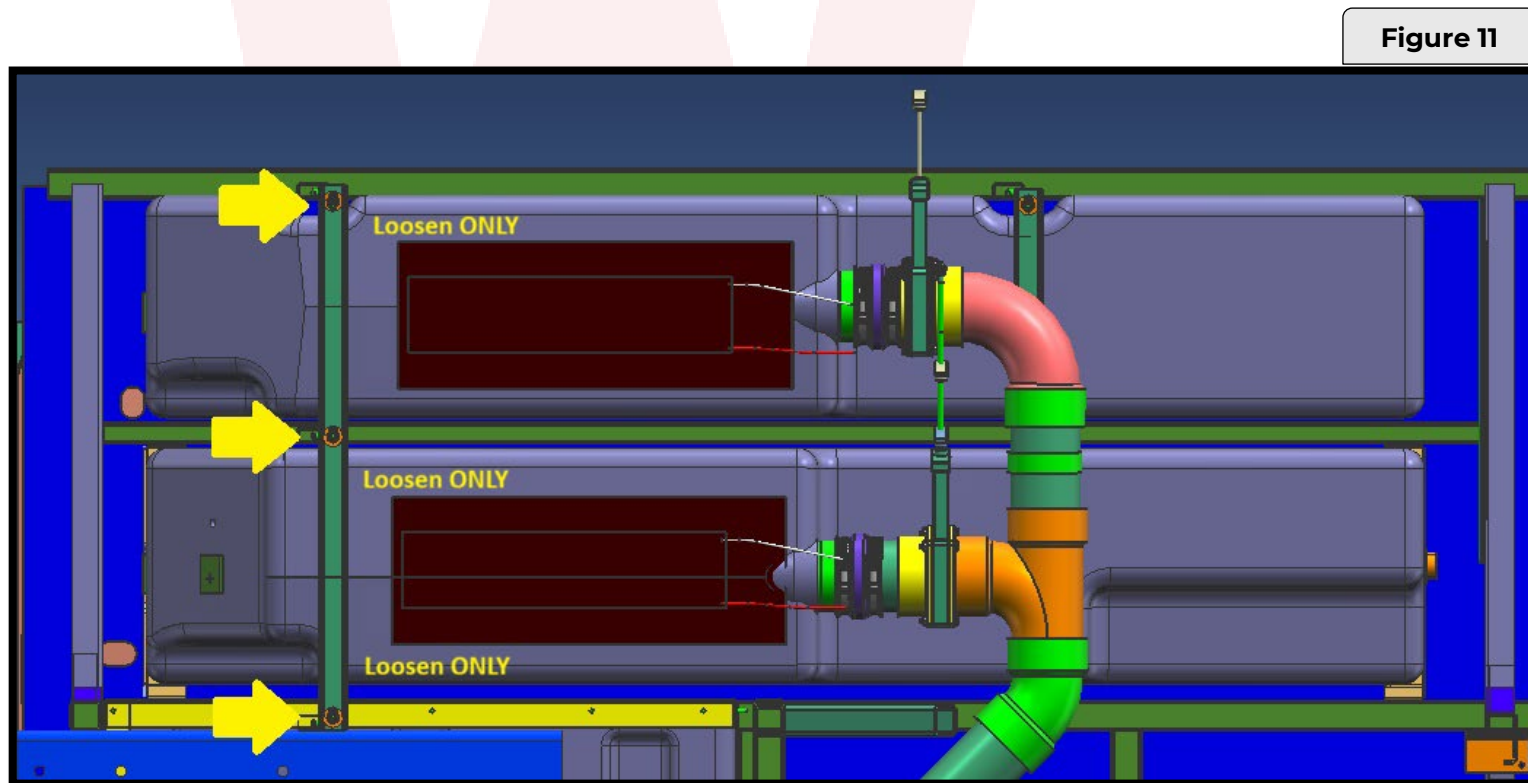
- A. The three nylon nuts on the J-bolts holding the rearmost channel may need to be loosened to get access to remove the old heat pad from under it. Use a $3/8$ " socket and wrench to loosen these nuts, but do not fully remove the channel assembly, keeping the tank in place. The holding tank heat pads are now accessible to remove. (Figure 11)

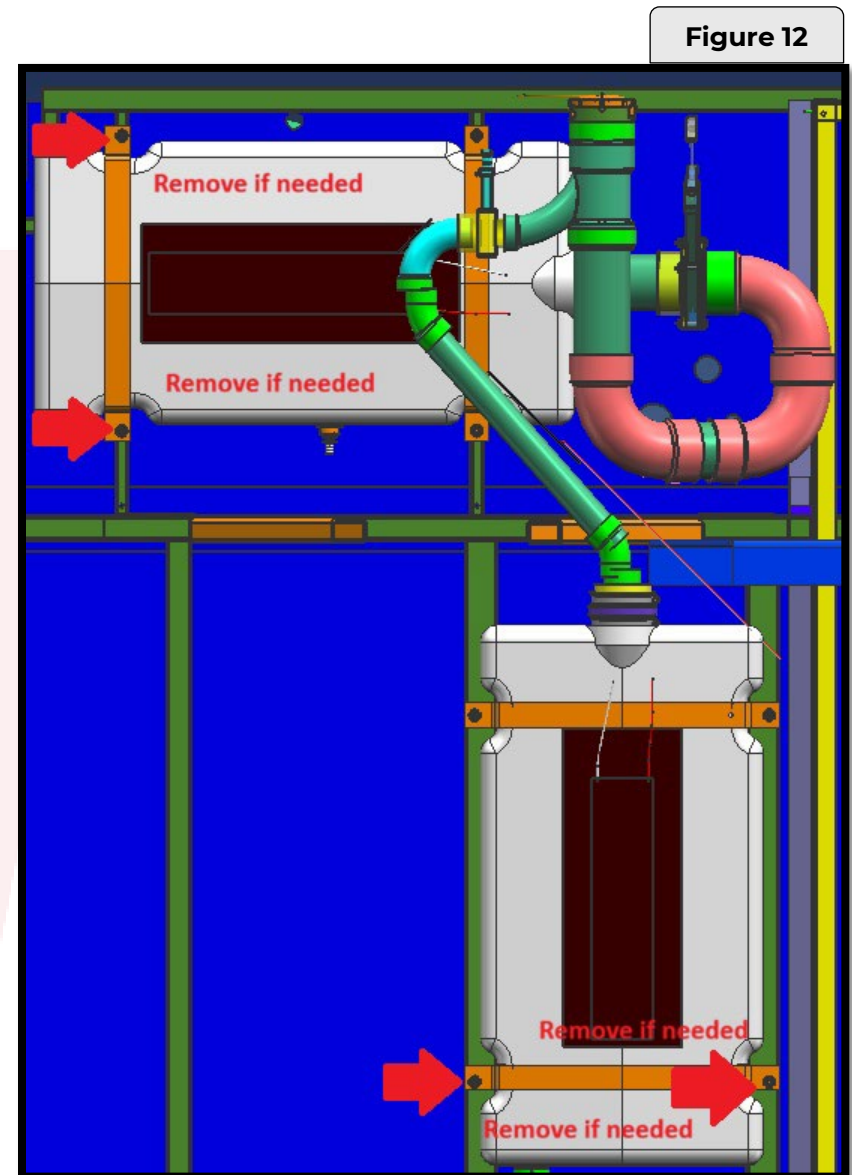
Do the same process to the outboard grey tank strap if needed. These straps are to only be removed to access and remove the old heating pad as the new heating pad is shorter and will not need to be applied under these straps again.

- B. For any straps removed, set aside for reinstallation later. The hex nuts that were removed should NOT be reused and should be thrown away. The holding tank heat pads are now accessible to remove. (Figure 12)

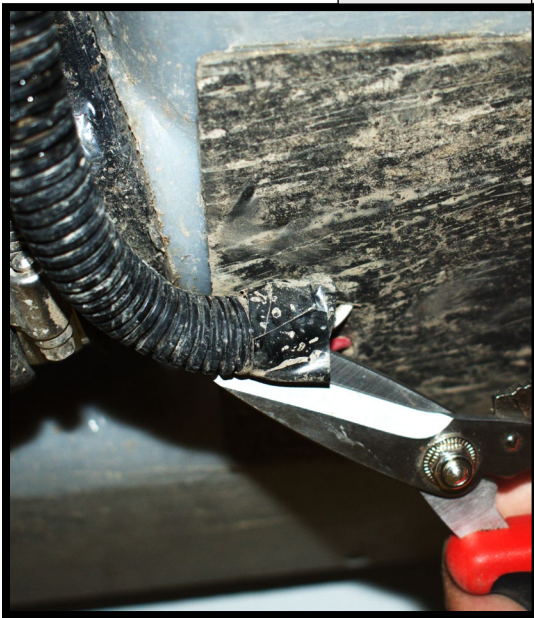
Figure 13

- A. Using a pair of scissors, safely remove the tape that secures the conduit at the heating pad wires. See (Figure 13) for general cases.
- B. Use the scissors to also cut off any zipties securing the chassis loom near the heating pad. You will be making a spliced connection, and this will allow for better access to the chassis loom wires. See (Figure 14) for general cases.
- C. Use a pair of wire cutters to cut the White and Red heating pad wires leaving at least 1 inch of these heating pad wires on the butt connectors. See (Figure 15) for general cases.

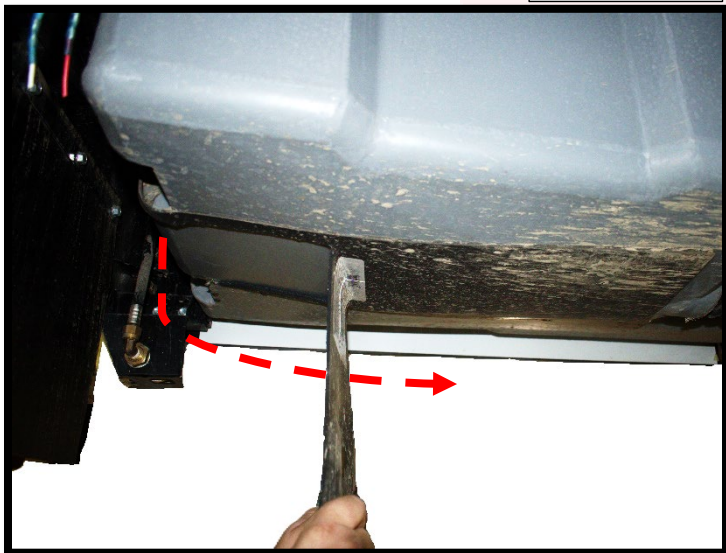
Figure 16

- D. Once the heating pad wires have been cut, carefully remove/detach the pad, beginning from the side where the wires are located and moving away from the wire connection. This method helps preserve the integrity of the removed pads as much as possible. See (Figure 16) for general cases.
- E. Use a plastic hand chisel/tool to remove any pad foam-residue left on the tank from the removed pad. See (Figure 17) for general cases.
- F. Using your bare hand, apply pressure and roll off any adhesive still on the tank. See (Figure 18) for general cases.
- ⚠ G. **CRITICAL:** If any signs of thermal damage are present on the tank or on the removed ThermaHeat Pad itself, please refer to the “**RECALL 201: TANK HEATING PADS DOCUMENTATION FORM**”. Submit only one form per vehicle, even if multiple tanks or pads on this vehicle show signs of a thermal event.

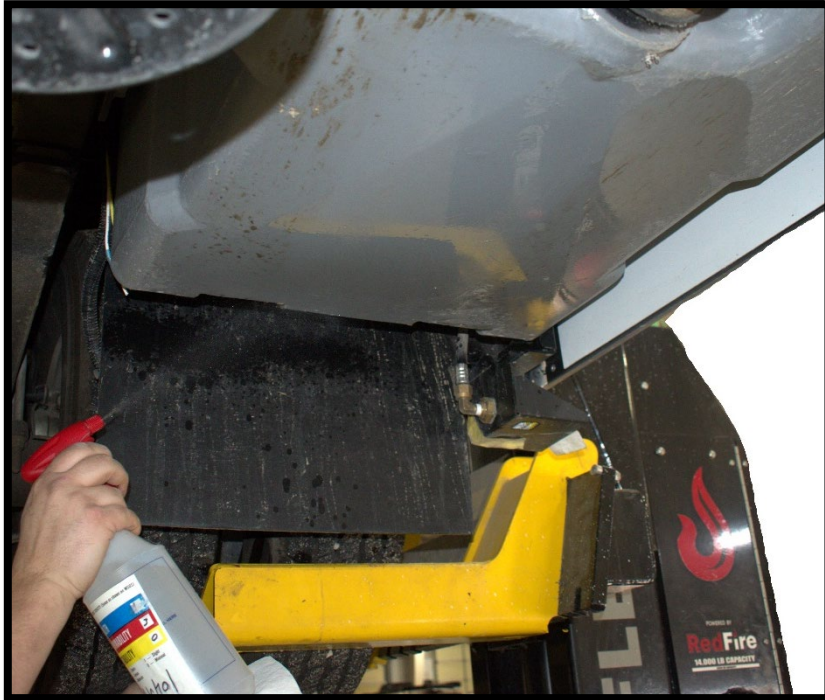
Figure 19

- A. Use Isopropyl Alcohol to prep the surface or surfaces of the tank to where the new heating pad will be adhered to. See (Figures 19 & 20) for general cases.

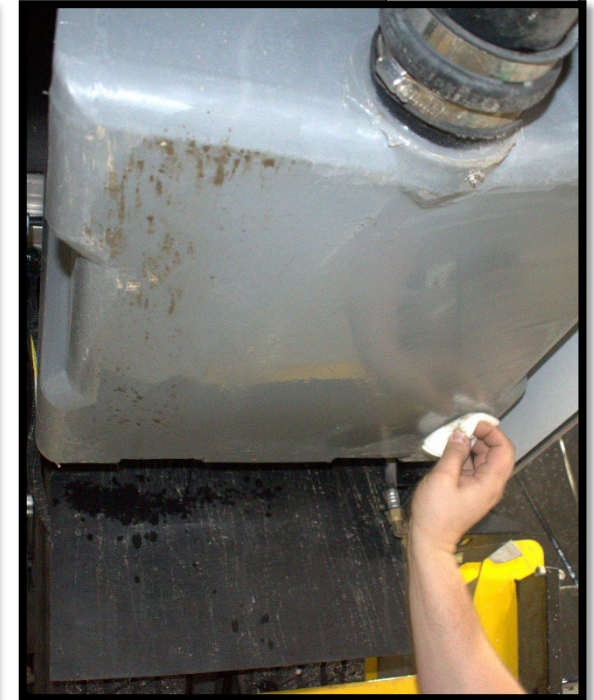
Figure 21

- B. Use clean shop towels and ensure to completely dry off the surface you applied isopropyl alcohol to. See (Figure 21) for general cases.

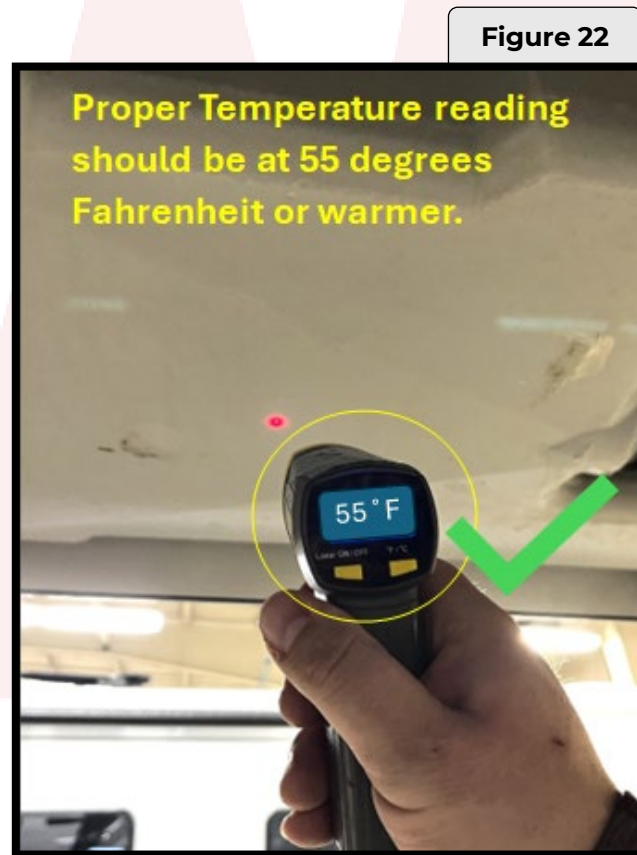
- A. Use a therma-gun to measure the temperature of the tank surface and ensure the temperature exceeds 55°F (12.8°C) or warmer. (Figure 22)

Note: If the tanks do not exceed this temperature, use a heat lamp or heat gun to ensure the tank is above this temperature. Failure to adhere the heating pads at an appropriate temperature may cause the adhesive to fail.

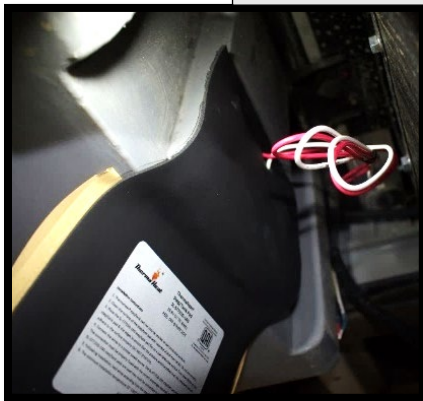
Figure 23

- B. Leaving the heating pad adhesive paper still on the pad, pre-fit the heating pad (364953-01-000) to secure accurate adhering surface location. See (Figure 23) for general cases. Reference (Figures 24-29) specific required locations by vehicle's floorplan on this page and the following page).

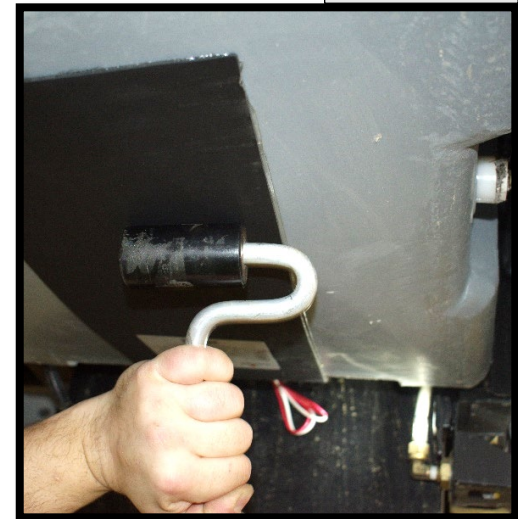
Figure 31

- D. Once the entire heating pad is applied to the tank, use a pressure roller and apply pressure to the adhered surfaces of the pad on the tank. See (Figure 31) for general cases.

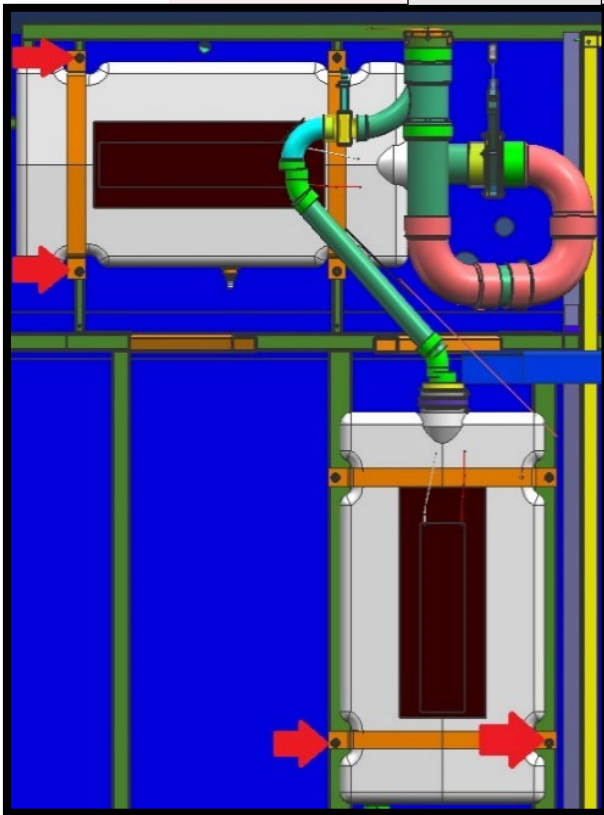
Figure 39

- D. If a tank strap was removed for access to remove the old heating pad (331H / 331K units only), use a 5/16" socket and wrench and hex nuts (000D39-05-00B) to install the tank strap(s) back to their original locations. (Figure 39). Use torque wrench to torque hex nuts to **17.8 +/- 1.8 Nm** (334988-01-000) (Figure 40)
- E. If a channel attached to a J-bolt was loosened for access to remove the old heating pad (322R / 322M units only), use a 3/8" socket and wrench and use new hex nylon lock nuts (000D29-06-00B) to replace the ones used. (Figure 41). Tighten hex Nylon lock nuts (330264-01-000) until tank is tight to the floor and will not move.™

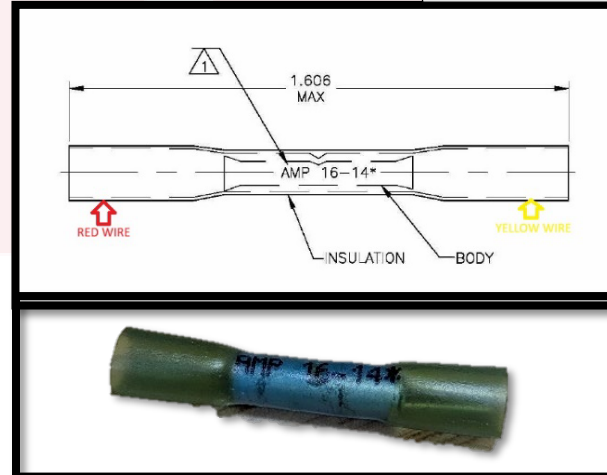
Figure 43

- C. Replace the butt splice connectors. The Yellow chassis loom wire should use the 16-14 AWG butt splice connector (326467-01-000). (Figure 43)
The White chassis loom wire should use the 16-14 AWG to 22-18 AWG butt splice connector (326905-01-000) paying close attention to the orientation of the connector, with the red stripe oriented towards the 18 AWG wire on the tank heater pad. (Figure 44)

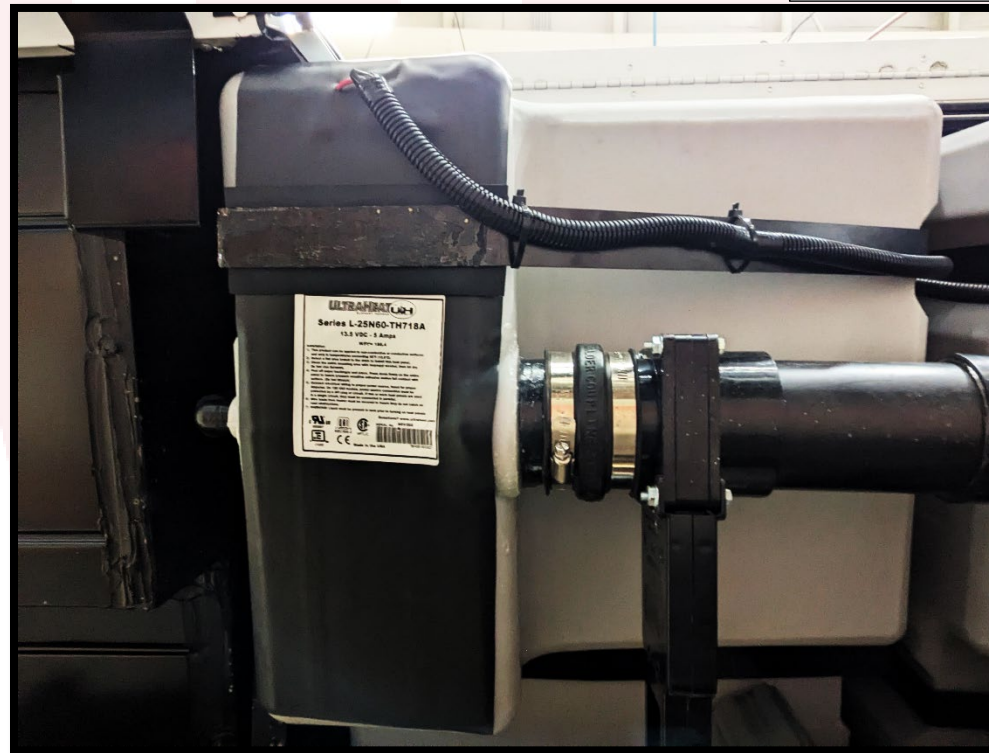
Figure 47

- H. Following the same heating pad replacement process, remove and replace the heating pad on the other tank (if applicable). Ensure you follow all steps accurately for a successful repair. See (Figure 47) for general cases.

DO NOT turn on tank heating pads if there is no water present within the tanks.

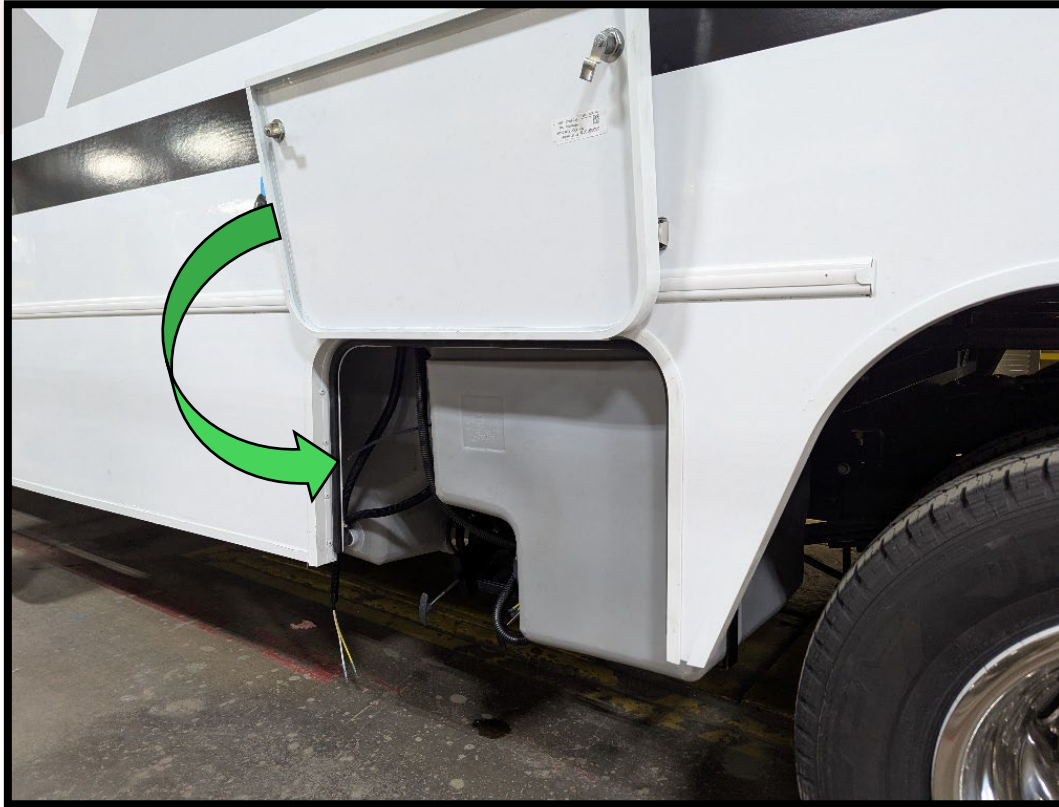
Figure 50

A. Close the driver's side drainage compartment door. (Figure 50)

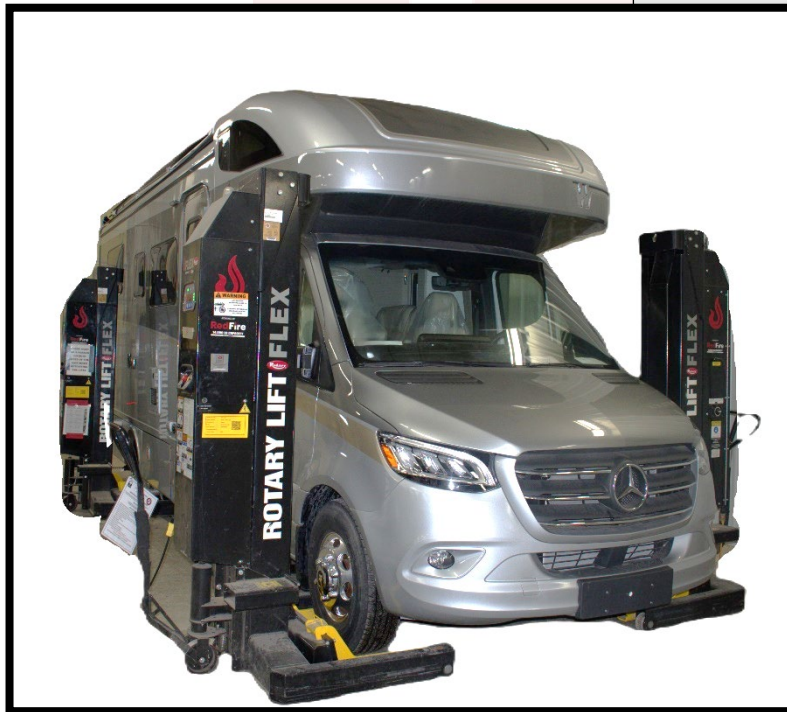
Figure 1

- A. Ensure the vehicle ignition and battery disconnect are both **OFF** before lifting the vehicle. ⚡
- B. Use 4 lifts or hoists to lift the vehicle and ensure they are safely set to hold the vehicle while the rework is done. (Figure 1)
- C. Ensure the hoists do not damage the windows or the sidewalls while the vehicle is being lifted. (Figure 2)

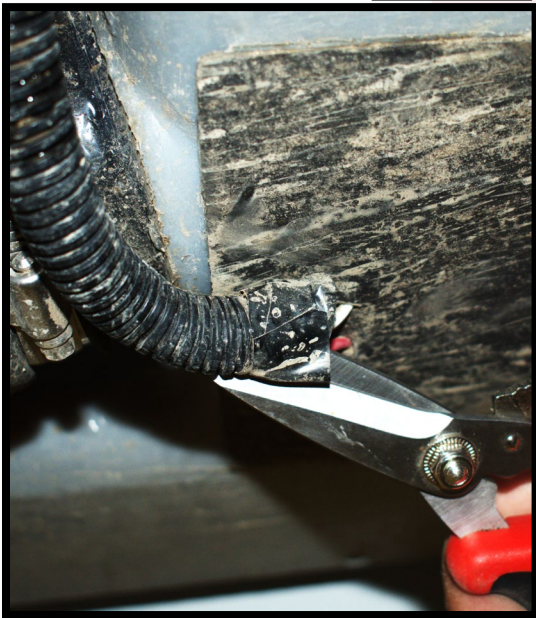
Figure 3

- A. Using a pair of scissors, safely remove the tape that secures the conduit at the heating pad cables. See (Figure 3) for general cases.
- B. Use the scissors to also cut off any wire ties securing the chassis loom near the heating pad. You will be making a spliced connection, and this will allow for better access to the chassis loom wires. See (Figure 4) for general cases.
- C. Use a pair of wire cutters to cut the White and Red heating pad wires leaving at least 1 inch of these heating pad wires on the butt connectors. (Figure 5)
This will help you reference which chassis loom wires the new heating pad wires need to be connected to.

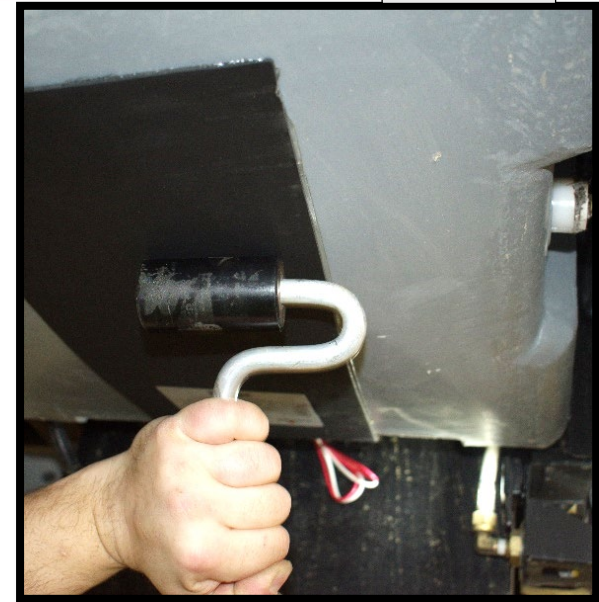
Figure 18

- C. Always start adhering the new pad at the wire connection side and then follow through and adhere the rest of the heating pad appropriately, removing the paper side of the adhesive with one hand as you apply the pad with pressure with your other hand. See (Figure 17) for general cases.
- D. Once the entire heating pad is applied to the tank, use a pressure roller and apply pressure to the adhered surfaces of the pad on the tank. (Figure 18)

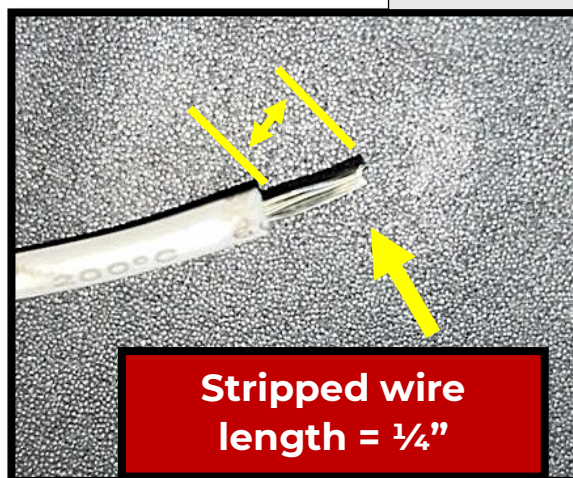
Figure 19

- A. Use wire cutters to cut both the Red and White wires on the heating pad, leaving at least 1 foot (12 inches) from the heating pad. Use wire strippers to strip the end of the heating pad wires about **1/4 inch**. (Figure 19) Discard the excess wires you just cut off.
- B. Cut the old butt splice connectors off the chassis loom wires (Yellow and White wires), making the cut as close to the splice connectors as possible. Strip the chassis loom wires to about 1/4 inch.
- C. Replace the butt splice connectors. The Yellow chassis loom wire should use the 16-14 AWG butt-splice connector (326467-01-000). (Figure 20)
- D. The White chassis loom wire should use the 16-14 AWG to 22-18 AWG reducing butt-splice connector (326905-01-000) paying close attention to the orientation of the connector, with the red stripe oriented towards the 18 AWG wire on the tank heater pad. (Figure 21)

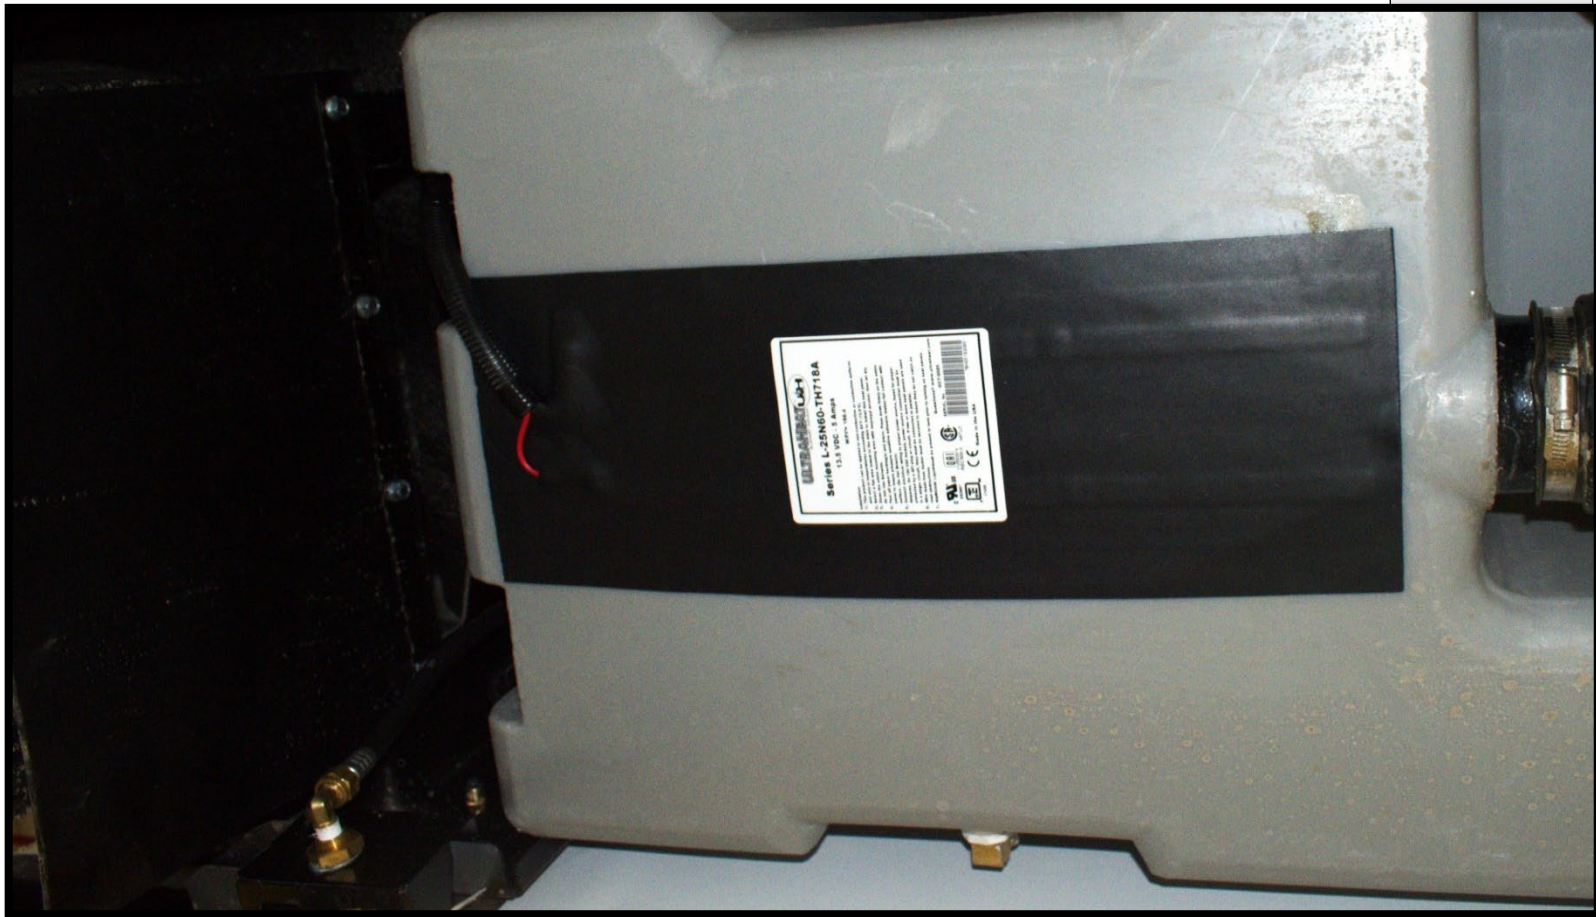
- A. Following the same replacement process, remove and replace the heating pad on the other tank (if applicable).
Ensure you follow all steps accurately for a successful repair. See Figure 24 below for reference.
