GROUP	MODEL
Safety Recall Campaign	2021-2024MY K5 (DL3a) w/1.6L T-GDI
NUMBER	DATE
SC356 (Rev 1, 02/05/2026)	January 2026

### FUEL TANK INSPECTION/REPLACEMENT AND PCSV CHECK VALVE AND ECU SW UPGRADE (SC356)

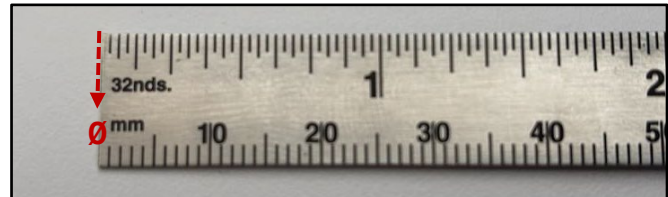
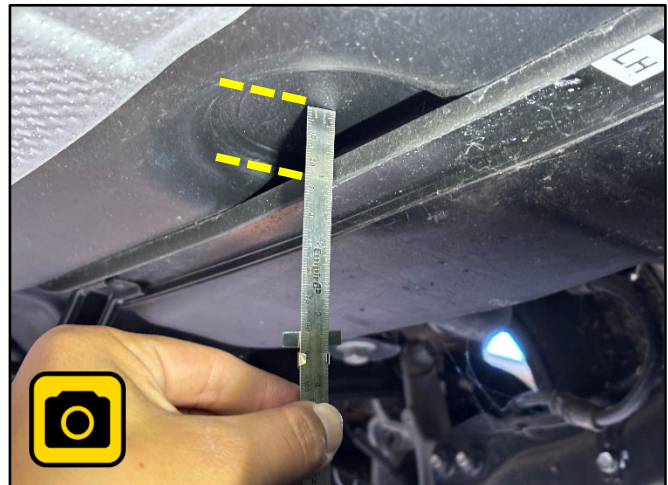
- 2a. Measure the gap between the inner red circled surface of fuel tank (B) and the top side of the **Left** fuel tank band (C), as shown.

- 2b. **FWD/2WD:**

- If the gap between the fuel tank and the top side of the fuel tank bands measures 24mm or LESS (OK), proceed to step 3 and follow the flowchart instructions.
- If the gap between the fuel tank and the top of the fuel tank bands measures 25mm or MORE (NG), take a clear photo of the NG condition and then proceed to step 3 and follow the flowchart instructions.

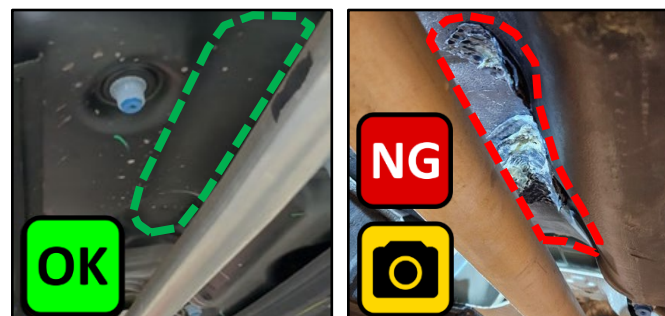
3. Remove the heat protector shield (removal of the exhaust is not required).

**Note:** In some cases, the heat protector shield may not come loose if the fuel tank surface has previously expanded and is melted/adhered to the heat shield **(NG)**.

4. Inspect the surface of the fuel tank for melting:

- If there is no visible contact from the fuel tank and the shield - no melting of fuel tank surface **(OK)**, follow the flowchart instructions on page 2.
- If there is visible contact and melting of the fuel tank surface to the heat shield **(NG)**, take a clear photo of the **NG** condition and then, proceed to step 5 to inspect the fuel pump service cover.

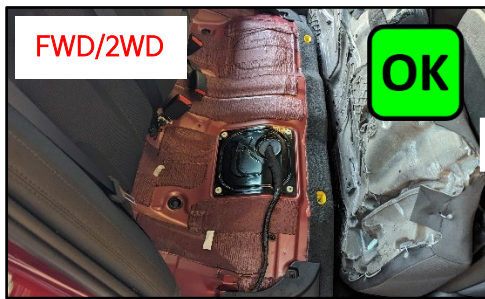
**Note:** AWD model shown on the right for reference use only, the FWD models shown below feature a single fuel tank service cover access.

- Inspect the seat floor to fuel pump service cover (E) (4 sides) for any visible gaps:

- If a gap is **NOT** present (**OK**), the cover is seated flush with the seat floor panel, follow the instructions on the flowchart on page 2.
- If a gap **IS** present (**NG**), the cover is lifted/detached from the seat floor panel, create a Techline Repair Assistance (RA) case, and take a clear photo of the NG condition using the KDS Warranty Claim Attachment tab, follow the instructions per Techline.

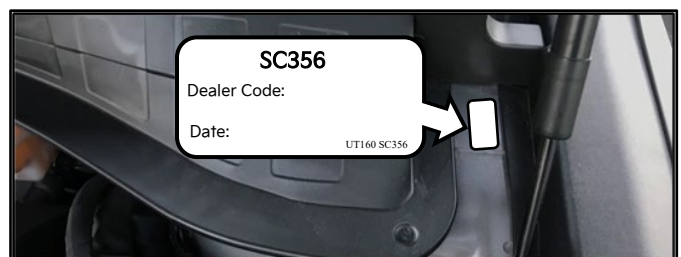
The dealer must fill in the Dealer Code and Date information fields on the Campaign Completion Label. Once complete, affix the campaign completion label under the hood of the vehicle, as shown below.

**CA and S.177 States Only:** Apply SC356 Campaign Completion Label onto the body in the area next to the shock tower, as shown. **NOTE: Be sure to clean the mounting surface to ensure proper label adhesion.**
