**TECHNICAL INSTRUCTIONS**

**SAFETY RECALL 26TA04**

**INCREASED RISK OF VEHICLE FIRE**

**2021-2023 MODEL YEAR SUPRA**

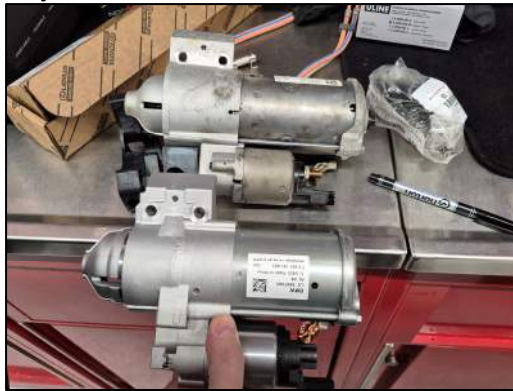
NOTE: The new starter is significantly smaller than the starter which will be removed.

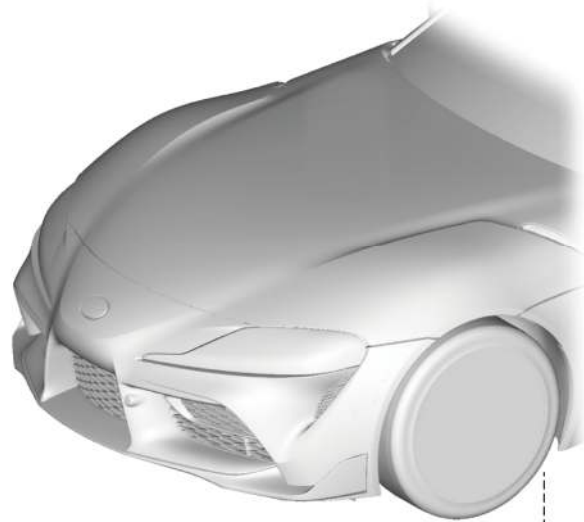
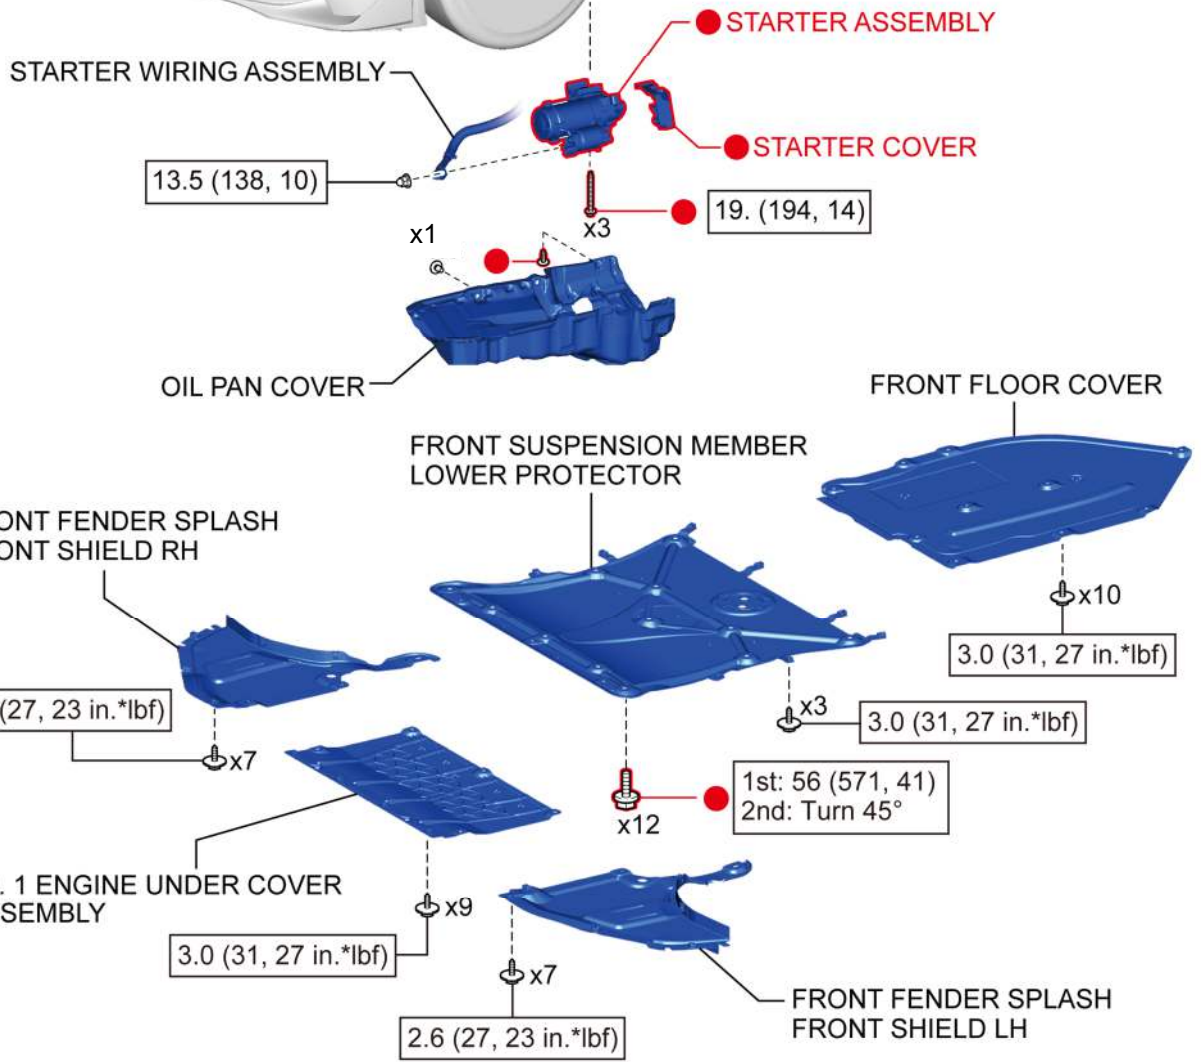
R2509180003a

● : Replacement part

**N\*m (kgf\*cm, ft.\*lbf)** : Specified torque

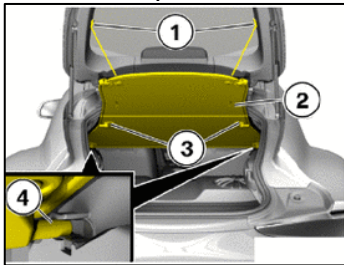
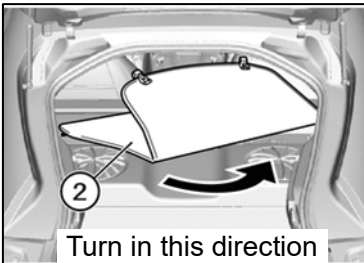
- c) Detach the retaining straps (1).
- d) Detach the rear mountings (3) to the top.
- e) Detach the front guides (4) to the rear.

- f) Fold the package tray trim panel assembly (2) together and remove.

Turn the package tray trim panel assembly (2) approximately 45° counterclockwise and remove it from the tailgate.

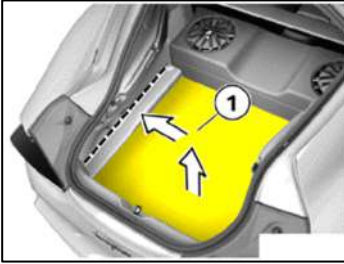
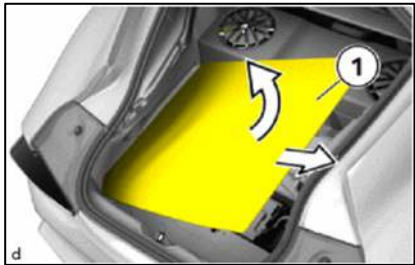
Remove in this Direction

- a) Slightly lift the deck board assembly (1) on the right side with a suitable tool.
- b) Slide the left edge of the deck board assembly (1) into the recess in the direction of the arrow of the deck board assembly.

- c) Remove the deck board assembly (1) in the direction of the arrow.

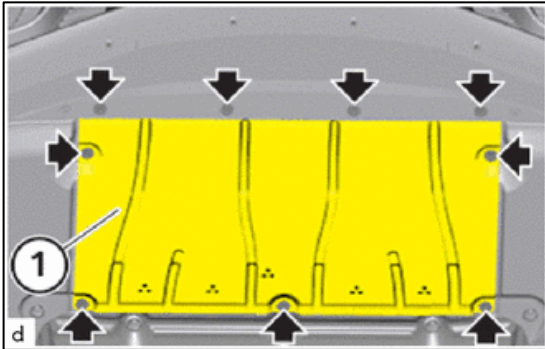
- Remove screws (arrows).
- Remove the No. 1 engine under cover assembly (1).

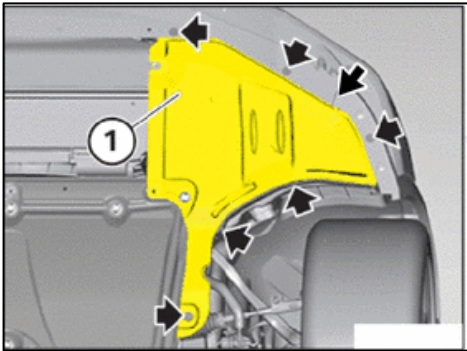
- Remove screws (arrows).
- Feed out the front fender splash front shield LH (1) to the side and remove.

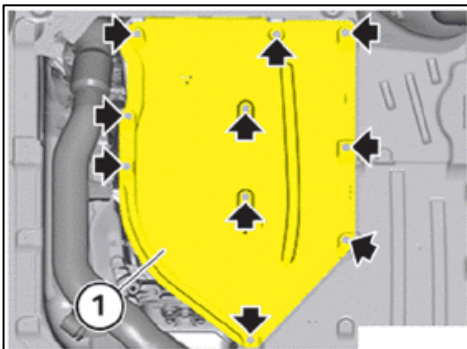
- Remove screws (arrows).
- Remove the front floor cover (1).

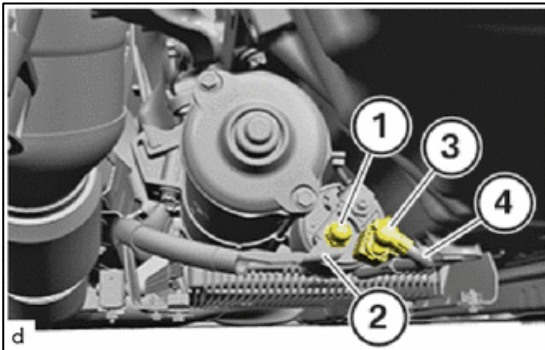
- Unfasten nut (1).
- Remove starter wiring assembly (2) from starter assembly.
- Unlock connector (3) and disconnect.
- Remove the transmission wire (4) for terminal 50 from the starter assembly

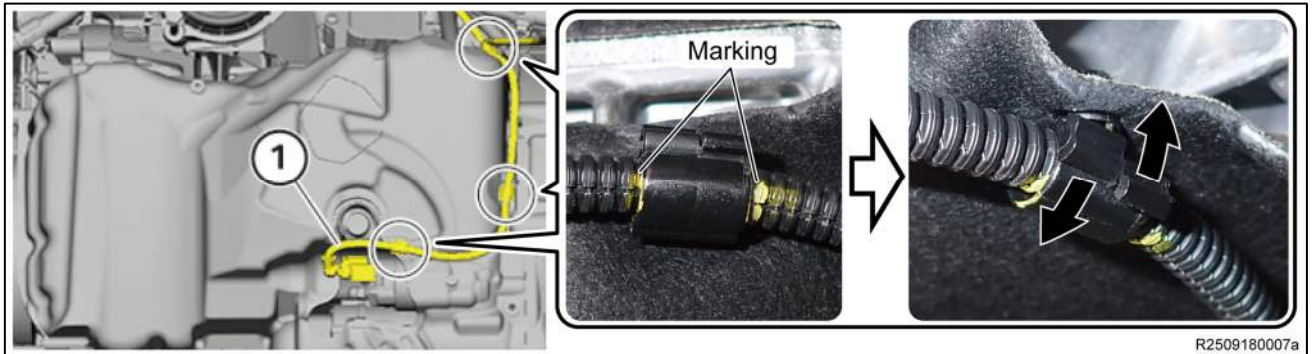
When disconnecting the transmission wire, **DO NOT** remove the harness clamp but first **mark** the clamp position and then release the clamp lock and disconnect only the transmission wire.

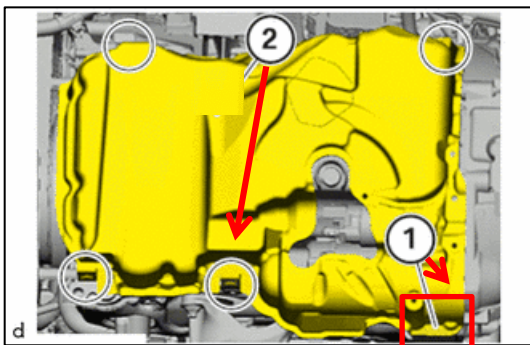
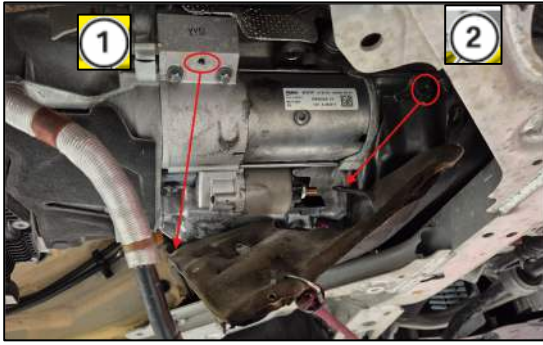
- Remove only two clips (1) and (2). The (1) clip is installed in the starter assembly and may break when removed, however there is no need to remove it, as it will be discarded with the old the starter assy.
- Note: The clip (1) from the starter assembly is non-reusable.

Although the oil pan cover is removed in the Repair Manual, to avoid damage to the oil pan cover, after removing the two clips, **DO NOT** remove the oil pan cover, but lower the oil pan cover just enough to remove the starter assembly and then remove the starter assembly.

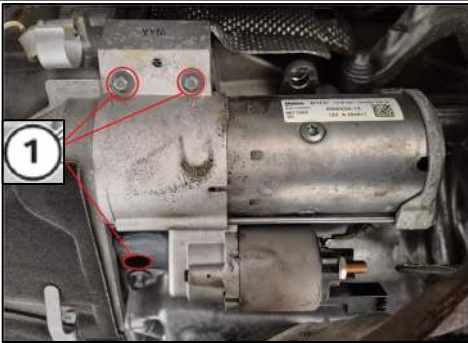
- a) Loosen the three E10 bolts (1).
- b) Remove the starter assembly (2).

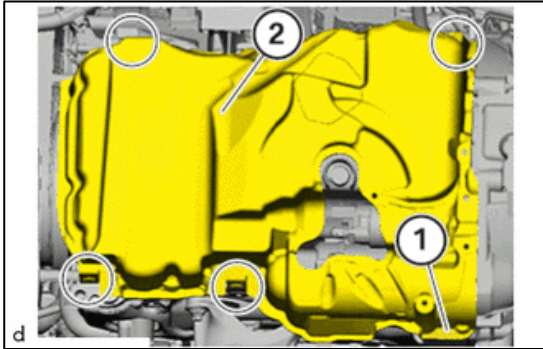
- a) Position the oil pan cover (2)
- b) Install the **NEW** clip (1).

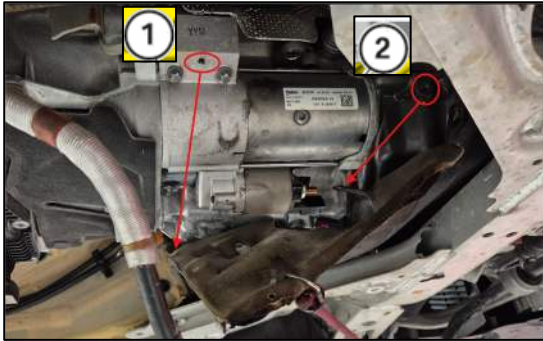
- c) Replace the other reusable clip (2)

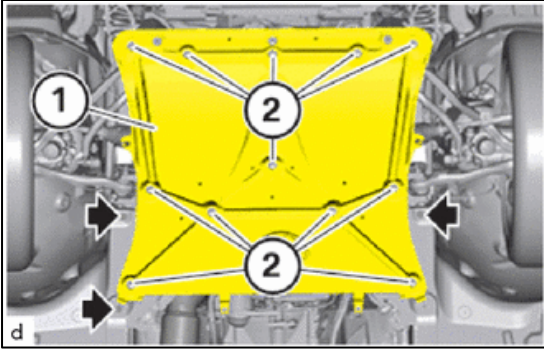
- Position front suspension member lower protector (1).
- Install **NEW** 16mm bolts (2). (qty twelve)
- Tighten the 16mm bolts (2).  
**Torque: 56 Nm (571 kgf·cm, 41 ft·lbf)**
- Tighten the 16mm bolts (2) an additional 45° using the angle setting on the digital torque wrench.

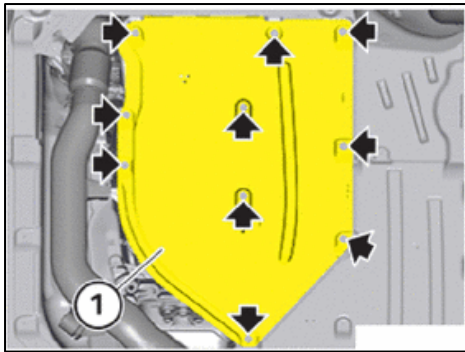
- Position front floor cover (1).
- Tighten screws (arrows) Tighten the 16mm bolts (2).  
**Torque: 3.0 Nm (31 kgf·cm, 27 in·lbf)**

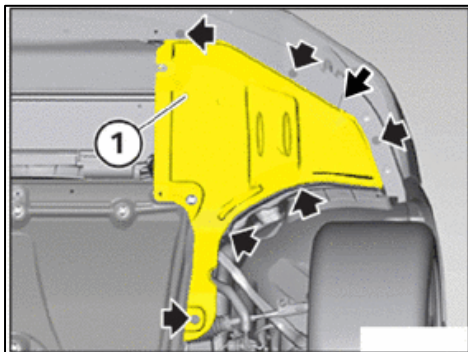
- Insert the front fender splash front shield LH (1) at the side.
- Tighten screws (arrows)  
**Torque: 2.6 Nm (27 kgf·cm, 23 in·lbf)**

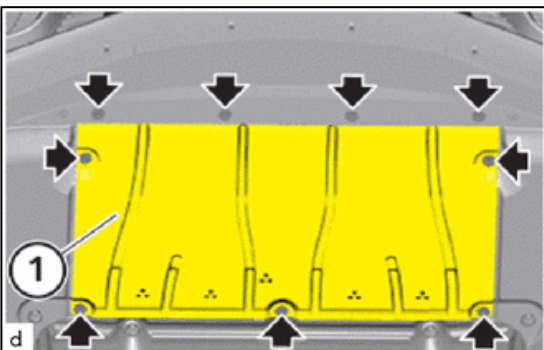
- Guide the No. 1 engine under cover assembly (1) in and position it.
- Tighten screws (arrows).  
**Torque: 3.0 Nm (31 kgf·cm, 27 in·lbf)**
