HYUNDAI Technical Service Bulletin

GROUP RECALL	NUMBER 26-01-014H-1
DATE MARCH 2026	MODEL(S) KONA (SX2)

SUBJECT: FRONT STEERING KNUCKLE INSPECTION & REPLACEMENT
(RECALL 295)

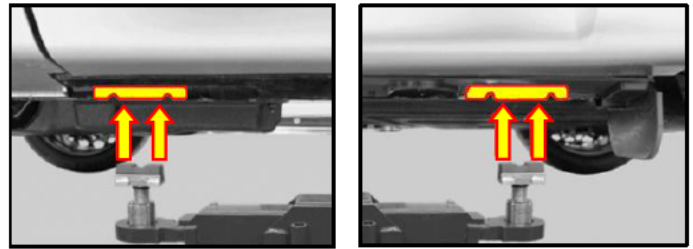
1. Visually check that the lift blocks are properly seated on the vehicle support points and raise the vehicle.

Raising the vehicle from anywhere other than the support points may damage vehicle components.

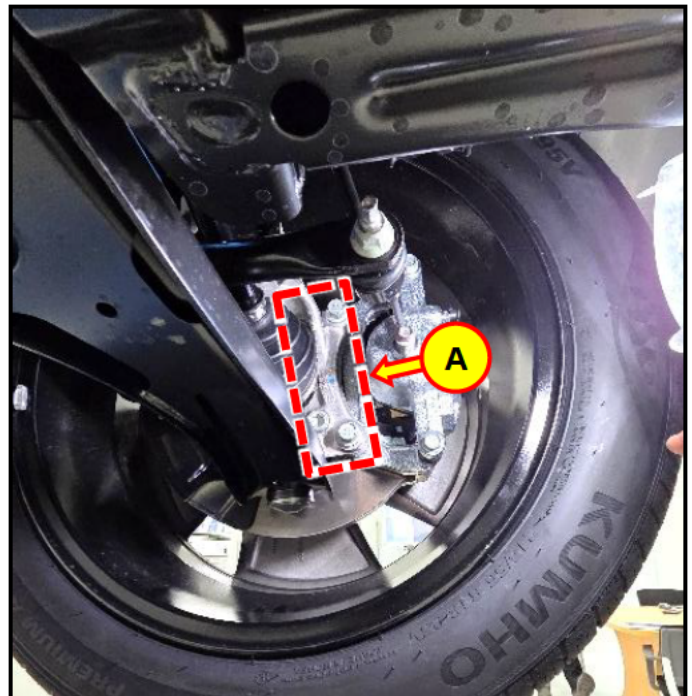
2. Locate the front steering knuckle (A) on the inner side of the wheel.

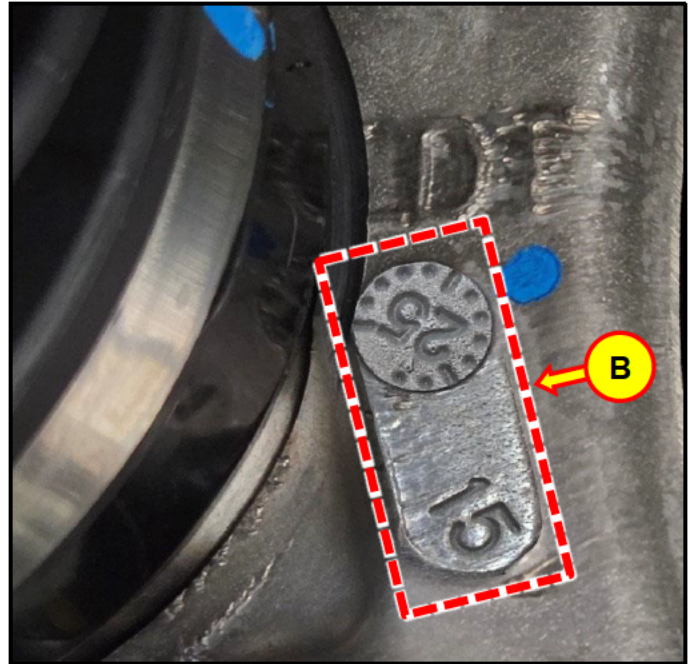
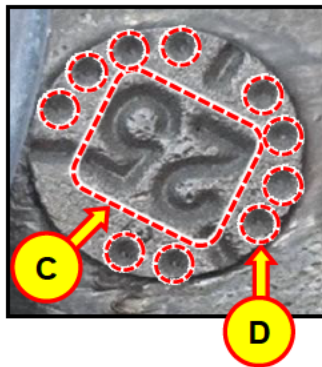
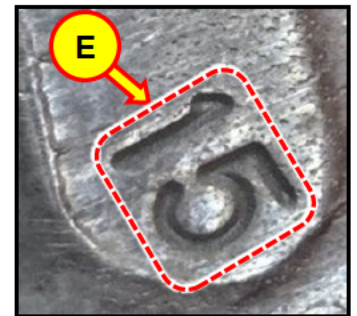
3. Check the lot code (B) to identify the production year, month, and day as described below.

Be sure to check the lot code on **BOTH** sides, LH and RH. It is recommended to start with the left side.

- C = Production Year: 2025
- D = Production Month: October (10 dots)
- E = Production Day: 15

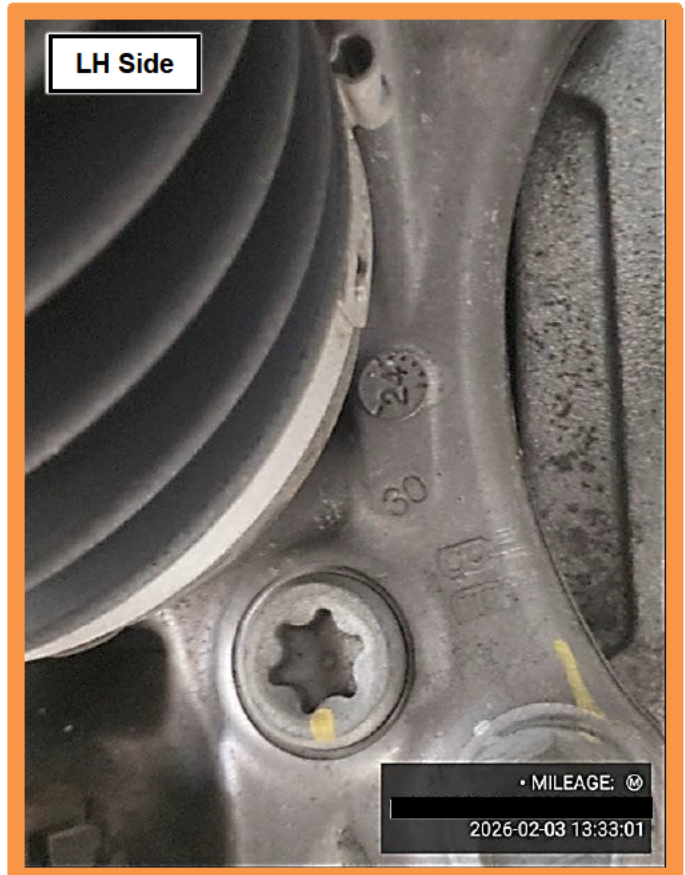
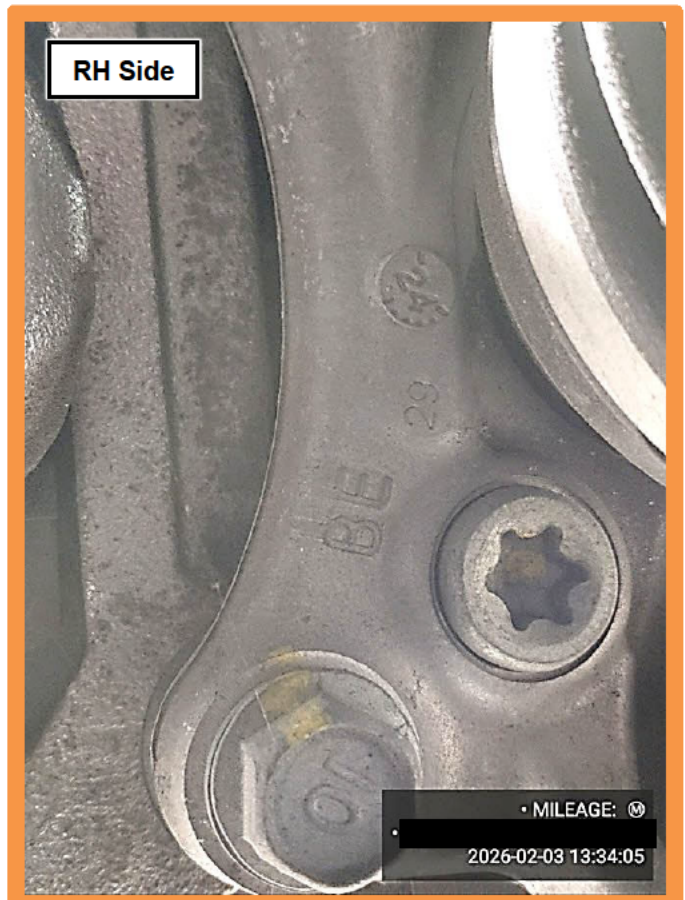
Using the STUI camera function, take photos of the lot code on **BOTH** LH and RH sides.

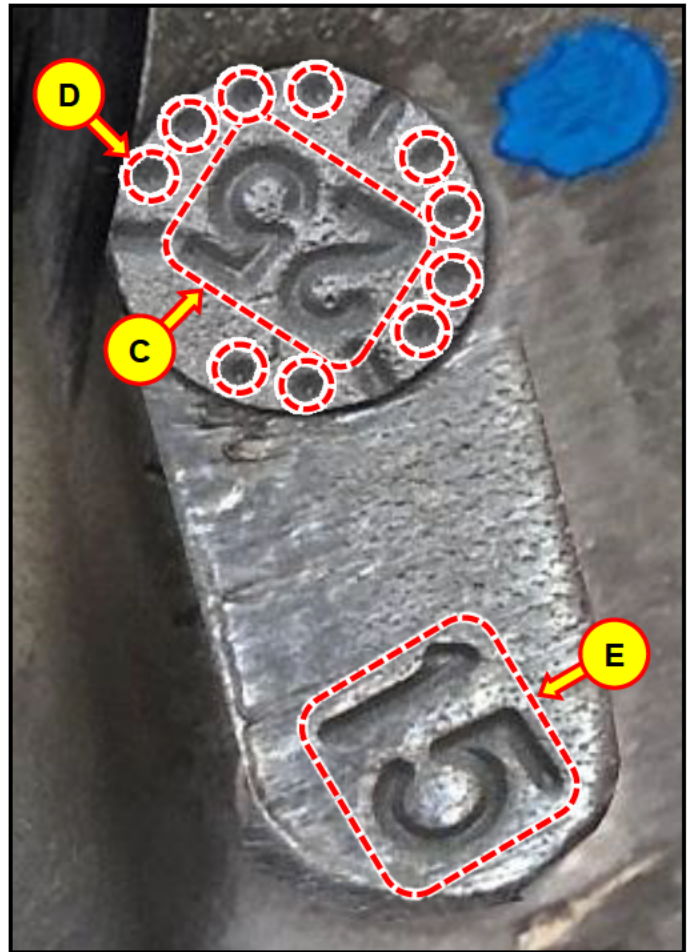
5. If the lot code is **October 15, 2025**, or if the code is **NOT** readable, proceed to the [Front Steering Knuckle Mold Number Inspection](#) procedure.

- C = Production Year: 2025
- D = Production Month: October (10 dots)
- E = Production Day: 15

6. If the lot code is **NOT** October 15, 2025 (e.g., any other date combination), then the front steering knuckles are **OK**.

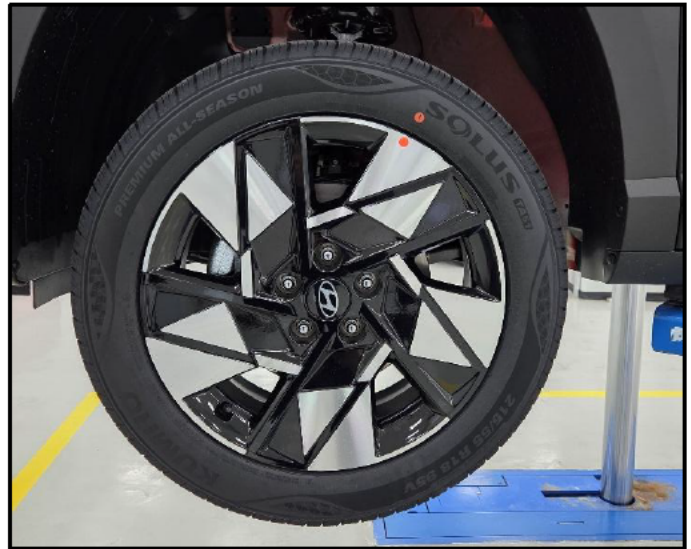
1. With the vehicle still on the lift, remove both front wheels.

lb-ft	87
N.m	118

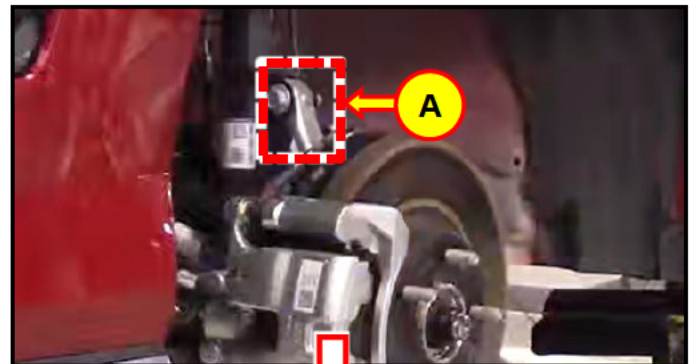
2. Locate the mold number on the front steering knuckle (A).

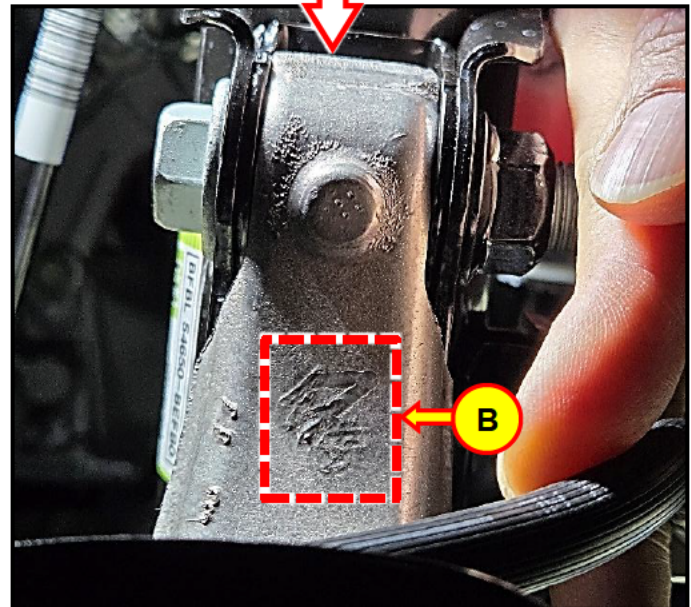
3. Check the mold number (B) stamped in the front steering knuckle.

Be sure to check the mold number on **BOTH** sides, LH and RH.

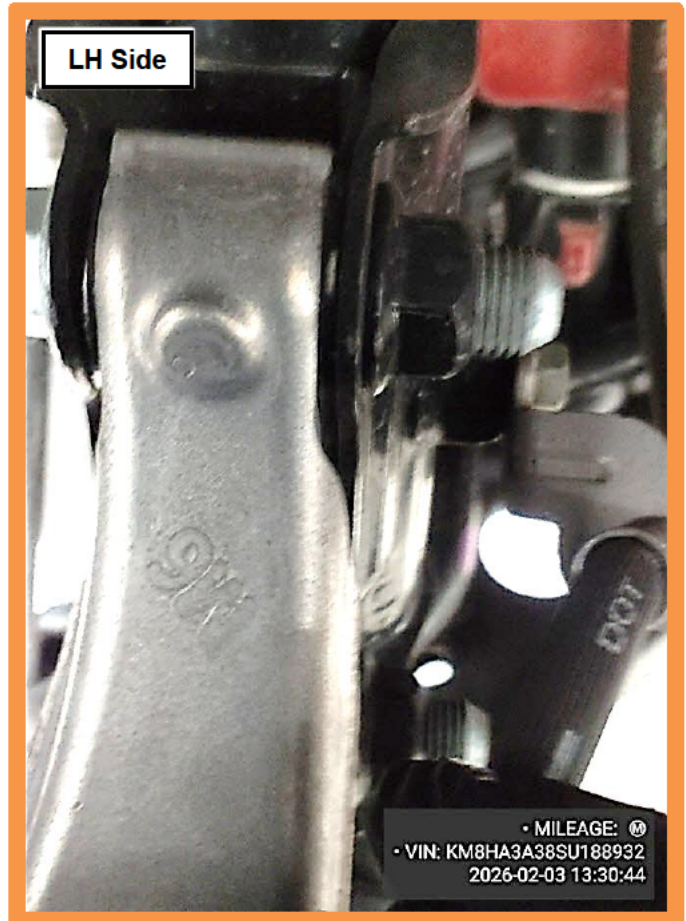
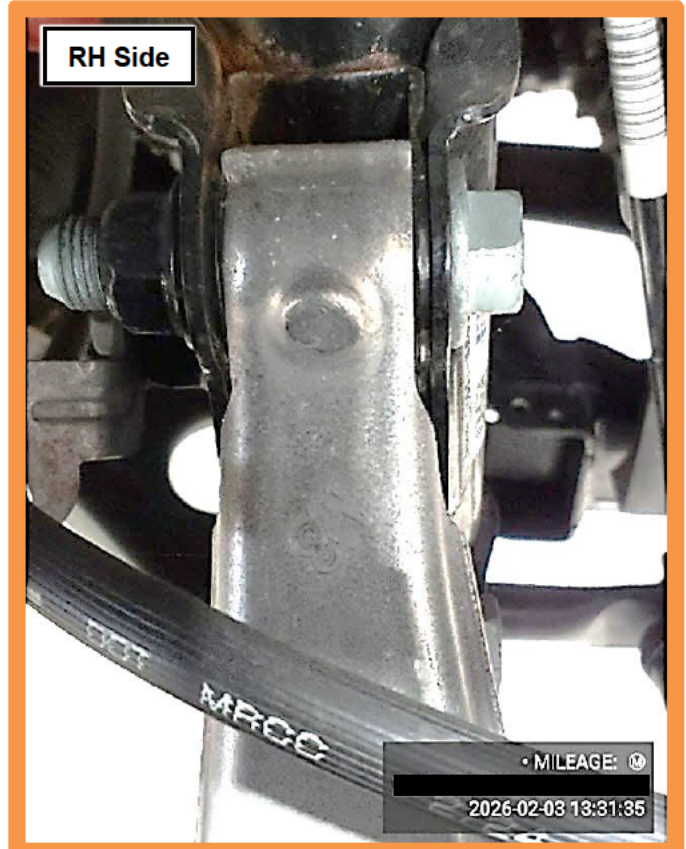
Using the STUI camera function, take a photo of the mold number on **BOTH** LH and RH sides.

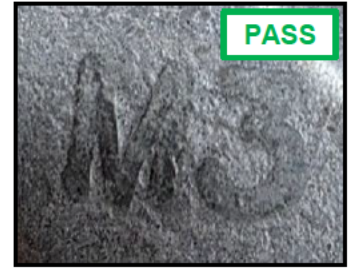
5. **PASS:** If the mold number is **NOT** M1 (e.g., any other number), then the front steering knuckle is **OK**.

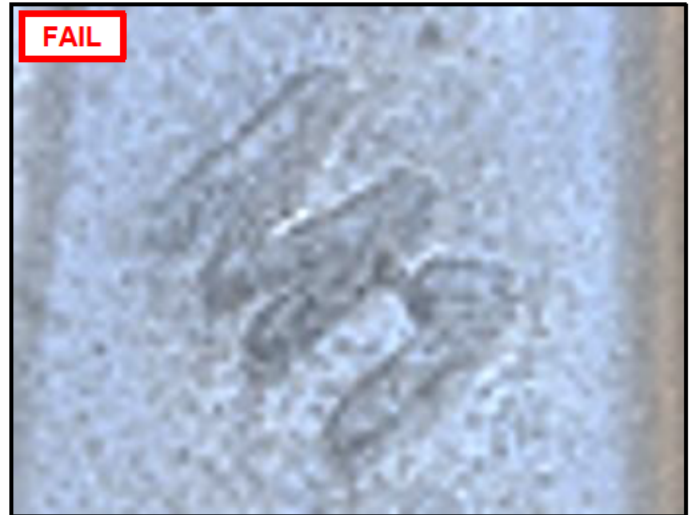
FAIL: If the mold number is **M1** on **either** the LH or RH side, or if the code is **NOT** readable, proceed to the [Front Steering Knuckle Replacement](#) procedure.

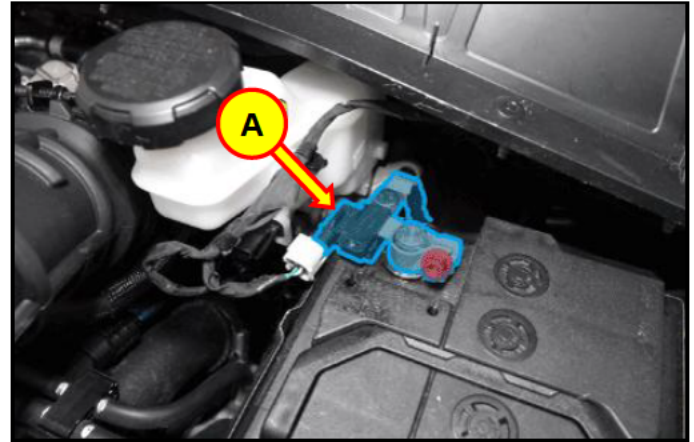
1. With the vehicle still on the lift, disconnect the negative (-) battery terminal (A).

lb-ft	6.5
lb-in	78
N.m	8.8

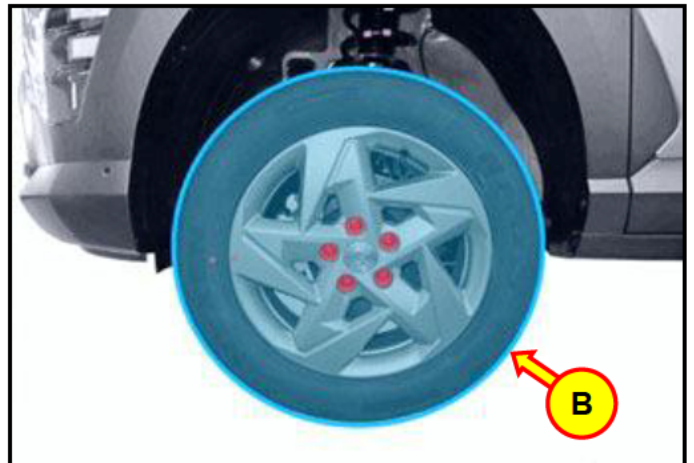
2. Loosen the front wheel nuts, then remove the front wheel and tire (B).

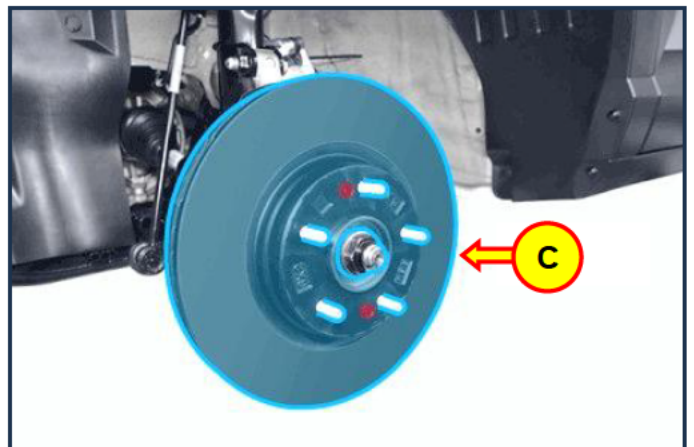
3. Remove the front brake disc (C) by referring to the shop manual:

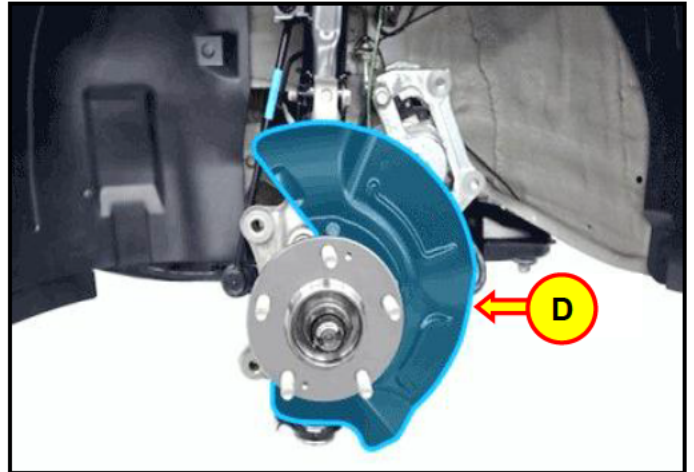
4. Remove the dust cover (D) after removing the bolts.

lb-ft	6.5
lb-in	78
N.m	8.8

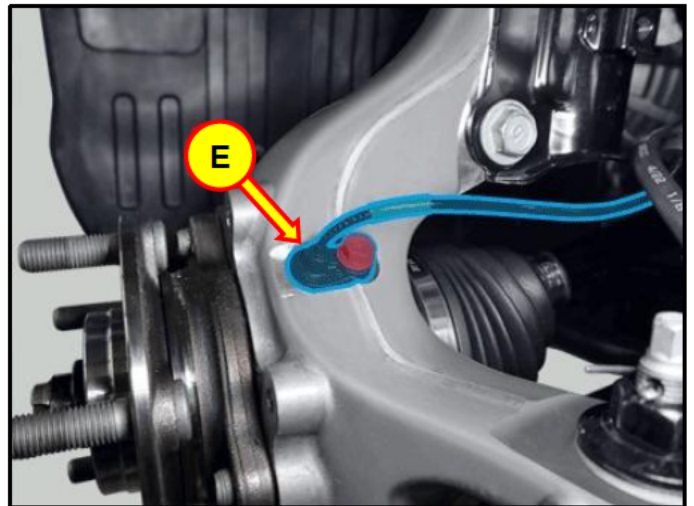
5. Disconnect the front wheel speed sensor (E) after removing the bolt.

lb-ft	7.2
lb-in	86
N.m	9.8

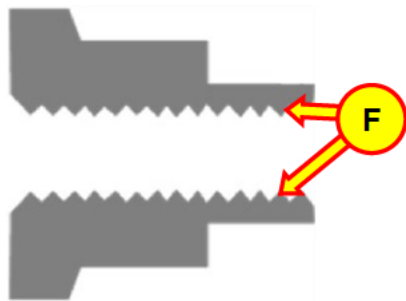
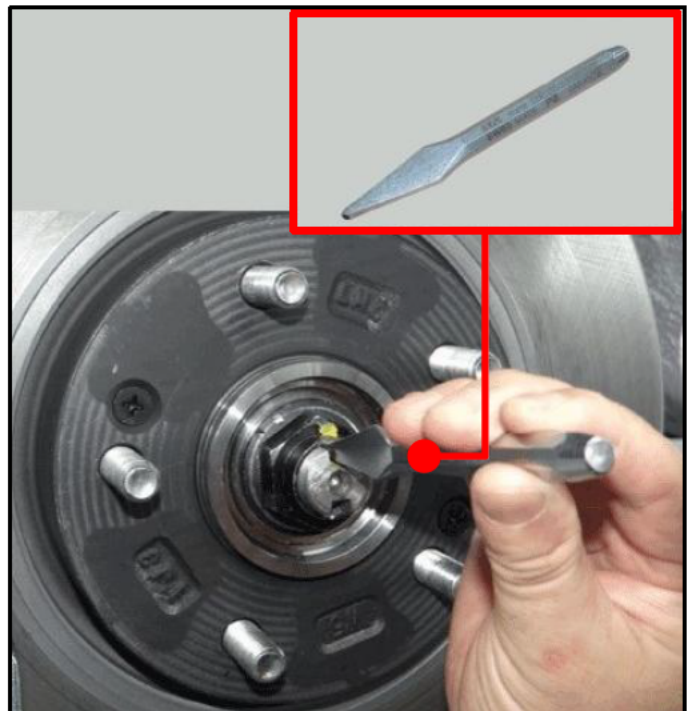
6. Use a chisel or appropriate tool to unstake the driveshaft axle lock nut.

Unstake the driveshaft axle lock nut by using a chisel or appropriate tool and then loosen the lock nut to prevent damaging the driveshaft threads (F).

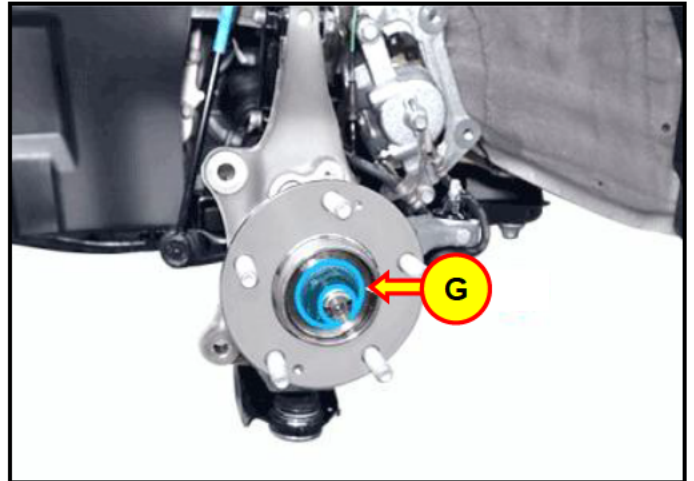
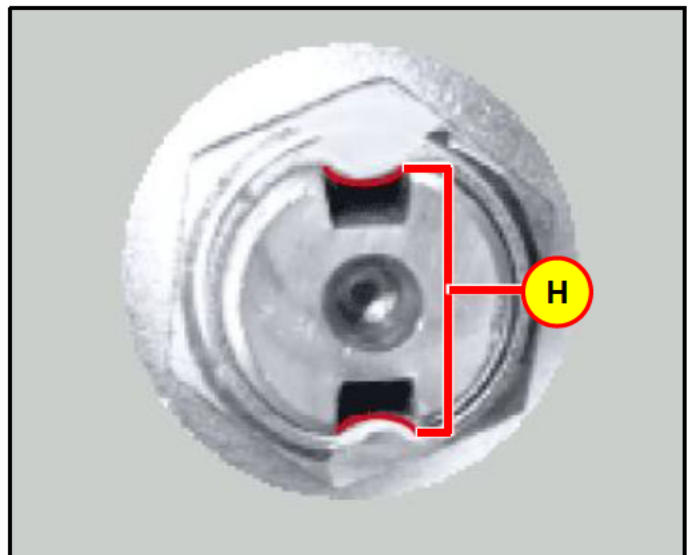
7. Remove the driveshaft axle lock nut (G).

lb-ft	210
N.m	284

The driveshaft axle lock nut **MUST** be replaced with a new part.

During reinstallation, tighten the driveshaft axle lock nut to the specified torque while pressing the brake pedal. After tightening the lock nut, stake the lock nut using a chisel or an appropriate tool in two places (H).

Stake depth: 1.5 mm (0.06 or 1/16 in.)

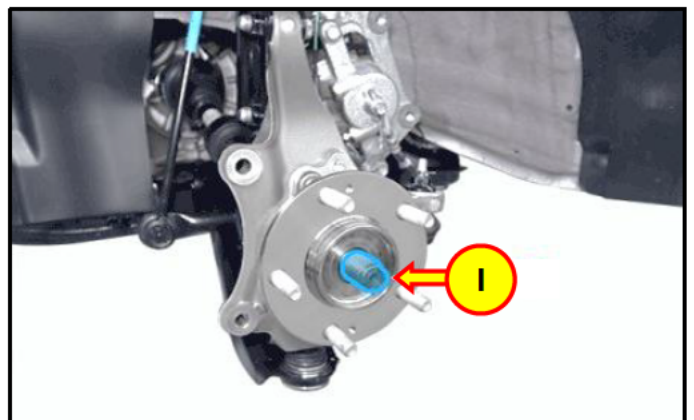
8. Using a plastic hammer, separate the driveshaft axle (I) from the hub assembly.

Use a plastic hammer to prevent damage to the driveshaft axle.

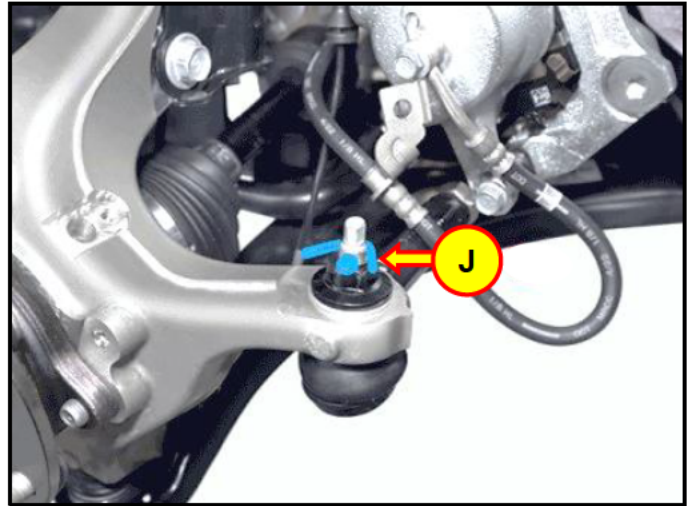
9. Remove the tie rod end split pin (J).

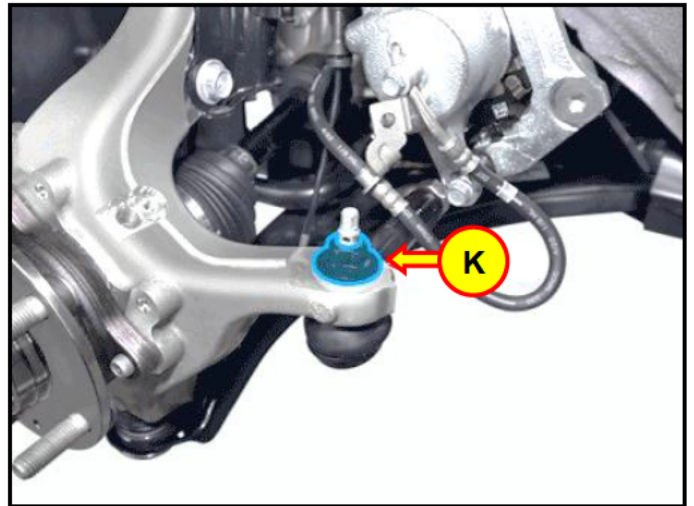
10. Remove the nut (K).

lb-ft	80
N.m	108

The washer, split pin, and nut **MUST** be replaced with the new parts supplied in the kit.

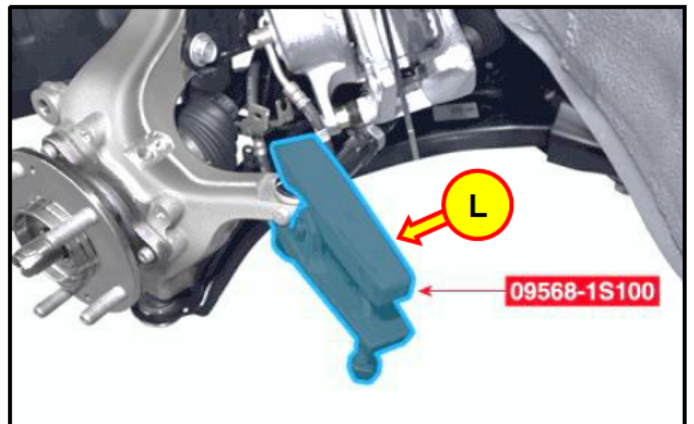
11. Separate the tie rod end ball joint by using the ball joint puller SST (L) (09568-1S100).

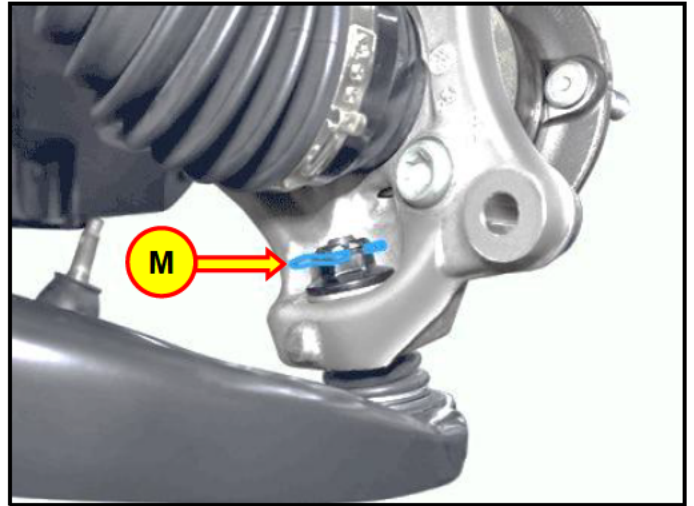
12. Remove the split pin (M) from the lower ball joint.

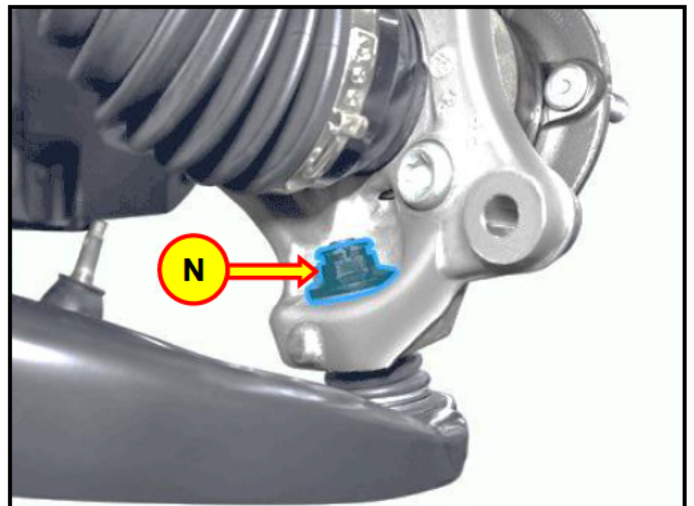
13. Remove the castle nut (N).

lb-ft	80
N.m	108

The washer, split pin, and nut **MUST** be replaced with the new parts supplied in the kit.

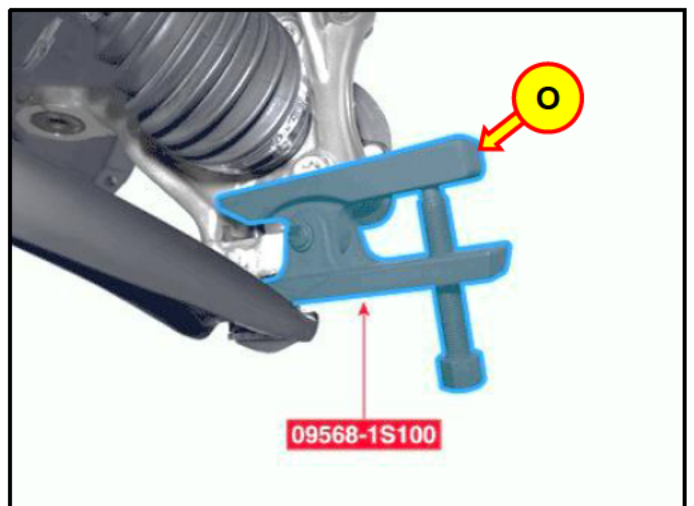
14. Separate the front lower arm ball joint by using the ball joint puller SST (O) (09568-1S100).

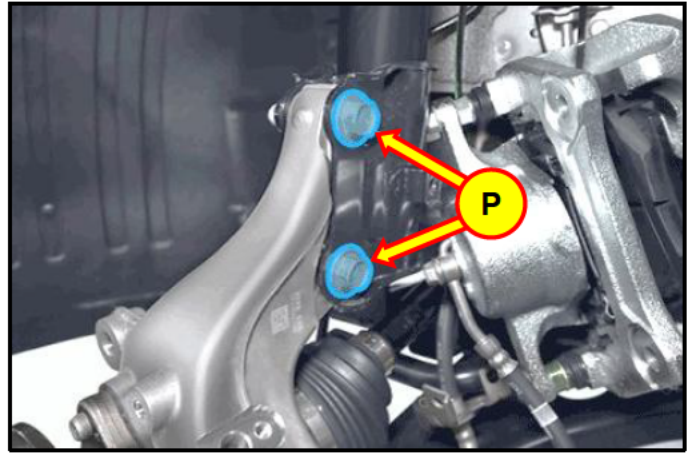
15. Remove the front strut lower bolts and nuts (P).

lb-ft	123
N.m	168

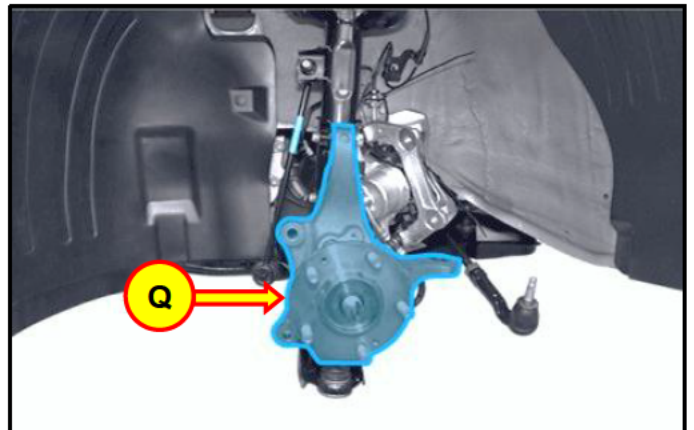
16. Remove the front steering knuckle assembly (Q).

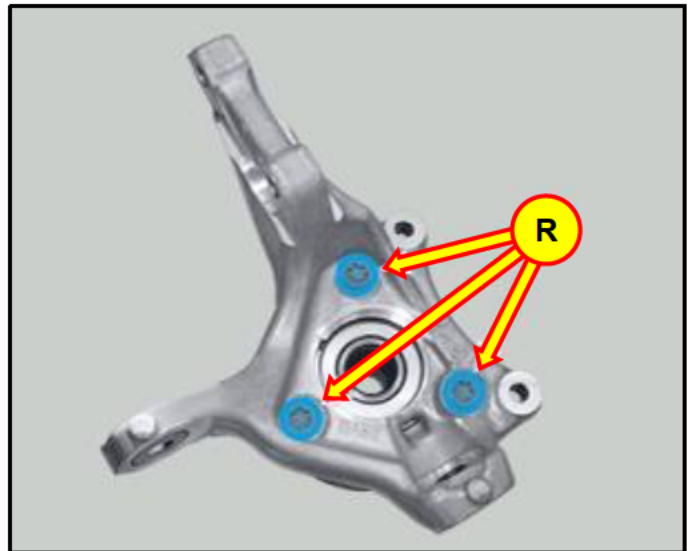
17. Remove the front hub bearing from the front steering knuckle after removing the bolts (R).

lb-ft	101
N.m	137

18. Install the removed front hub bearing onto the new front steering knuckle.

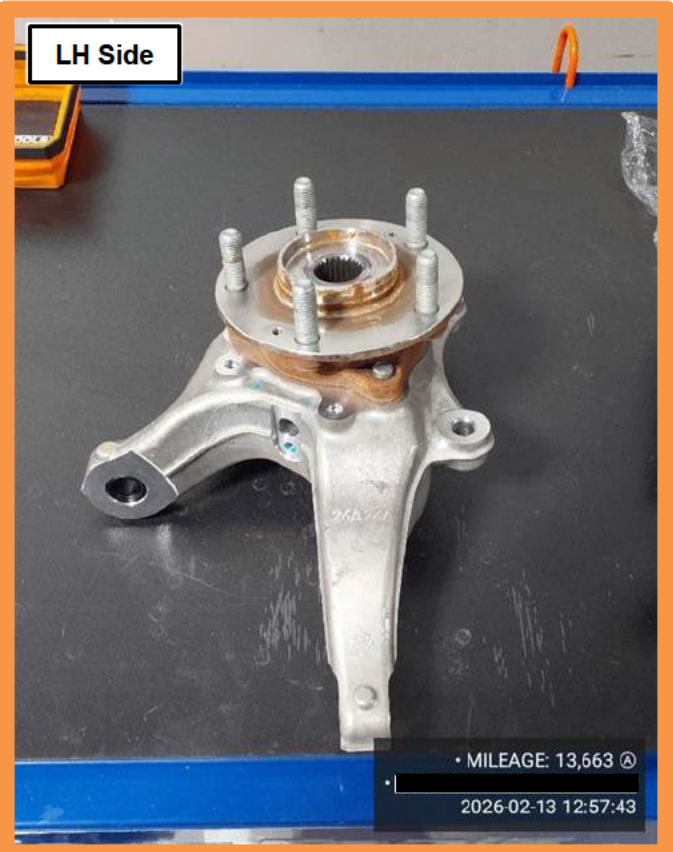
LH Side

Using the STUI camera function, take a photo of the new front steering knuckle with the hub bearing installed.
