**Volvo Car Customer Service****QB Instruction R89978**

<b>Title</b>	Door latch, front door	<b>Page</b>	1 ( 16 )
<b>Action</b>	Replacement	<b>Operation number:</b>	97674-2

**Affected vehicles**

<b>Title</b>	Door latch, rear door	<b>Page</b>	1 ( 13 )
<b>Action</b>	Replacement	<b>Operation number:</b>	97674-2

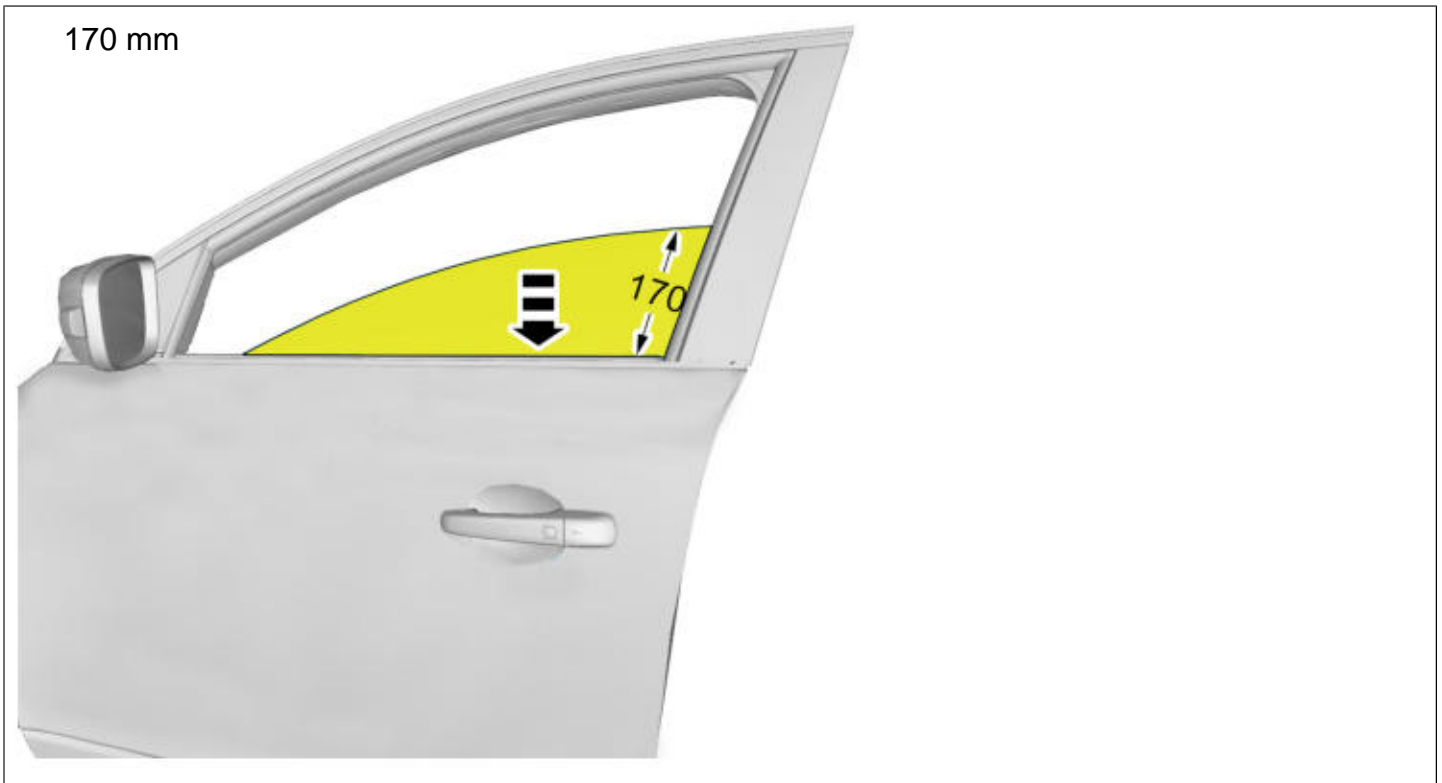
Remove panel side door front , refer to:  
Removal, replacement and installation  
8 - Body and interior  
85 - Interior  
851 - upholstery for wall/door, side, rear  
shelf, luggage rack

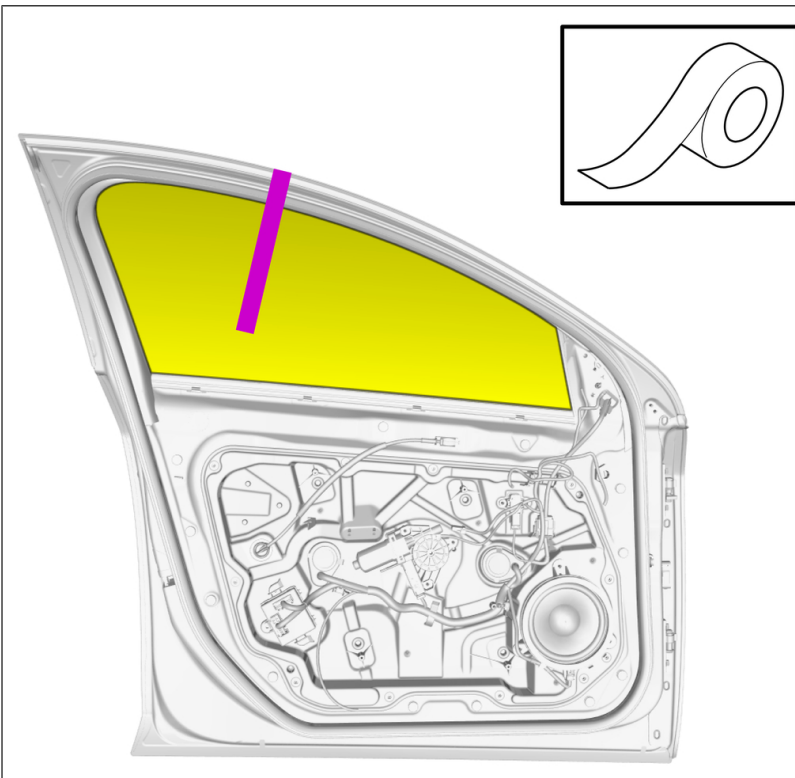
**Note! Ensure that the tape is fixed to the surface.**
