**PREVOST**

## SAFETY RECALL

**SR26-03**

| SUBJECT: | <b>DRIVER SIDE MIRROR INSPECTION</b> | |

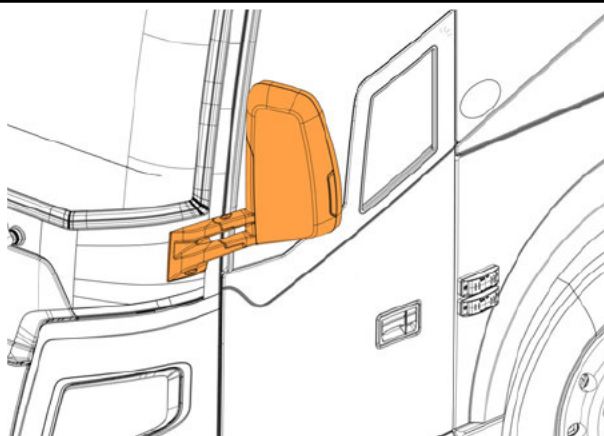
1. Locate the driver's side mirror.

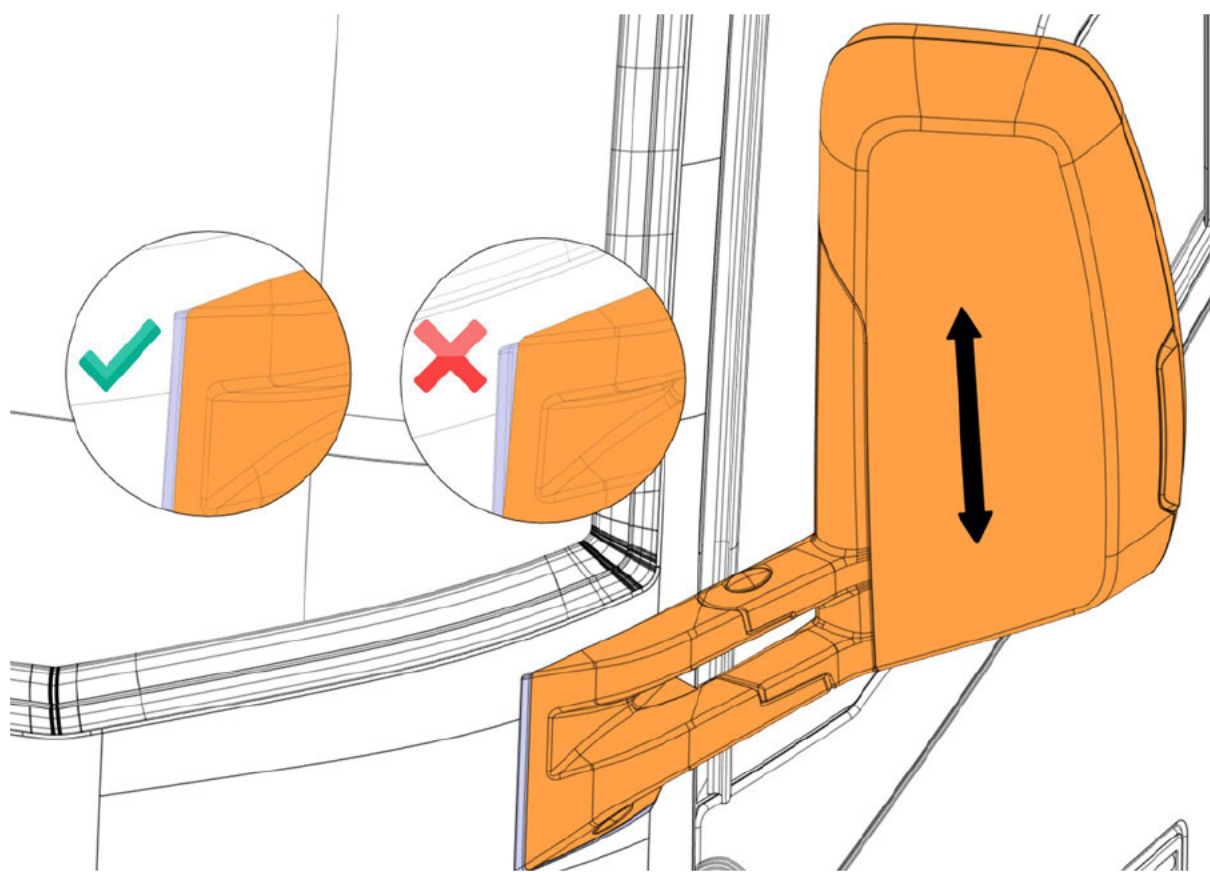
2. Move the mirror up and down.

- If there is no gap between the mirror base and the mirror anchor plate, this is acceptable and the bulletin is complete.
- If you observe a gap between the mirror base and the mirror anchor plate, this is not acceptable. Proceed to the Mirror Base Replacement section.

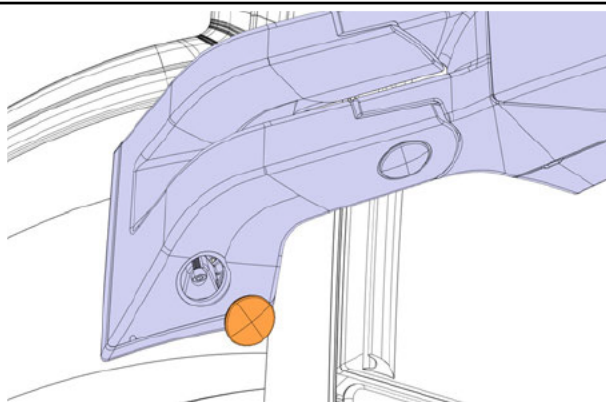
2. Remove the finishing cap.
3. Keep for reuse.

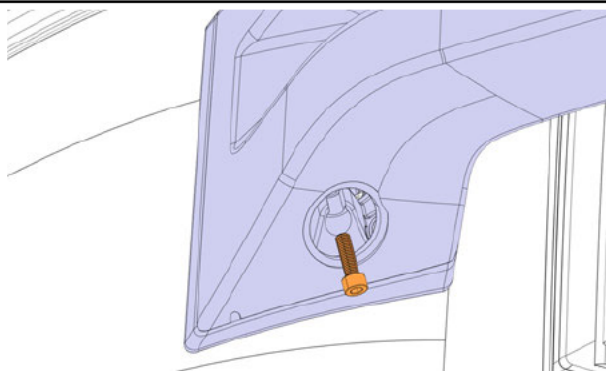
4. Remove the screw that secures the mirror to the anchorage.
5. Keep for reuse.

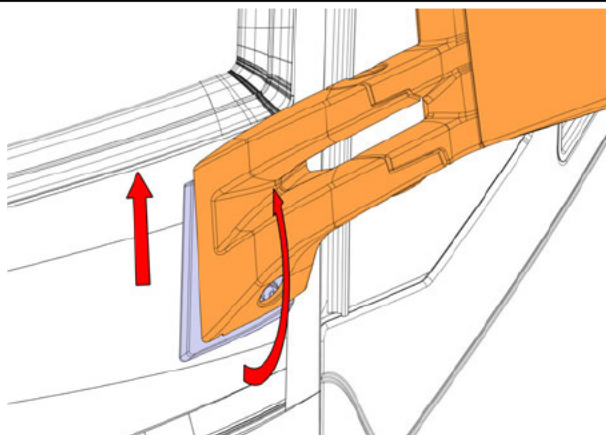
6. Lift the mirror off the anchor plate.
7. Tilt it toward the vehicle.
8. Remove it from the anchor.

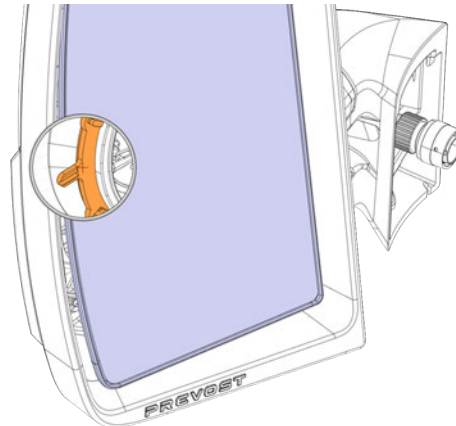
11. Use tool 990684 to rotate the lock ring by pushing upwards and remove the glass mirror.

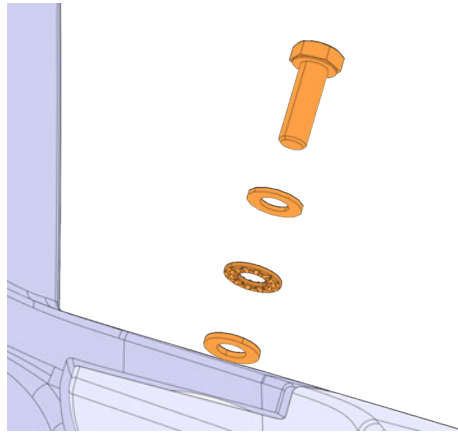
15. Remove the screw, the washers and the bearing of the upper section.

16. Discard the hardware.

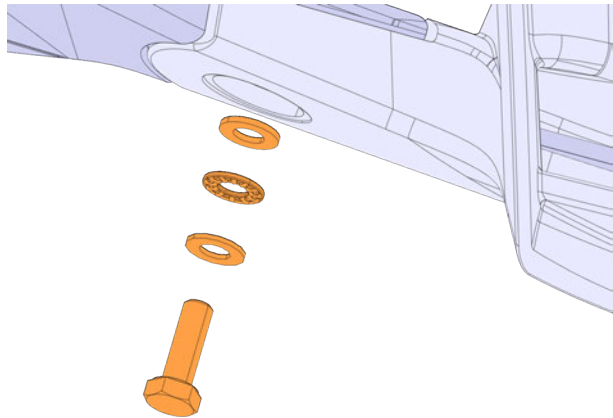
17. Remove the screw, the washers and the bearing of the bottom section.

18. Discard the hardware.

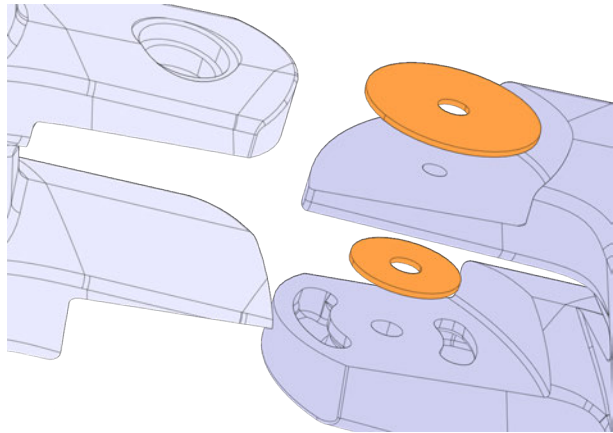
23. Reinstall the spacer washers (2x) the large one on the top section and the small one in the bottom section.

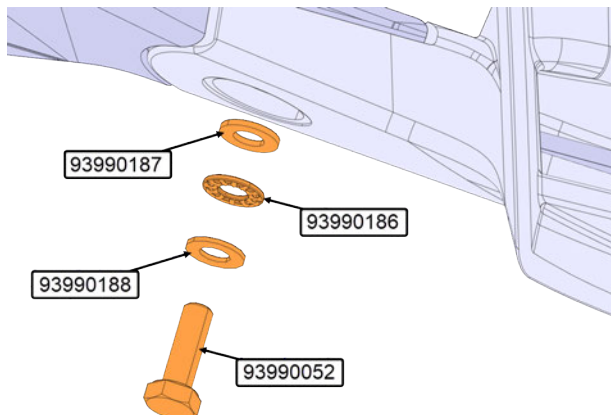
24. Apply the thread locker 680038 on screw 93990052.

25. Apply the grease 685485 on the bearing 93990186.

26. Install the screw 93990052, the thin washer 93990188, the bearing 93990186 and the thick washer 93990187.

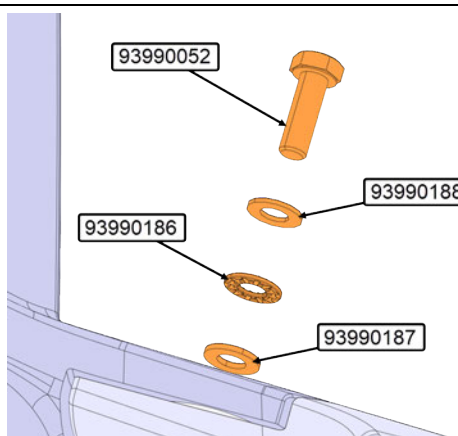
27. Apply the thread locker 680038 on screw 93990052.
28. Apply the grease 685485 on the bearing 93990186.
29. Install the screw 93990052, the thin washer 93990188, the bearing 93990186 and the thick washer 93990187.

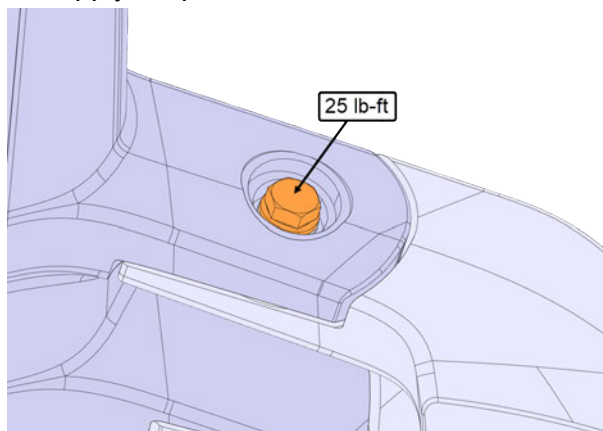
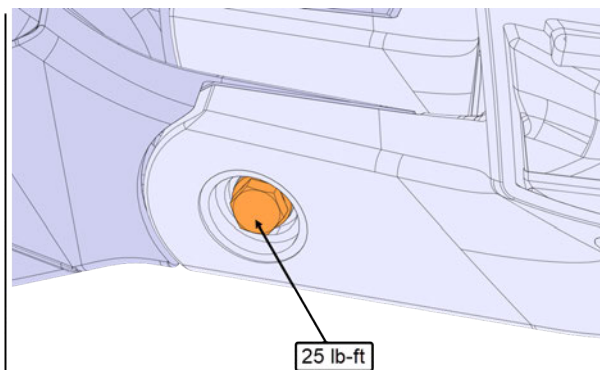
30. Apply torque of **25lb-ft**.

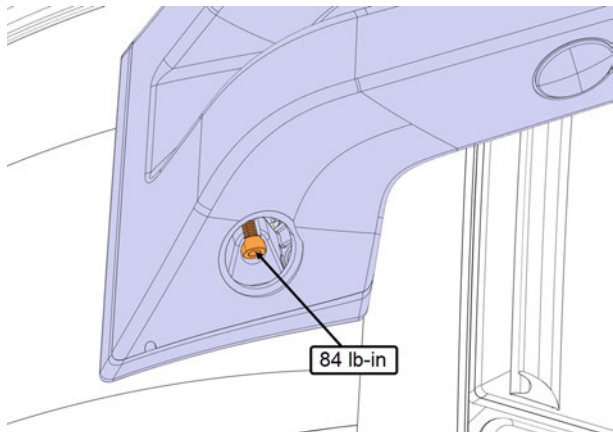
42. Apply torque of **84lb-in**.
