GROUP	MODEL
	Safety Recall Campaign	2026MY K4 (CL4) Hatchback 2027MY Telluride (LQ2)
	NUMBER	DATE
	SC364 (Rev 1, 03/18/2026)	March 2026

SAFETY RECALL CAMPAIGN

**CENTER SEAT BELT ANCHOR BUCKLE
INSPECTION AND/OR REPLACEMENT (SC364)**

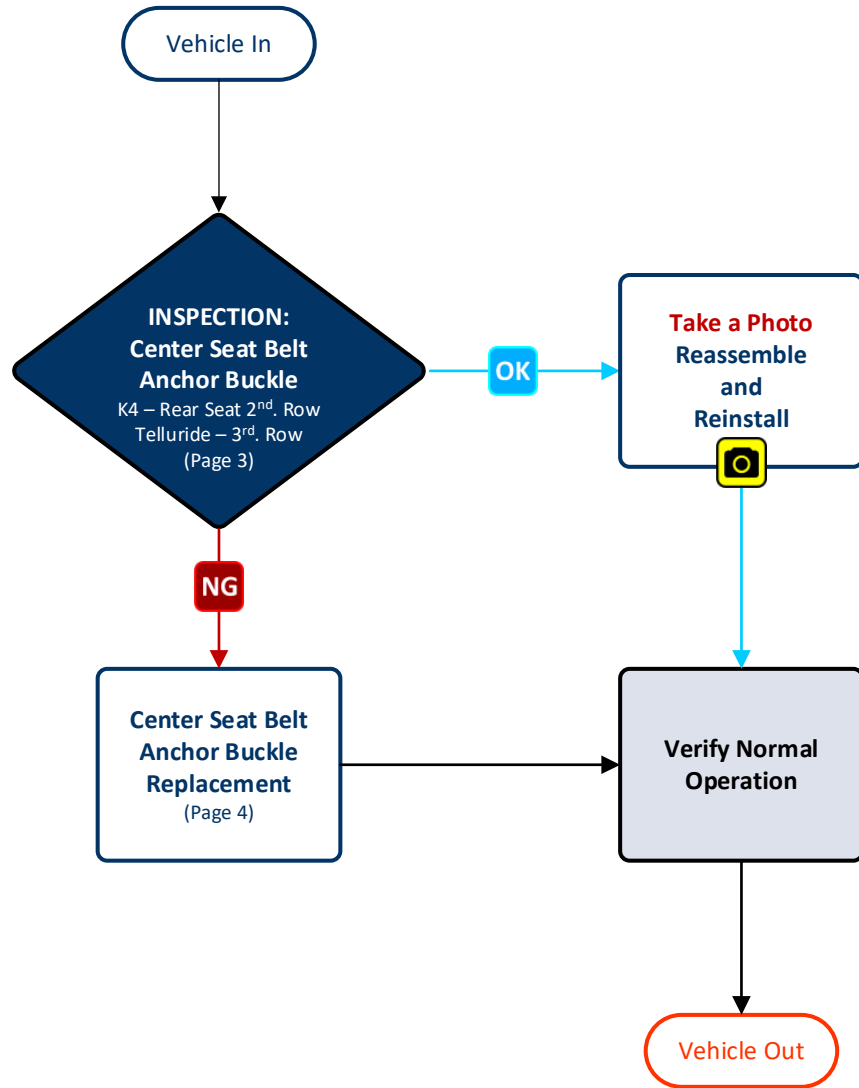
Inspection of the center seat belt anchor buckle:

- **K4** - Rear Seat
- **Telluride** - 3rd-Row Seat

Removed **(NG)** center seat belt anchor buckle assembly **CANNOT** be reused. The removed part must be taped up and sealed in the new part's original box at the dealer for 30 days after claim payment and are subject to Mandatory Part Return (MPR). If the part is not returned, the claim may be subject to chargeback. [Refer to Warranty Bulletin 2026-10 for further instructions.](#)

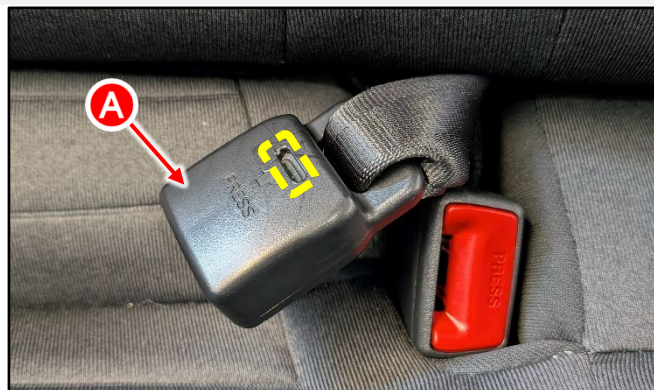
If needed, release the seat belt from the seat belt anchor buckle by pressing down the inner locking tab.

- **Telluride:** The extra seat belt buckle end may be inserted for use.

- **K4:** The blade key or a flathead screwdriver may be used.

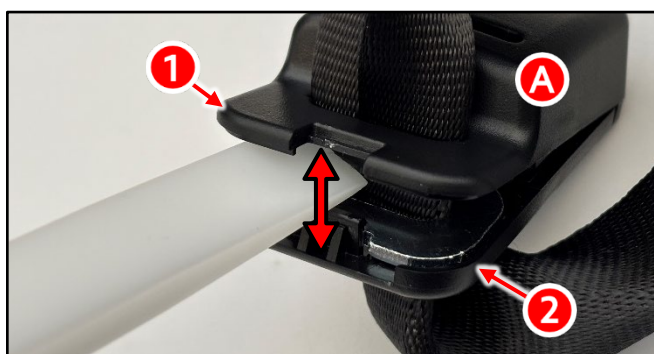
2. Separate the two (1&2) seat belt buckle (A) covers by inserting a non-marring pick tool between the center of the two areas shown.

Be careful not to scratch or damage the seat belt buckle covers or any of the surrounding interior trim.

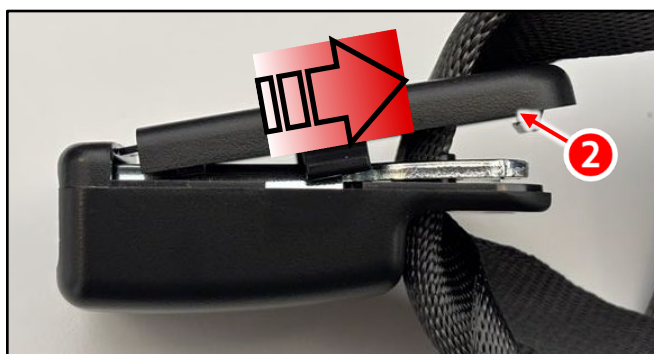
3. Slide the buckle cover (2) back as shown.

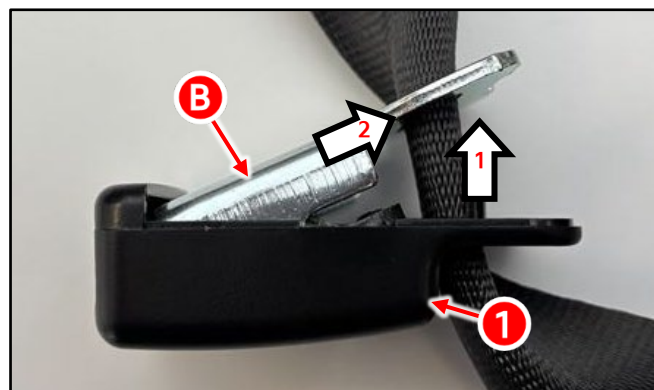
- 4a. First, lift the buckle plate assembly (B) up and away from the buckle cover (1).

- 4b. Second, pull the buckle plate assembly (B) outward as shown to separate it from the buckle cover (1).

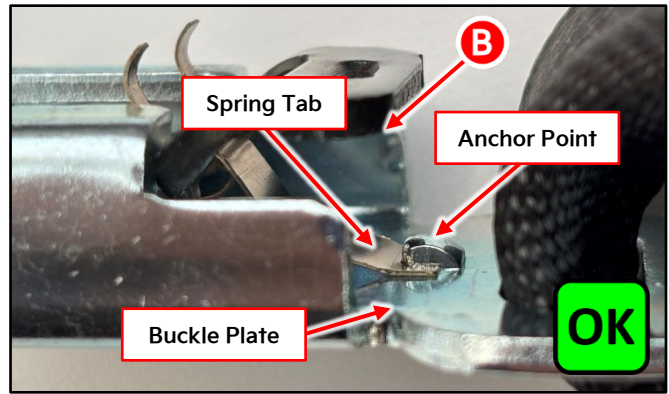
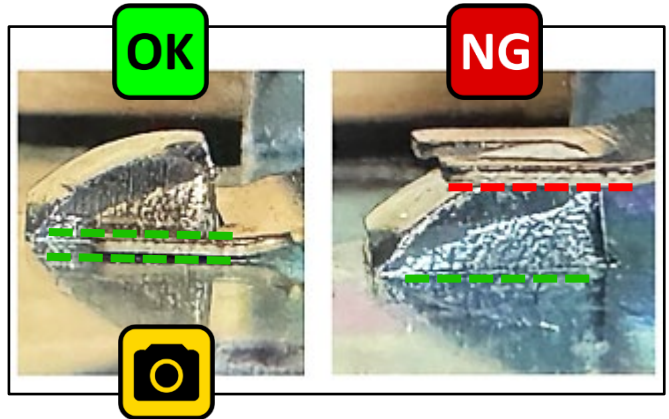
5a. Locate the spring tab and retainer point area on the anchor buckle plate assembly (B):

- The spring tab is properly seated against the retainer point and anchor buckle plate surface (OK). If so, take a photo of the (OK) condition and attach it to the claim. Reassemble the seat belt anchor buckle in the reverse order of removal and proceed to step 6.
- The spring tab is **not** properly seated against the retainer point and anchor buckle plate surface (NG). If so, refer to the **'Repair Procedure'** below to replace the center seat belt anchor buckle assembly and verify normal operation after replacement.

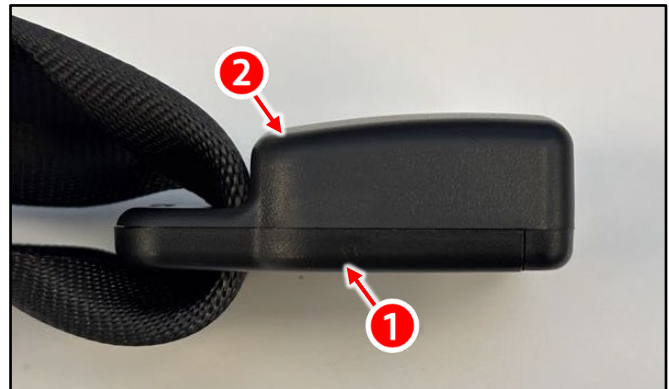
6. After reassembling the (OK) center seat belt anchor buckle assembly, verify that the two (2) covers are properly aligned and secured (no gaps shown in between) and that the seat belt is properly looped through the buckle.
