## Volvo Car Customer Service

QB Instruction VCC-494872-4

| <b>Title</b> | Audio module (AUD) | <b>Page</b> | 1 ( 3 ) |
| <b>Action</b> | Product fix | <b>Operation number:</b> | 99923-2 |

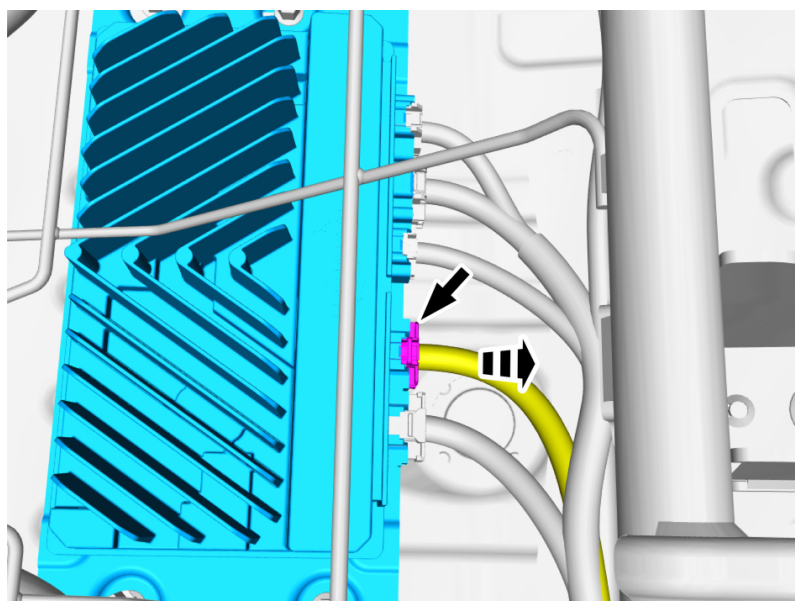
Remove seat cushion, rear seat , refer to:  
Removal, replacement and installation  
8 - Body and interior  
85 - Interior  
853 - rear seat, passenger seat, bench

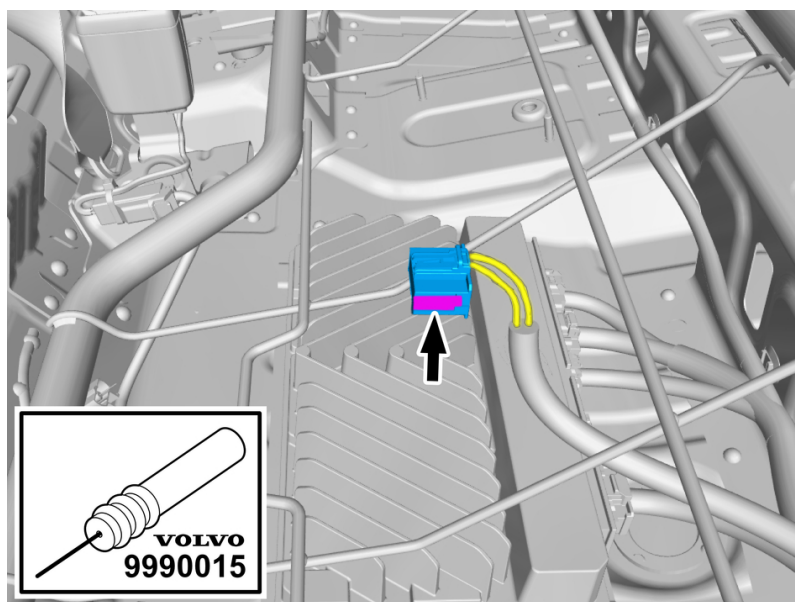
Disconnect the connector.

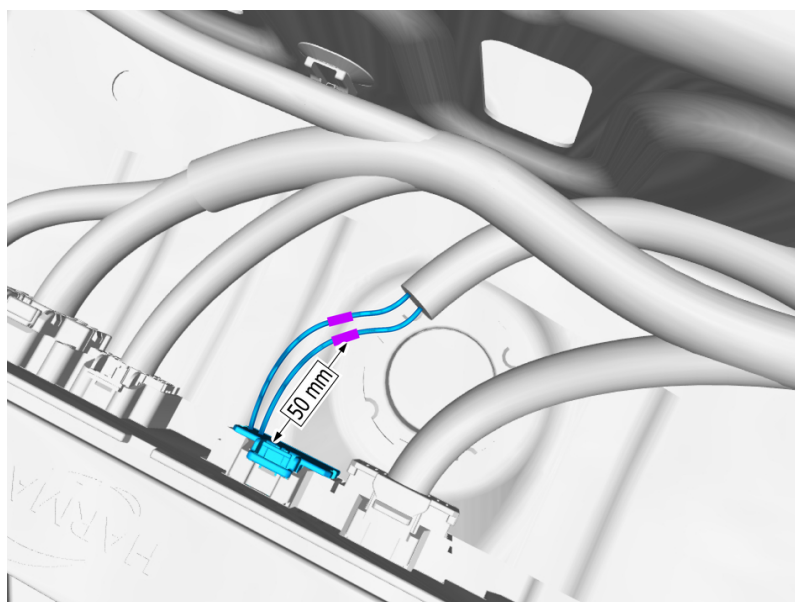
**Caution! Make sure that the wiring harness is not stretched.**

Release the catch.

Install the repair terminals and plugs in the positions according to the vehicle's existing wiring.

Perform joining cables , refer to:  
Cleaning, Inspection and Adjustment  
3 - Electrical system  
37 - Cables and fuses  
371 - cables
