Safety Recall

Code: 97TC

Subject Transmission Ground Wire

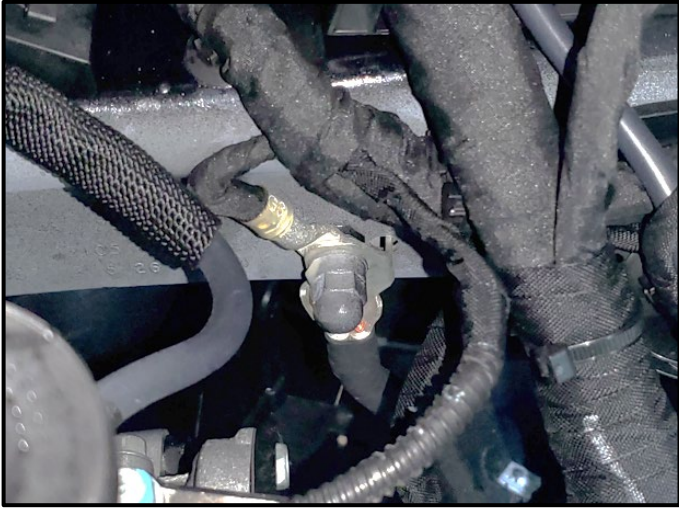
Repair Overview

- Inspect transmission ground cable connection (673).

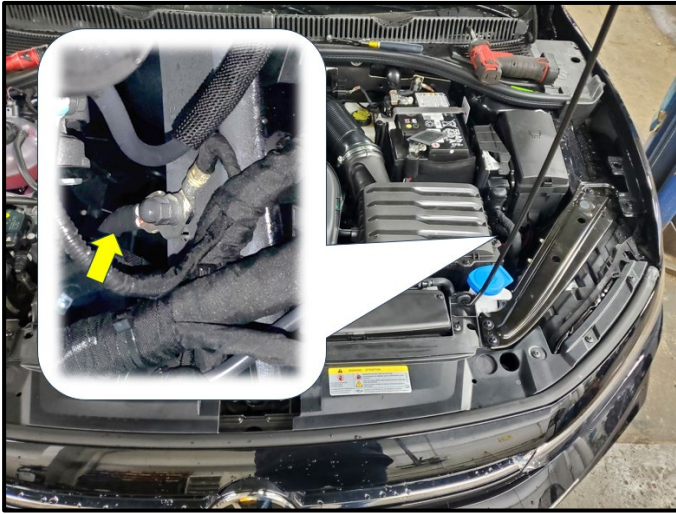
There is no need to check the torque of the ground connection. If the issue is present, the transmission ground cable will not be connected at all.

- The ground connection for the transmission ground cable <arrow> to left front crossmember will be checked.

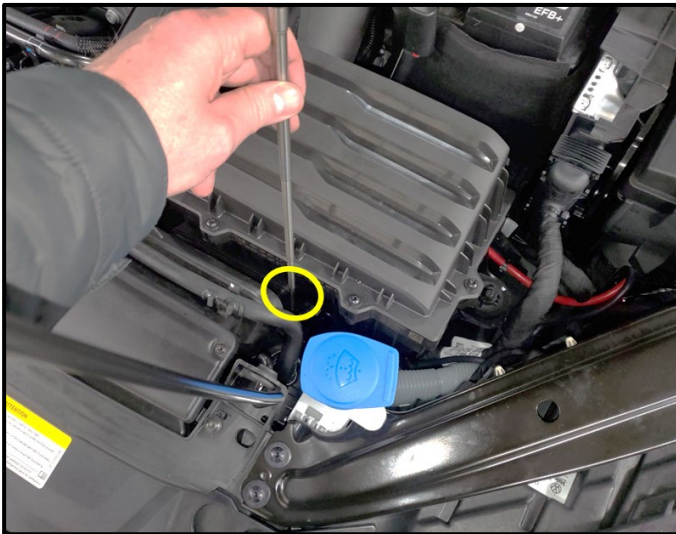
- Using adequate lighting, the ground connection can be checked using an inspection mirror (as shown) or a suitable borescope/endoscope.
- The airbox does not require removal to complete the inspection.

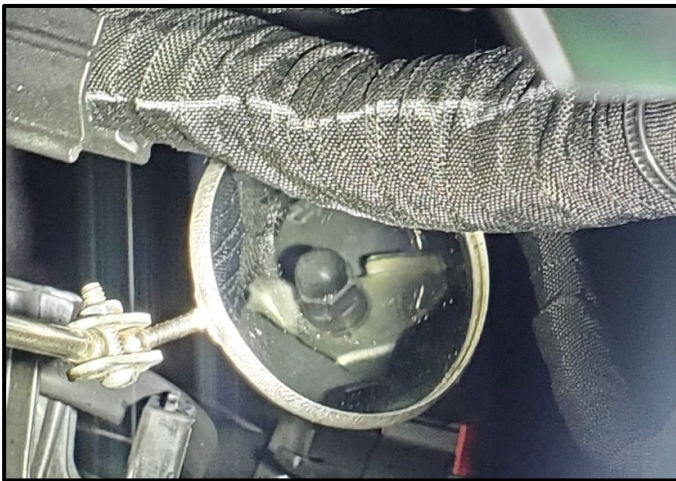
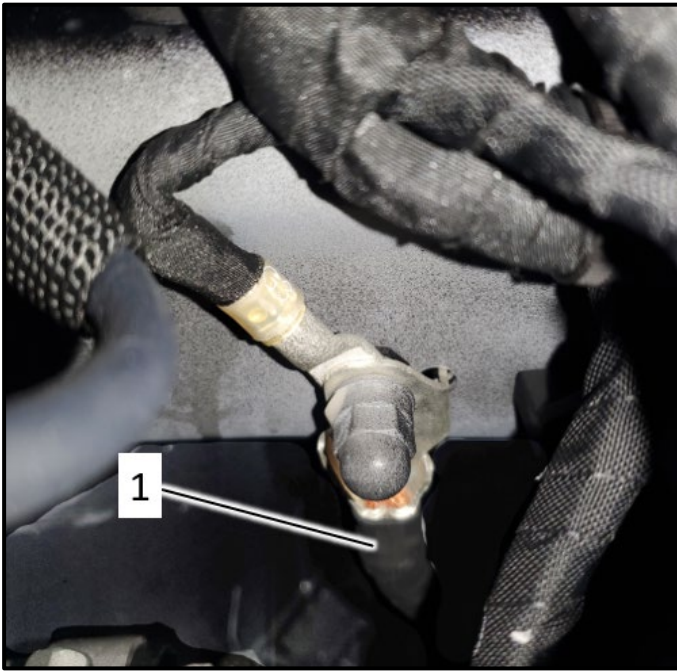
- If the transmission to body ground cable <1> is connected:
 - No further work is required.
 - Proceed to Section D.
- If the transmission to body ground cable <1> is not connected:
 - The Auxiliary Hydraulic Pump Control Module and its connector must be replaced.
 - Proceed to Section C.

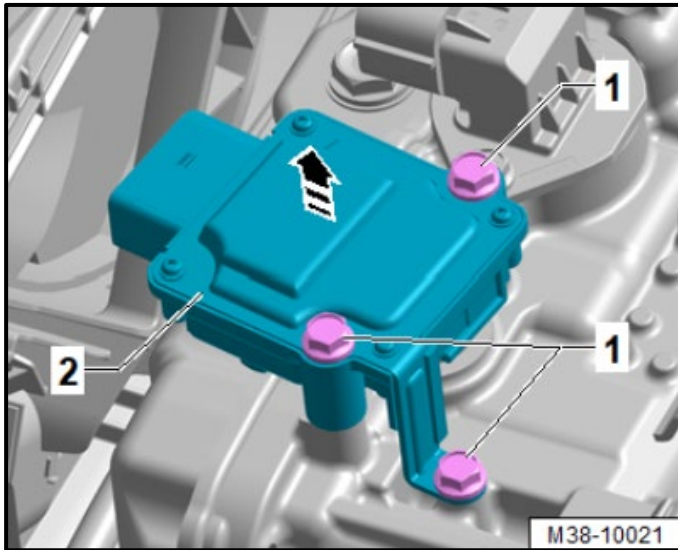
Without a proper transmission ground, high current flows through the Auxiliary Hydraulic Pump Control Module ground during engine start. This can damage the module. Therefore, the module, the 4-pin module connector and any damaged wiring must also be replaced if the transmission ground cable was not connected to the left crossmember.

- Replace the module <2> according to the ELSA Repair Manual:
 - Repair manual > Drivetrain > 8-Speed Automatic Transmission 09U > 38 Gears, Hydraulic Controls > ATF System > Auxiliary Hydraulic Pump Control Module, Removing and Installing
- Replace the 4-pin connector housing to the module.
- Replace any damaged wires, ensuring the proper wire size, pin type and connector seals are used.
