## SAFETY RELATED RECALL

Global Recall Action  
Number: D113v1

| Subject:<br><b>Defender 110 Third Row Seatbelt Mounting Bracket - Incorrect Specification</b> | Publication No.: D113v1 |

# SERVICE INSTRUCTION - D113V1

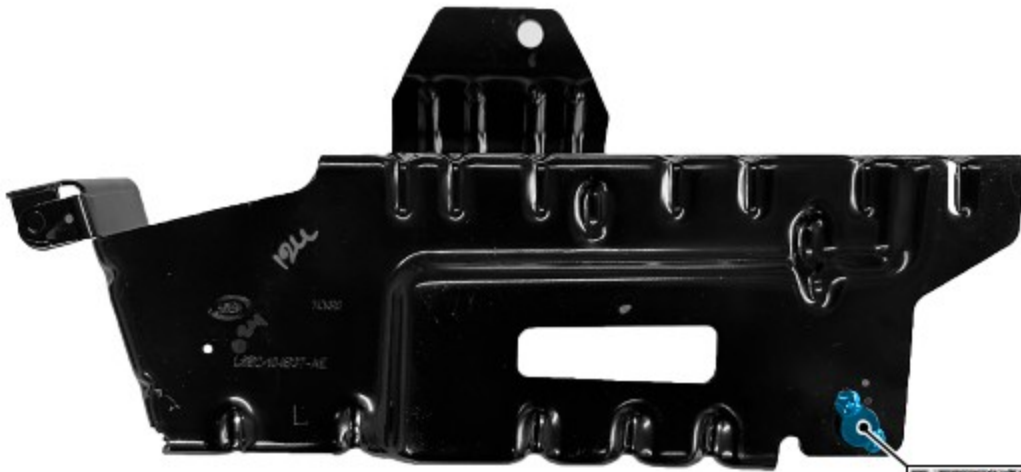
E413092

8. Identify the location of the existing stud to be reworked.

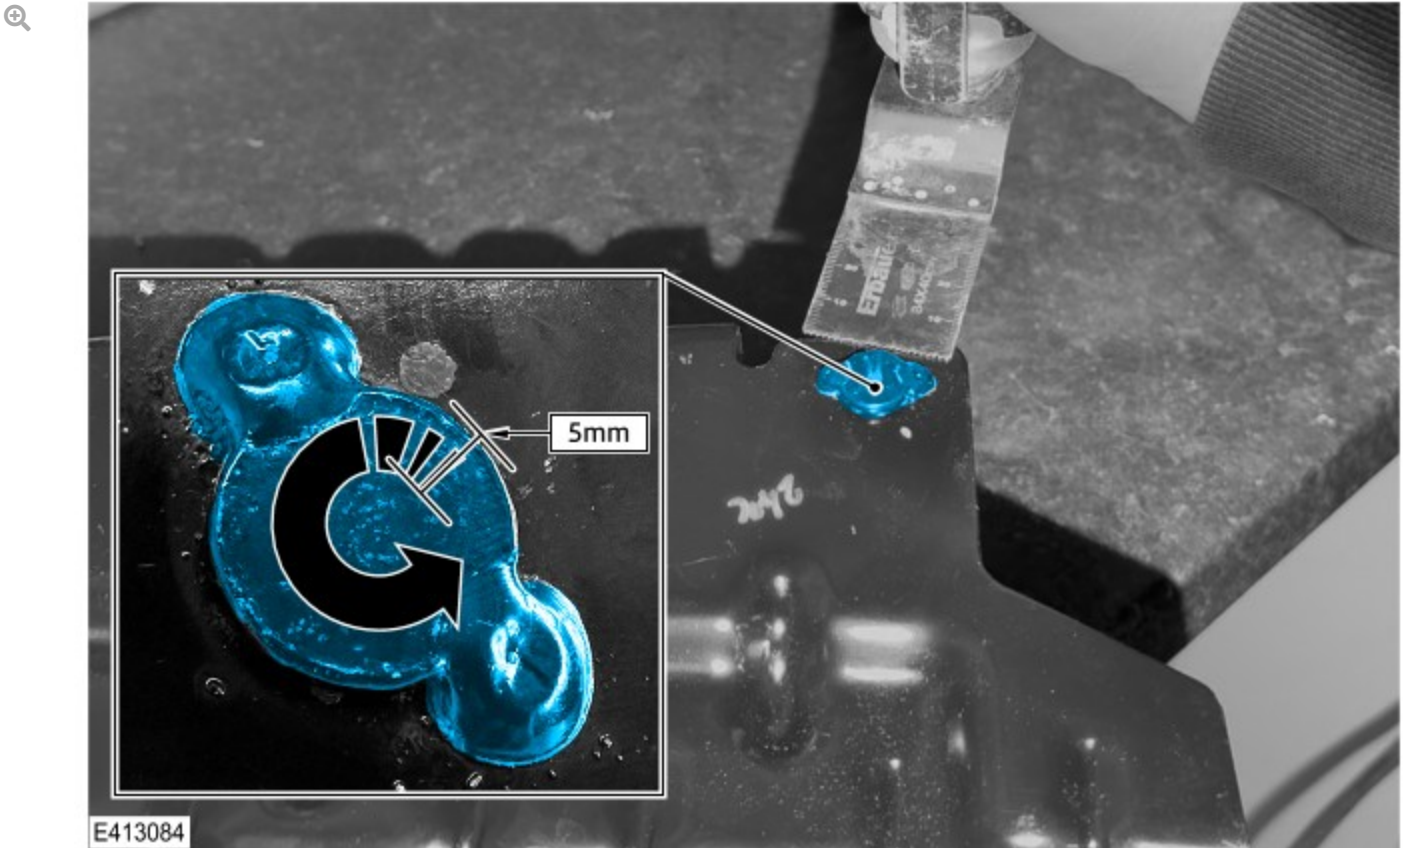
Using an oscillating multitool with a suitable metal cutting blade, follow the instructions below.

- Cut through the 2 welds securing the stud to the third row seatbelt anchor bracket.
- Cut a minimum of a 5 mm deep groove below the stud head and around the entire circumference of the stud.

- A titanium carbide or obsidian carbide oscillating multitool blade can help with this step but is not essential.
- The multitool blade must be flat to the surface of the third row seatbelt anchor bracket at all times.

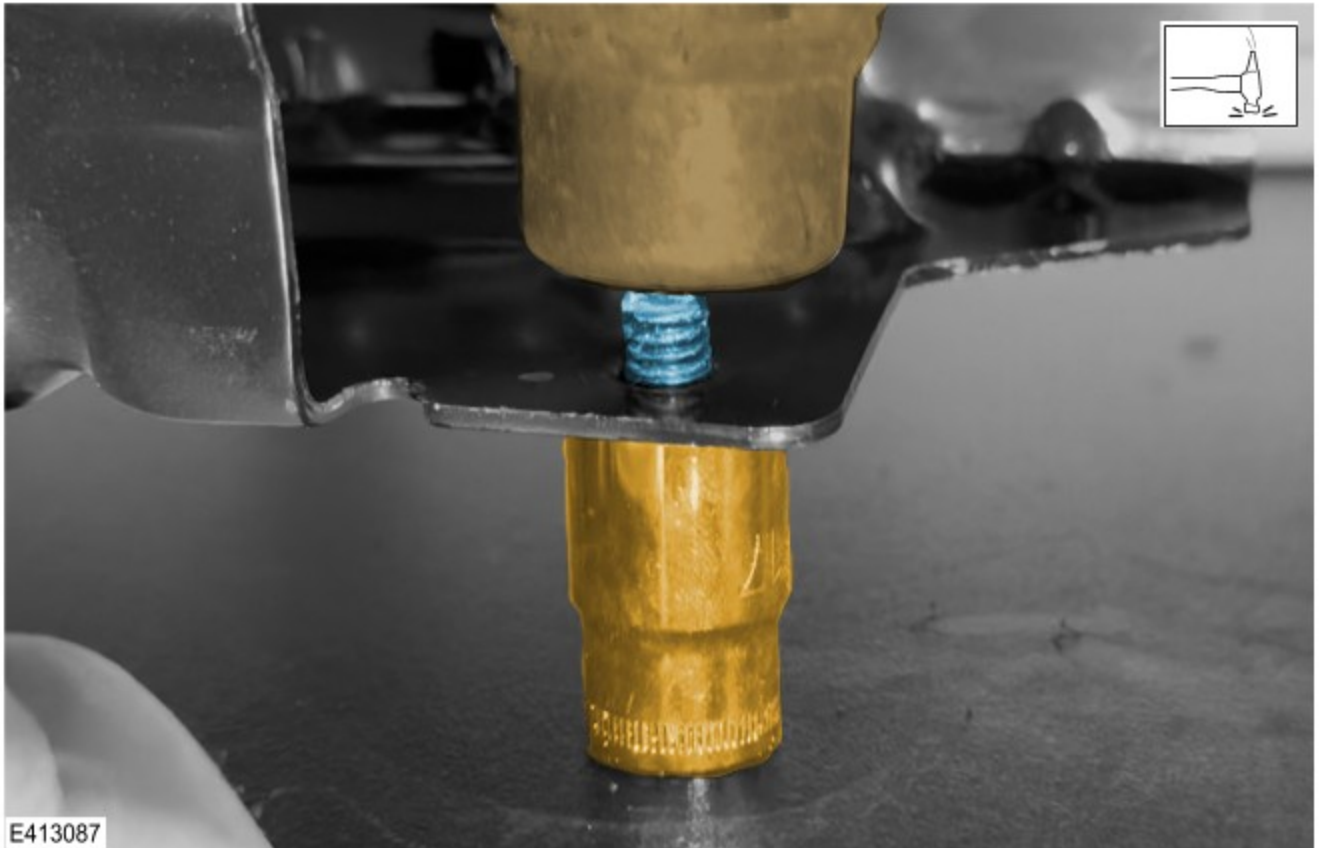
**10.** Remove the stud from the third row seatbelt anchor bracket.

- Remove the third row seatbelt anchor bracket from the vice.
- Rest the bracket on a suitable size socket, or similar tool, with the thread of the stud pointing upwards, as shown in the illustration.
- Using a suitable hammer and punch, hammer the stud out of the third row seatbelt anchor bracket.
- The third row seatbelt anchor bracket must be straight, without deformities, before continuing.

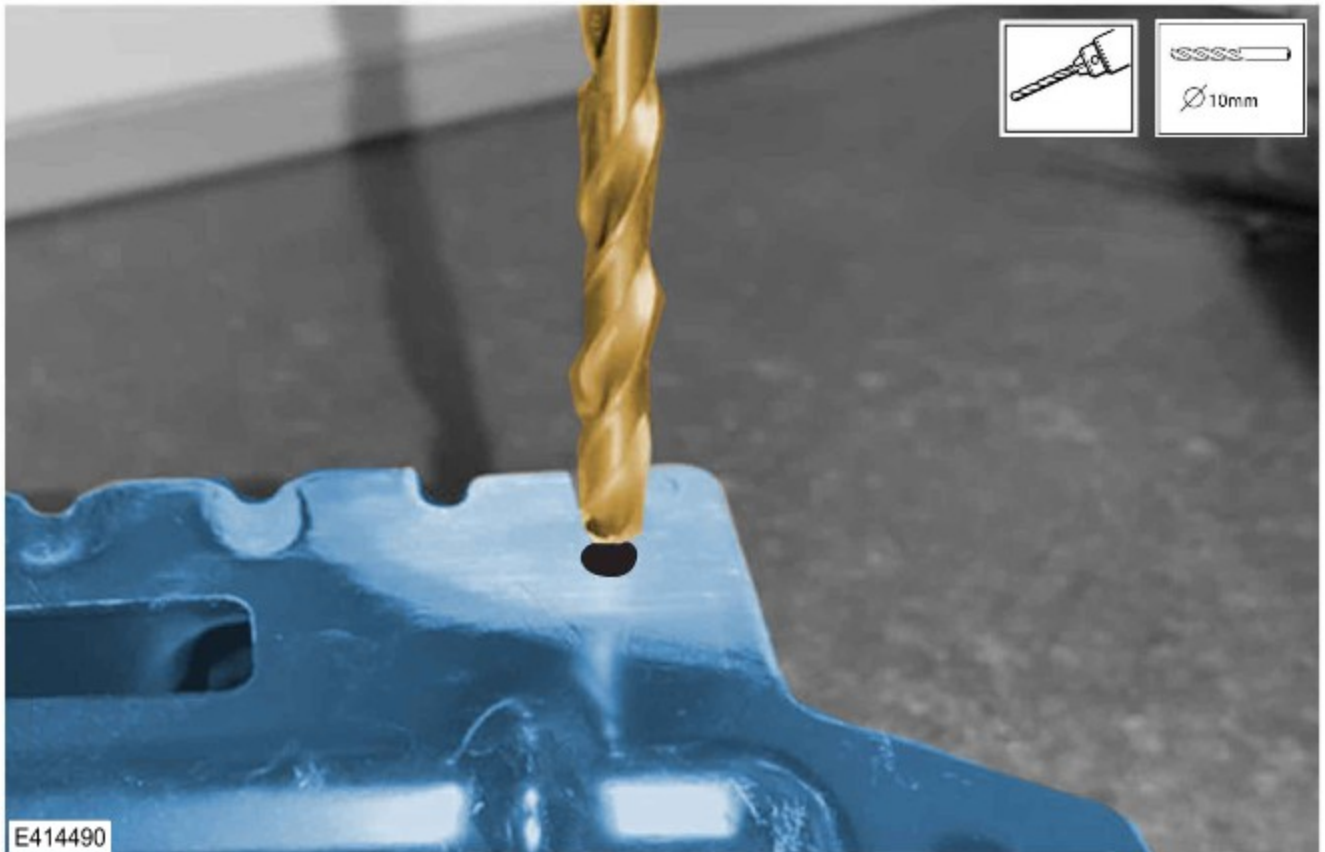
The drill must be upright and central at all times.

Run a 10 mm drill bit through the third row seatbelt anchor bracket hole.

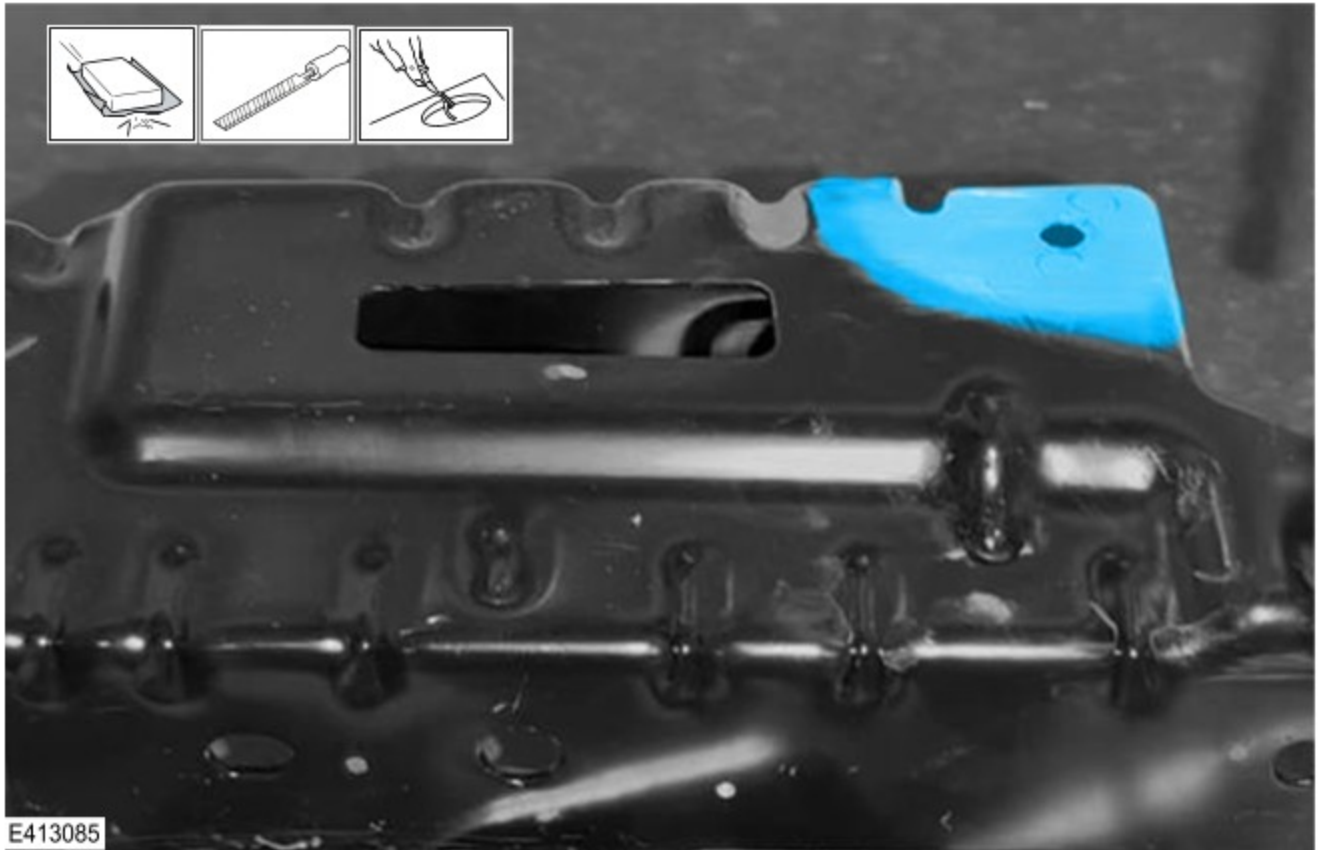
12. Using a suitable file and abrasive paper, flatten the surface of the third row seatbelt anchor bracket. The hole must be free of material before continuing.

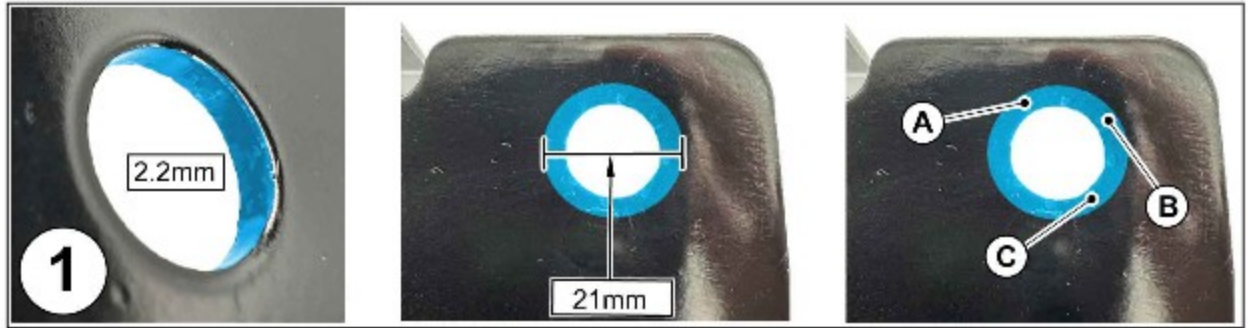
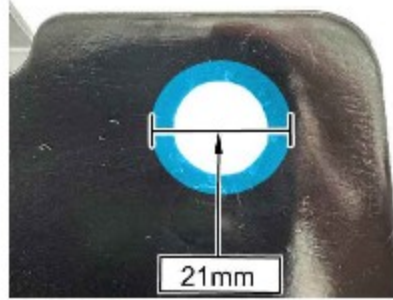
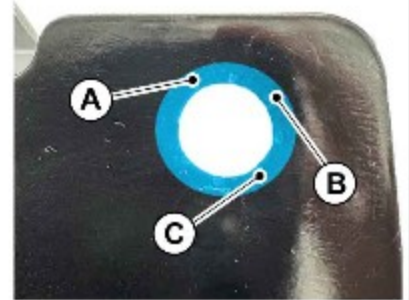
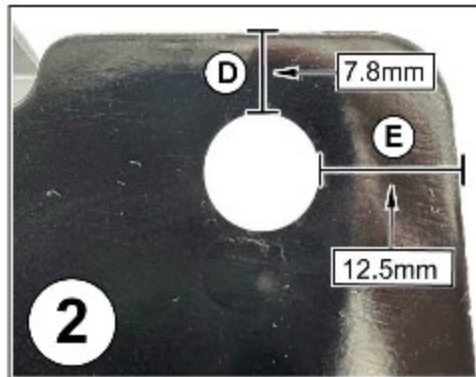
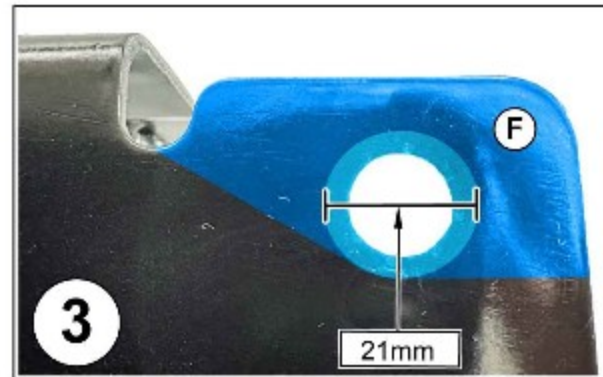
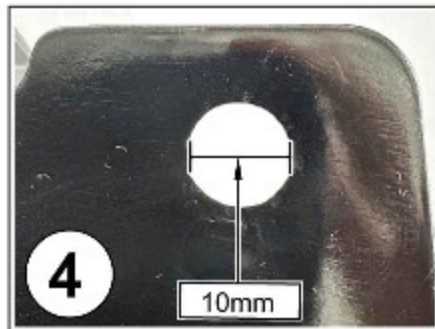
E414491

Complete the following 4 steps, the modified third row seatbelt anchor bracket **MUST** meet the requirements. **Take a photograph to show each of the below measurements being completed, including a photograph of the area to be inspected in step 3. The photographs must be attached to the Warranty Claim. Failure to follow this instruction may result in a rejection or delay in the claim being processed.**

1. Using the images provided for reference, measure the thickness of the third row seatbelt anchor bracket. There must be a **minimum** thickness of 2.2 mm within the 21 mm perimeter around the drilled hole. Also, specifically measure the thickness of the areas marked A, B, and C. The deviation in thickness across points A, B, and C **MUST NOT** exceed 0.5 mm.

2. Measure from the edge of the drilled hole to the edge of the third row seatbelt anchor bracket, in the areas shown.
  - D) There **MUST** be a **minimum** of 7.8 mm from the edge of the drilled hole to the edge of the third row seatbelt anchor bracket, in the area shown.

- E) There **MUST** be a **minimum** of 12.5 mm from the edge of the drilled hole to the edge of the third row seatbelt anchor bracket, in the area shown.

3. Visually inspect the wider area of the third row seatbelt anchor bracket shown as Dark Blue in the illustration and marked F. Inspect for any incidental damage caused during steps 9 to 12. Any incidental damage present **MUST NOT** reduce the thickness of the third row seatbelt anchor bracket to less than 2.2 mm in the area shown.

4. Measure the diameter of the drilled hole. The diameter of the drilled hole **MUST** measure between 10 mm - 10.5 mm.

If **1 or more** of the below requirements cannot be achieved, a new third row seatbelt anchor bracket **MUST** be installed, continue to quarantine the vehicle and await a further communication. Do **NOT** install any third row seatbelt anchor bracket which does not meet **1 or more** of the below requirements.

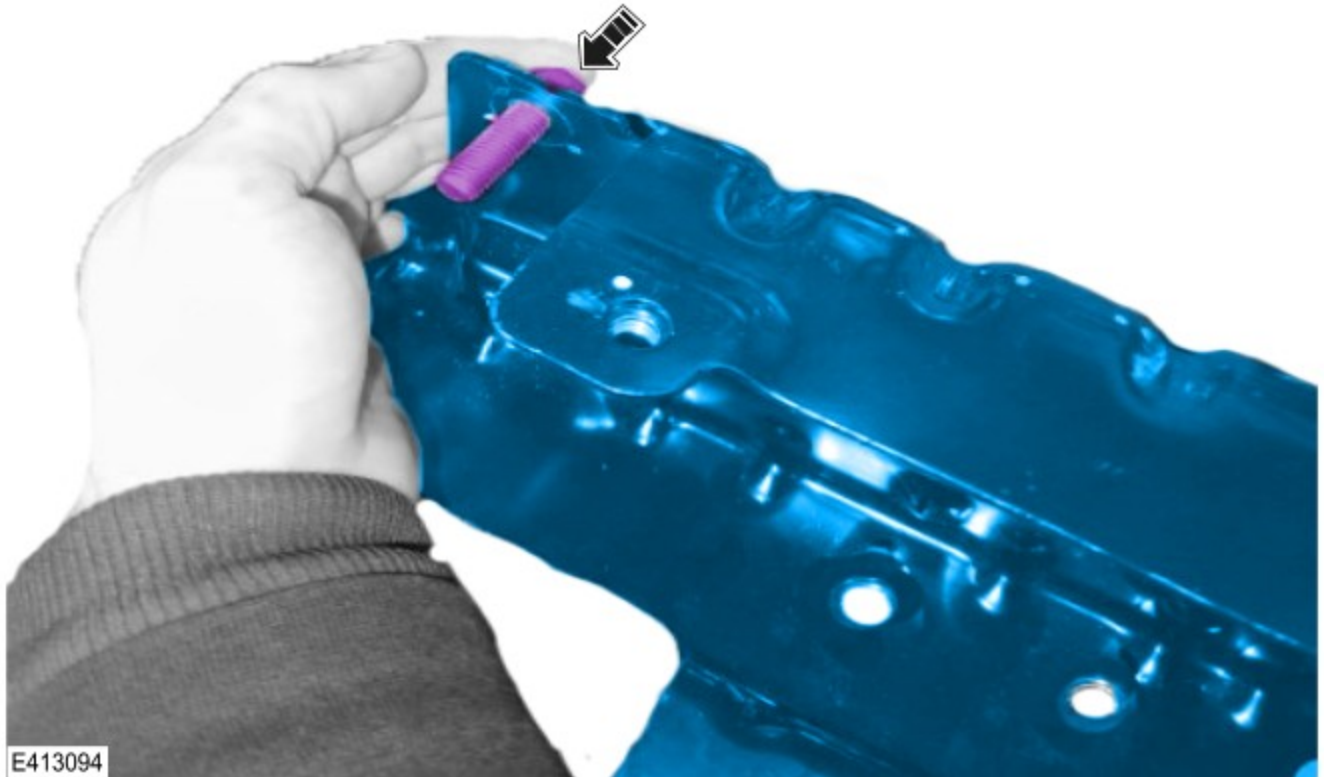
- The new bolt must be inserted from the rear of third row seatbelt anchor bracket.
- The head of the new bolt **MUST** be flush against the matting surface.

Insert the new bolt through the reworked hole in the third row seatbelt anchor bracket.

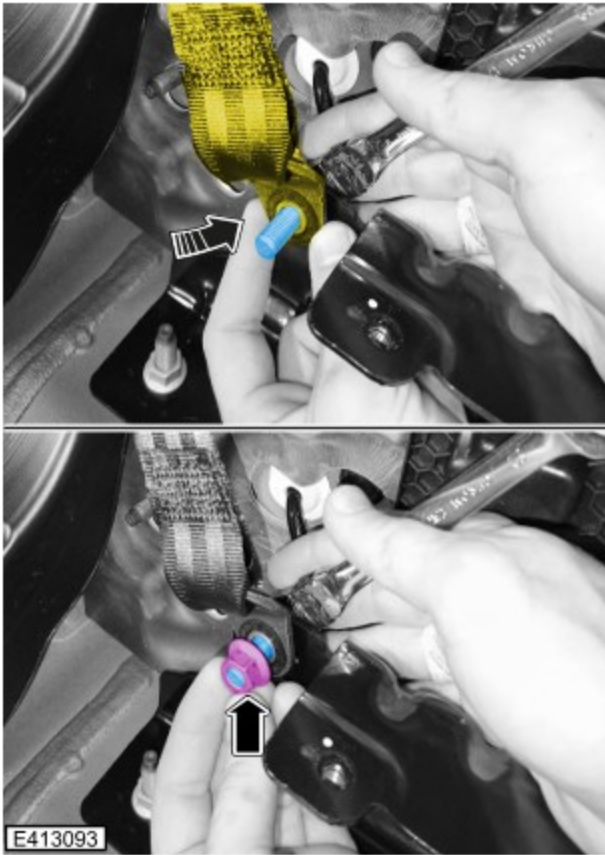
20. Install the left side and right side third row seatbelt anchors.

- Reposition the third row seatbelt anchor over the new bolt.
- Install the nut.

The head of the bolt must be flat against the rear surface of the bracket when torqued.

Hold the bolt using a suitable spanner and torque the nut.

- Torque: **40Nm**

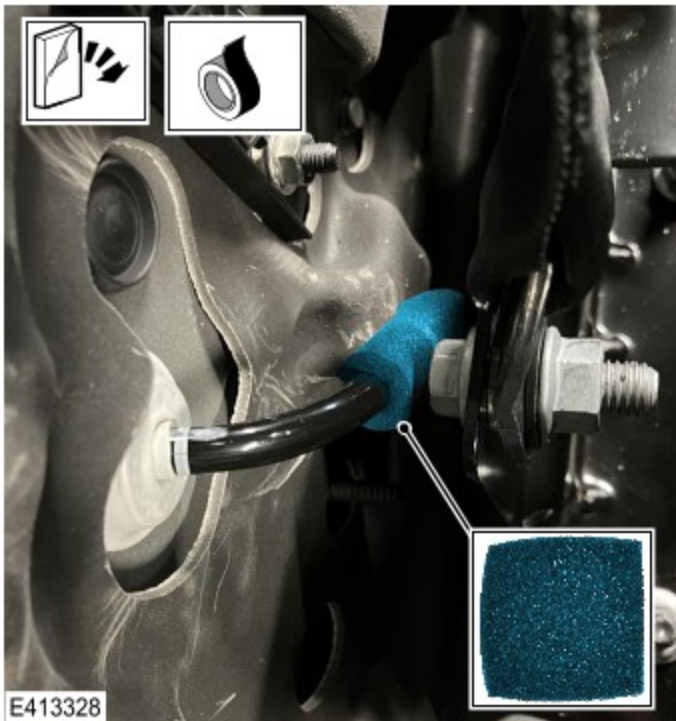
The energy absorbing foam tape foam is required prevent any contact between the air suspension pipe and the head of the bolt.

Install the energy absorbing foam tape.

- Install the energy absorbing foam tape onto the air suspension pipe, as shown in the illustration.
- Apply a suitable anti-abrasion tape to the foam [Noise, Vibration and Harshness \(NVH\)](#) pad.
