<b>HYUNDAI</b> <b>Technical Service Bulletin</b>	GROUP <b>RECALL</b>	NUMBER <b>26-01-036H</b>
	DATE <b>APRIL 2026</b>	MODEL(S) <b>PALISADE (LX3) PALISADE HYBRID (LX3 HEV)</b>
<b>SUBJECT:</b> 3 <sup>RD</sup> ROW LH SEAT BELT BUCKLE WIRE HARNESS INSPECTION & WIRING EXTENSION INSTALLATION (RECALL 297)

**SUBJECT:** 3RD ROW LH SEAT BELT BUCKLE WIRE HARNESS INSPECTION  
& WIRING EXTENSION INSTALLATION (RECALL 297)

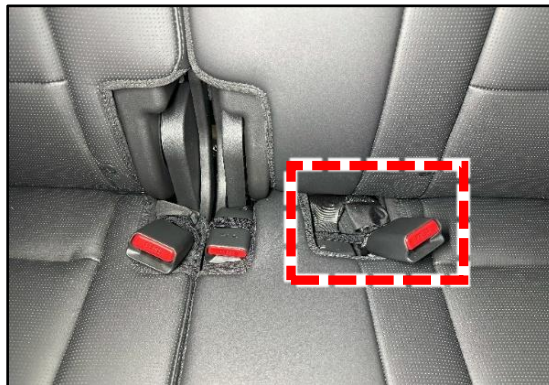
**Description:** In certain 2026MY Palisade (LX3) and Palisade Hybrid (LX3 HEV) vehicles with Limited and Calligraphy trims, the internal wiring within the 3<sup>rd</sup> row left-hand (driver side) seat belt buckles may become damaged due to excessive tension applied when the buckle is pulled. Damage to the buckle wiring can prevent detection of the seat belt latch status for the 3<sup>rd</sup> row driver side seating position. Unfastened seat belts could increase the risk of injury during a crash. This bulletin provides instructions for inspecting the 3<sup>rd</sup> row LH seat belt buckle wiring, installation of a wiring extension and, if necessary, replacement of the seat belt buckle.

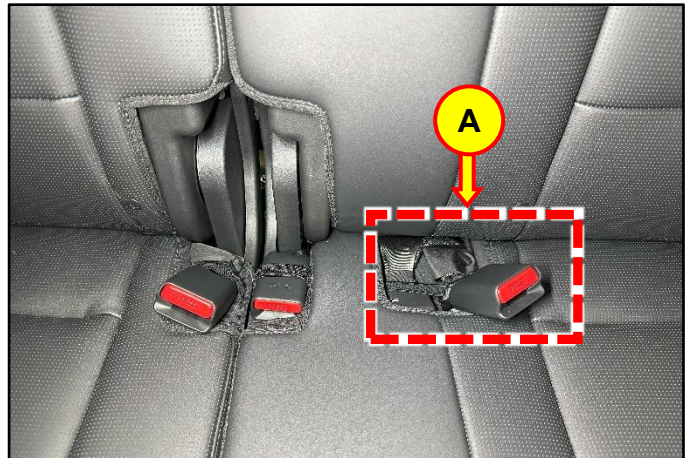
1. Locate the 3<sup>rd</sup> row LH (driver side) seat belt buckle (A).

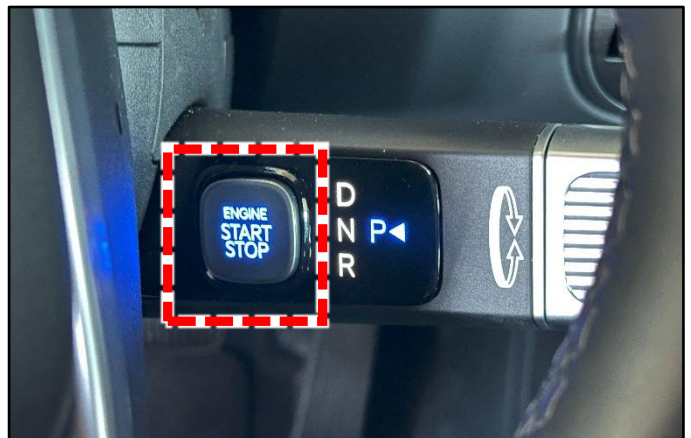
2. Apply the parking brake and then turn the vehicle ignition **ON**.

Without depressing the brake pedal, press the **START/STOP** button twice.

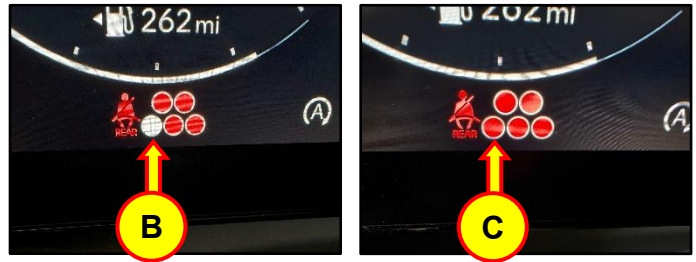
4. Confirm the light indicator on the instrument cluster for the 3<sup>rd</sup> row LH (driver side) changes to **white** (B) when buckled and **red** (C) when unbuckled.

- If the indicator does **NOT** change to white when buckled (C), then go to **step 6**.
- If it is operating as designed (B), then go to the next step.

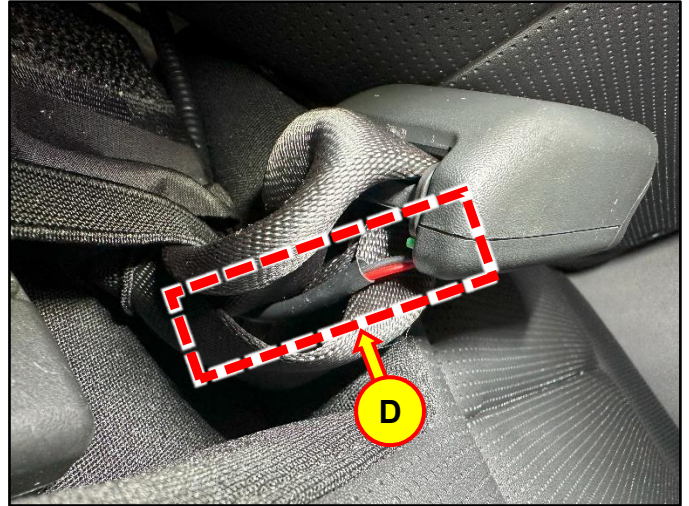
5. Inspect the red and black wire harness (D) from the seat belt buckle.

Inspect for possible damage such as torn, cut, or exposed wire.

- If damage is found with the wire harness, then go to **step 6**.
- If the seat belt buckle is operating as designed and **NO** damage is found with the wire harness, then proceed to [3<sup>rd</sup> Row LH Seat Belt Buckle Wire Extension Installation](#).

6. Replace the seat belt buckle by referring to the shop manual:
- **Body (Interior / Exterior / Electrical) > Seat Belt > Rear Seat Belt Buckle > Removal and Installation > 3<sup>rd</sup> Row Seat Belt Buckle [LH]**

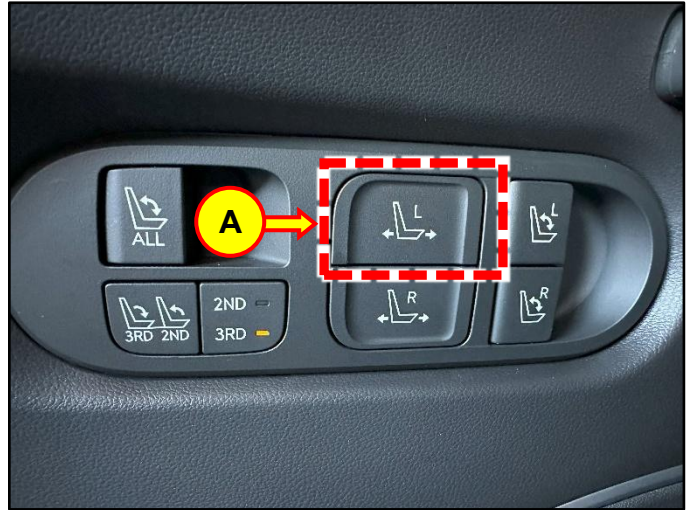
1. Open the tailgate and move the LH (driver side) 3<sup>rd</sup> row seat to the most forward position by pressing and holding the forward button (A).

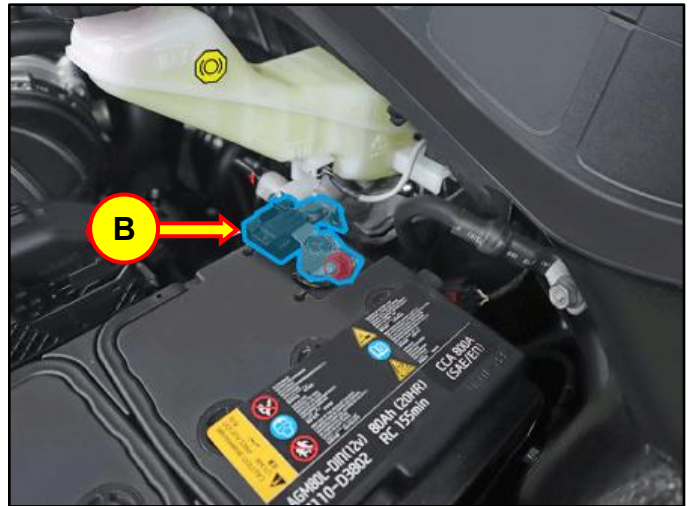
2. Disconnect the 12V negative (-) battery terminal (B).

lb-ft	6.5
lb-in	78
N.m	8.8

On Palisade Hybrid vehicles, the 12V battery is in the rear cargo area of the vehicle under the luggage center tray.

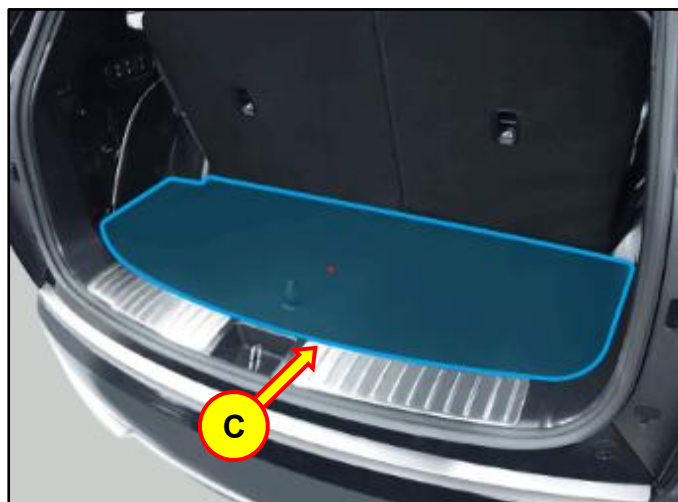
3. Open the luggage center tray cover (C).

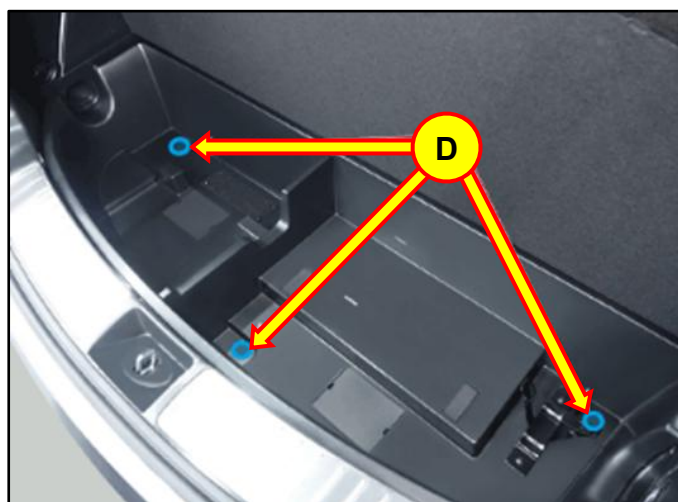
4. Remove the hole plugs (D) in the luggage center tray.

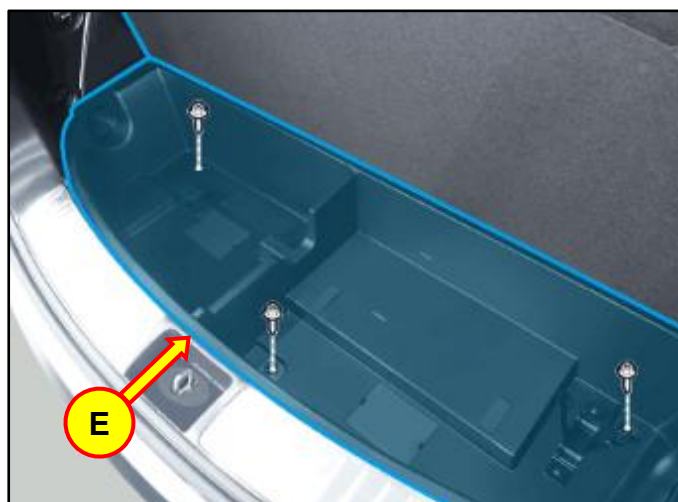
5. Remove the screws, then remove the luggage center tray (E).

On Palisade Hybrid vehicles, disconnect the negative (-) battery terminal on the 12V battery, which can now be accessed under the luggage center tray.

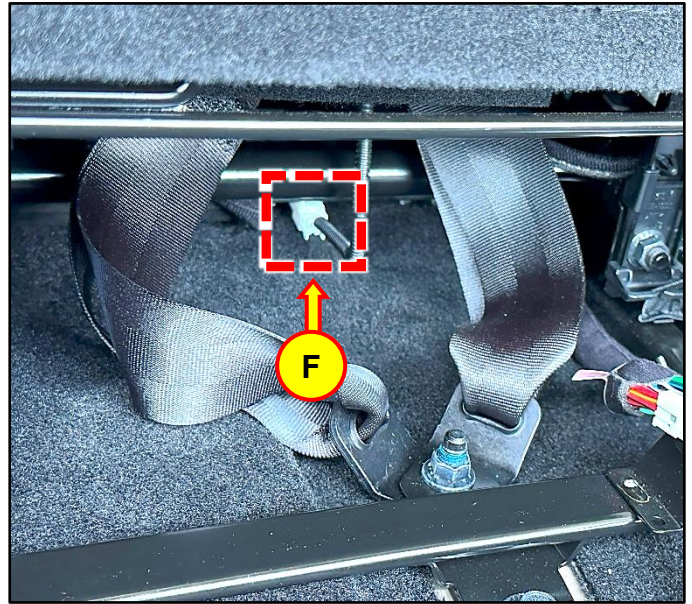
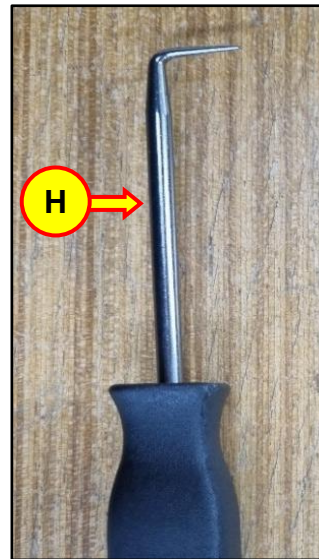
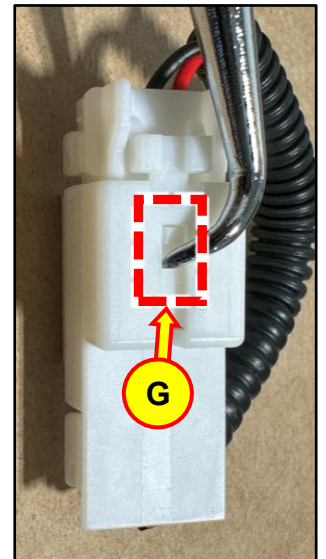
6. Disconnect the connector (F) of the lower 3<sup>rd</sup> row LH seat belt buckle by pressing the locking pin from the center groove (G) in the connector with an angled pick tool (H), or equivalent.

The connector sits facing down, place the pick underneath the connector and push upward to unlock the pin.

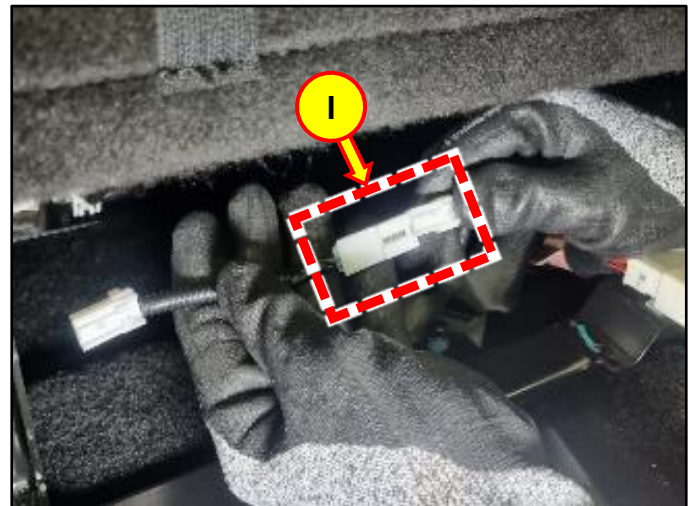
7. Securely connect the new extension wiring (I) from the kit to the disconnected wiring connector.

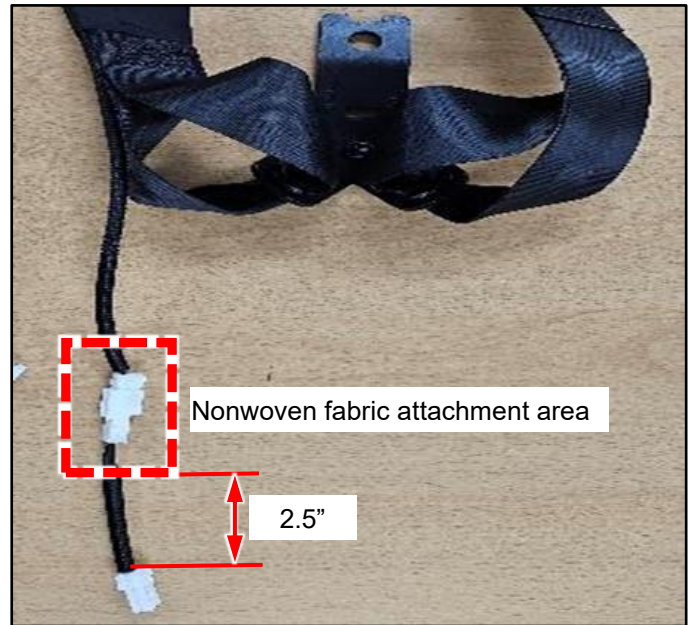
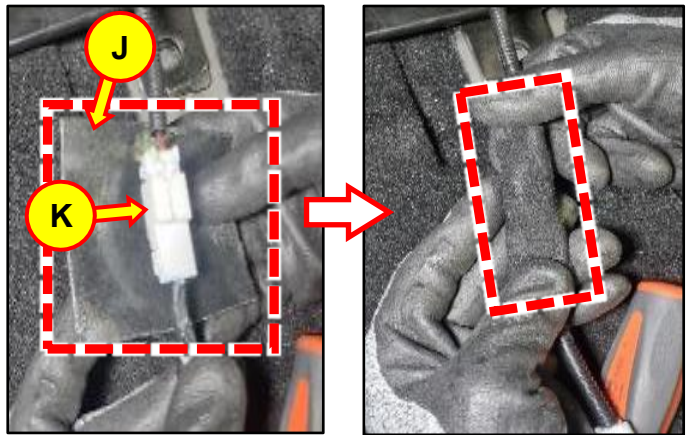
8. Wrap the nonwoven fabric (J) from the kit around the extension wiring connector housing (K) about **2.5" inches** from the end connector as shown in the picture to the right.

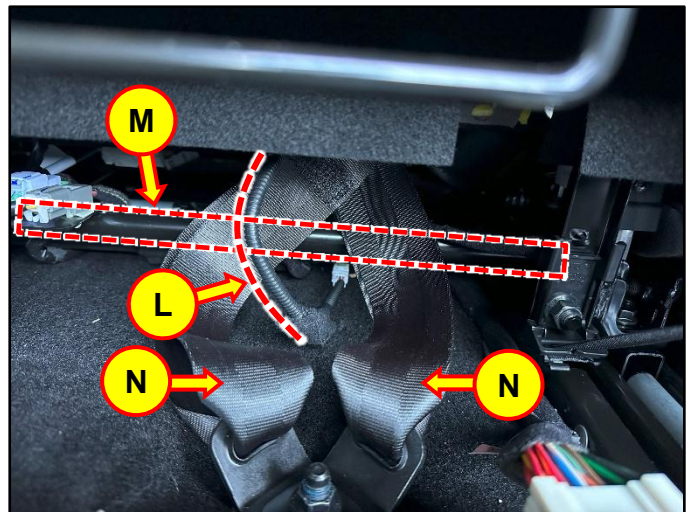
9. Position the extended wire harness (L) around the seat beam (M) and between the two seat belts (N) as shown in the picture to the right.

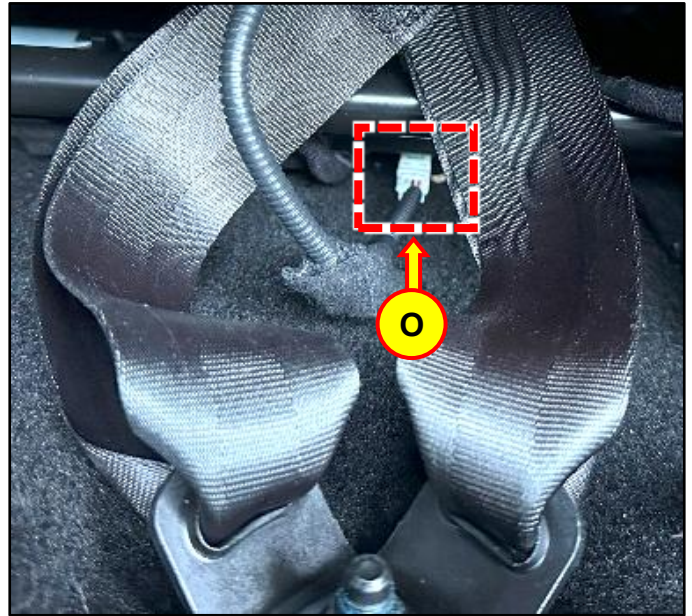
10. Connect the extension wiring connector (O).

Ensure the wrapped connector is in the position shown.

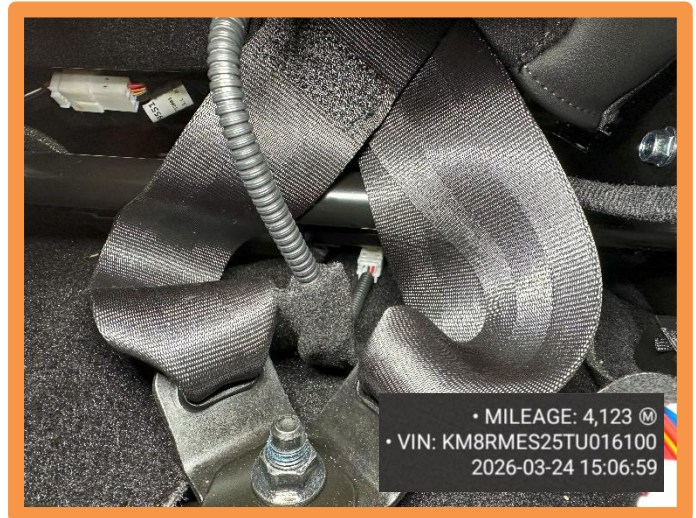
Using the STUI camera function, take a photo of the new wiring extension installed at the LH 3rd row seat belt buckle.

Upload the photo to STUI.
