# Recall Campaign Bulletin

| SUBJECT | Replace Rear Center Seat Belt |
| MODEL(S) | GLC (254 platform) |
| MODEL YEAR(S) | 2026 |

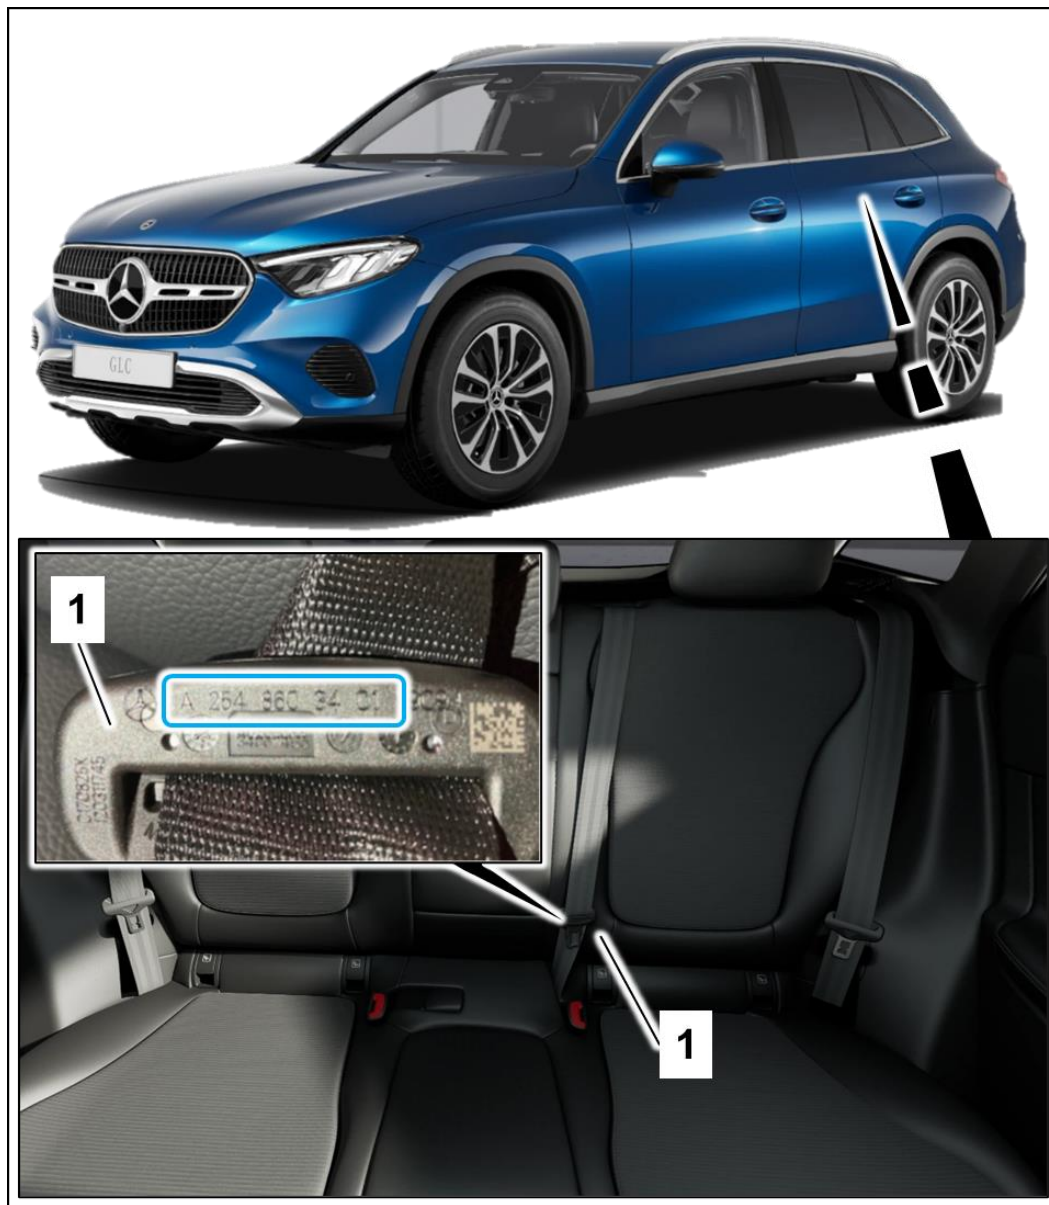
**Figure 1**

1. Check part number of belt tongue (Figure 1, 1) on the center seat belt in rear passenger compartment.

- a. If the installed belt tongue (Figure 1, 1) does **not** have **part number A 254 860 36 01 (model 254.3) or A 254 860 23 00 (model 254.6)**: Perform **Work Procedure**.
- b. If the installed belt tongue (Figure 1, 1) has **part number A 254 860 36 01 (model 254.3) or A 254 860 23 00 (model 254.6)**: No further action required.

1. Replace center seat belt in rear passenger compartment.
