2022-2026 (RU) Chrysler Pacifica
 2022-2026 (RU) Chrysler Voyager

SYMPTOM DESCRIPTION

SAFETY RECALL
NORTH AMERICA
Side Curtain Airbag

Reference: 10D / NHTSA 26V-189

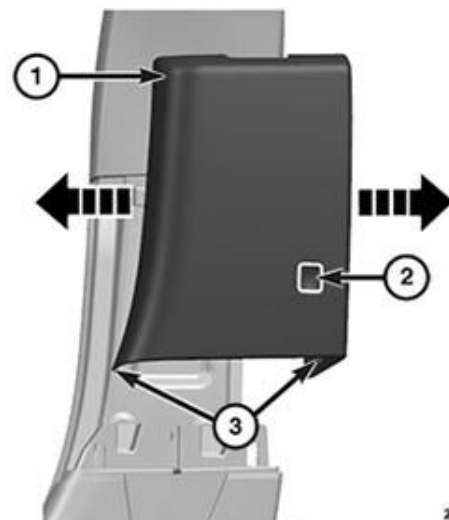
Figure 5 – B-Pillar Extension

- 15. Spread the bottom flanges of the B-pillar extension apart to disengage the lower side snaps, then use a trim stick or equivalent to disengage the remaining clips. Pull at the top edge seat belt opening to disengage the top retainers (Figure 5).

- 1 - Top Retainer
- 2 - Seat Position Switch
- 3 - Clips

92. Tighten the grab handle bolts securely (Figure 6).
93. Install the B-pillar extension and engage the remaining clips (Figure 5).

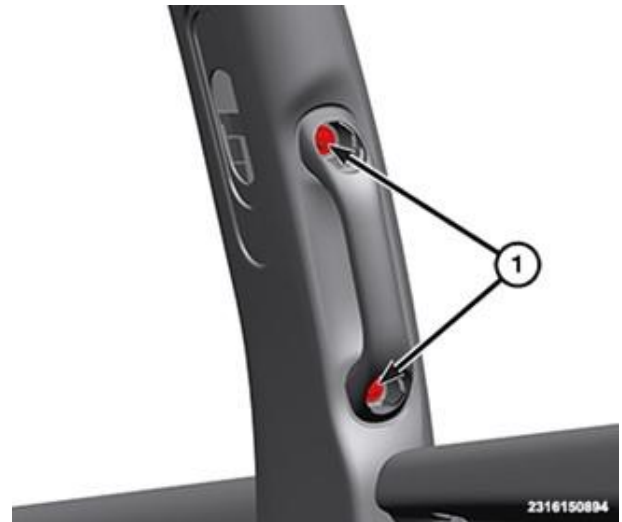
Figure 6 – Grab Handle

16. Using a small flat bladed tool, remove the bolt covers then the grab handle bolts (Figure 6).

1 - Grab Handle Bolts

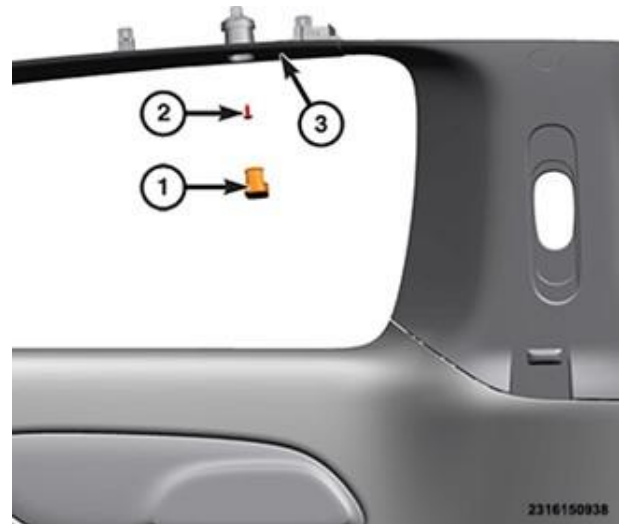
Figure 10 – C-Pillar Extension Trim

25. For LEFT side of vehicle open the coat hook and remove the screw from C-pillar extension trim (Figure 10).

- 1 - Coat Hook
- 2 - Screw
- 3 - Extension Trim

87. For LEFT side of vehicle, engage the C-pillar extension trim retaining clips, install the screw, tighten securely then install the screw cover (Figure 10).

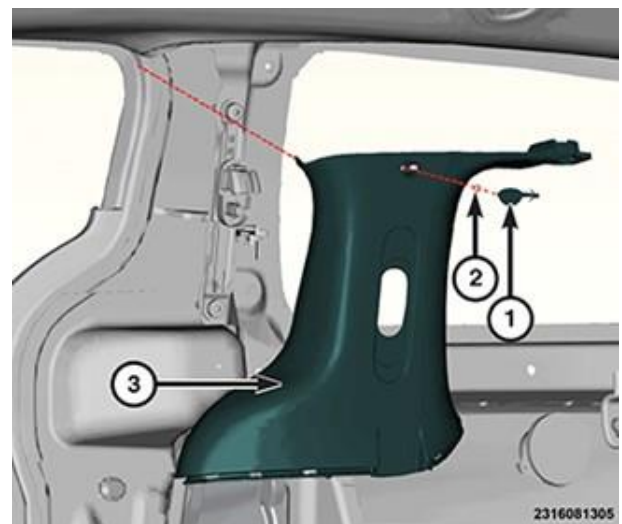
Figure 13 – C-Pillar Trim Panel

30. Using a small flat bladed tool, remove the screw cover then the screw (Figure 13).

31. Using a trim stick release the upper front edge of the quarter trim panel from the bottom of the C-pillar trim panel. (Figure 13).

32. Pull at the bottom of the C-pillar trim panel and release it from the vehicle (Figure 13).

33. It is not necessary to separate the C-pillar trim panel from the seat belt. Position the C-pillar trim panel as low as possible within the vehicle (Figure 13).

- 1 - Screw Cover
- 2 - Screw
- 3 - C-Pillar Trim Panel

83. Install the quarter trim panel engaging the retainers (Figure 14).
84. Position the C-pillar trim panel to the vehicle and engage the retainers (Figure 13).

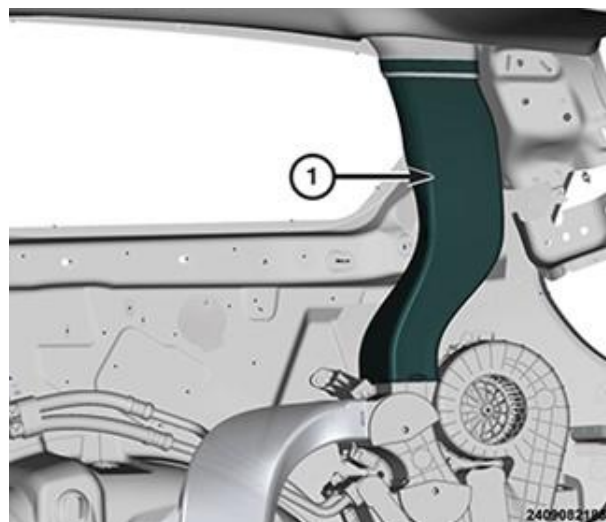
Figure 15 – Ceiling Distribution Duct

- 36. Pull the bottom end of the rear ceiling distribution duct away from the rear HVAC housing and disengage the duct from the duct located in the headliner (Figure 15).
- 37. Remove the rear ceiling distribution duct from the vehicle (Figure 15).

- 1 - Rear Ceiling Distribution Duct

81. Install the D-pillar extension to the vehicle then install the curtain airbag push-fastener (Figure 16).
82. Install the rear ceiling distribution duct to the vehicle by first engaging the duct to the headliner then install the bottom end to the rear HVAC housing (Figure 15).

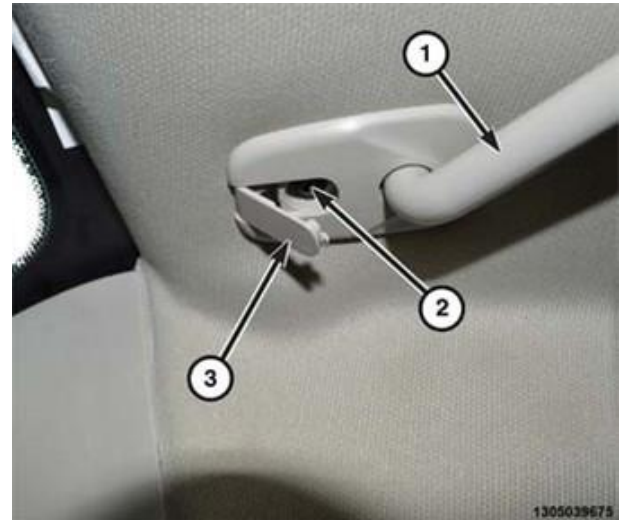
Figure 17 – Sun Visor

39. Using a small pry tool, open the visor screw cover and remove the screw (Figure 17).
40. Rotate the visor upward towards the roof to remove it from the opening (Figure 17).
41. If equipped, disconnect the harness connector from the visor (Figure 17).

- 1 - Sun Visor
- 2 - Screw
- 3 - Screw Cover

73. If equipped with grab handles, position the grab handle to the headliner, install the screws and tighten securely then install the screw covers (Figure 22).
74. Position the coat hook to the headliner, install the screw and tighten securely then close the screw cover (Figure 21).
75. Connect the wire harness connectors to the lamp and camera, install the rear dome lamp / camera to the headliner (Figure 20).
76. Install the two screws securing the front overhead console (Figure 19).
77. Close the front overhead console rear observation mirror (Figure 19).
78. Position the sun visor support and install the screw, tighten securely then close the screw cover (Figure 18).
79. Connect the harness connector to the visor (Figure 17).
80. Install the visor to the roof and install the screw, tighten securely then close the screw cover (Figure 17).

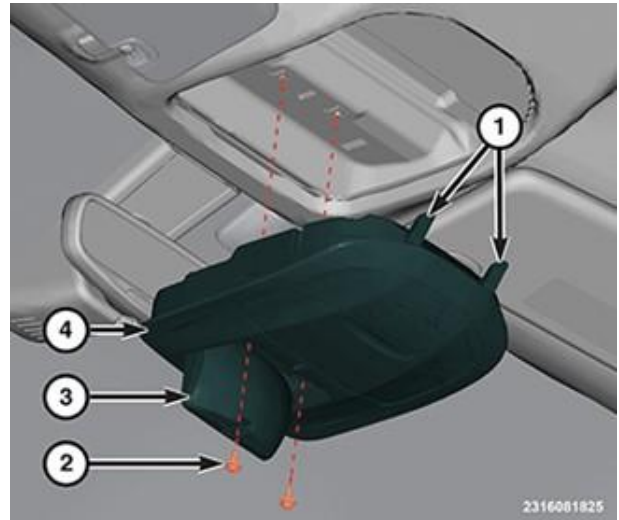
Figure 19 – Front Overhead Console

44. Open the rear observation mirror of the front overhead console (Figure 19).

45. Remove the two screws (Figure 19).

- 1 - Hooks
- 2 - Screws
- 3 - Observation Mirror
- 4 - Overhead Console

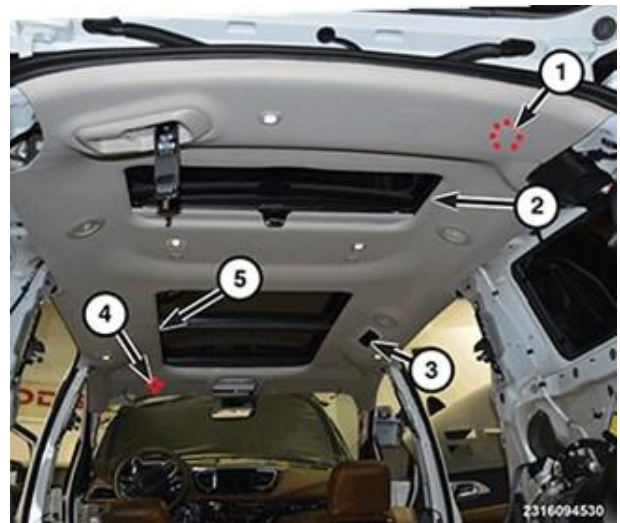
Figure 23 – Headliner

- 49. Using a trim stick or equivalent, release the push fastener at the location at the rear of the headliner (Figure 23).
- 50. With the help of an assistant starting at the rear of the vehicle, release the hook and loop fasteners by hand, then around the sunroof openings, if equipped (Figure 24).
- 51. Using a long trim stick, reach up above the headliner and release the three steel retainers that retain the rear heater controls bracket to the roof panel (Figure 23).

- 1 - Push Fastener
- 2 - Sunroof Opening
- 3 - Rear Heater Controls
- 4 - Push Fastener
- 5 - Sunroof Opening

- 70. Connect the rear window washer hose (Figure 24).
- 71. Attach all the hook and loop fasteners (Figure 24).
- 72. Attach the three steel retainers that retain the rear heater controls bracket to the roof panel (Figure 23).

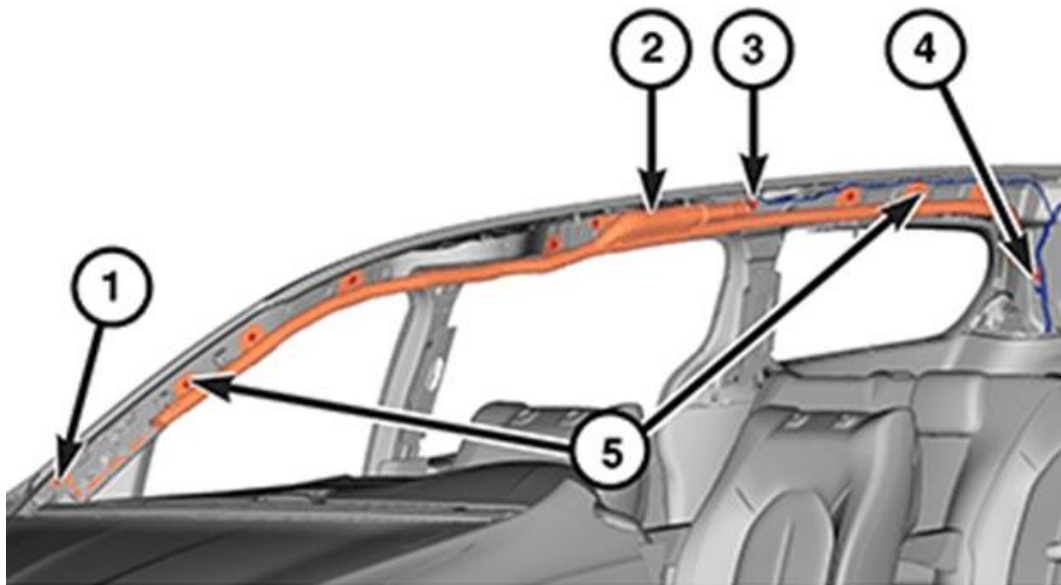
Figure 25 – Side Curtain Airbag (CAB)

The left side (driver side) Curtain Airbag (CAB) on about 17,433 of the above vehicles may not retain sufficient pressure during deployment. CABs which do not have proper pressure retention may reduce occupant protection and increase the risk of partial and complete ejection and injury of an occupant through a side window during certain types of crashes.

55. Disconnect the body wire harness connector for the CAB from the connector receptacle of the inflator above the front door opening (Figure 25).
56. Remove the fastener that secures the airbag front tether to the A-pillar (Figure 25).
57. Remove the fastener that secures the airbag rear tether to the D-pillar (Figure 25).
58. Remove the fasteners that secure the CAB to the inner roof rail (Figure 25).
59. Remove the CAB from the vehicle as a unit and **DISPOSE** of in a proper manner (Figure 25).

- 1 - Fastener
- 2 - SABIC
- 3 - Body Wire Harness Connector
- 4 - Fastener
- 5 - Fasteners

Replace the left side (driver side) curtain airbag.

- 60. Obtain the **NEW** left side (driver side) CAB for the vehicle.
- 61. Clean the CAB mounting studs with mineral spirits, toluene, or equivalent (Figure 25).
- 62. Apply blue threadlocking compound Mopar Part Number 04318031AB (MS-90061) or equivalent to the CAB mounting studs (Figure 25).
- 63. Install the **NEW** CAB to the vehicle as a unit (Figure 25).
- 64. Engage the CAB to the weld studs of the inner roof side rail. Be certain that the CAB is not twisted.
- 65. Working from front to rear, install the fasteners that secure the CAB and the inflator bracket to the inner roof rail and tighten to 6 N·m (53 in. lbs.) (Figure 25).

- 66. Install the fastener that secures the airbag front tether to the A-pillar and tighten to 6 N·m (53 in. lbs.) (Figure 25).
- 67. Install the fastener that secures the airbag rear tether to the D-pillar and tighten to 6 N·m (53 in. lbs.) (Figure 25).
- 68. Connect the body wire harness connector for the SABIC to the connector receptacle of the inflator above the sliding door opening (Figure 25).
