# SAFETY RECALL

## Side Curtain Airbag

Reference: 06D / NHTSA 26V-189

2022-2026 (RU) Chrysler Pacifica  
2022-2026 (RU) Chrysler Voyager

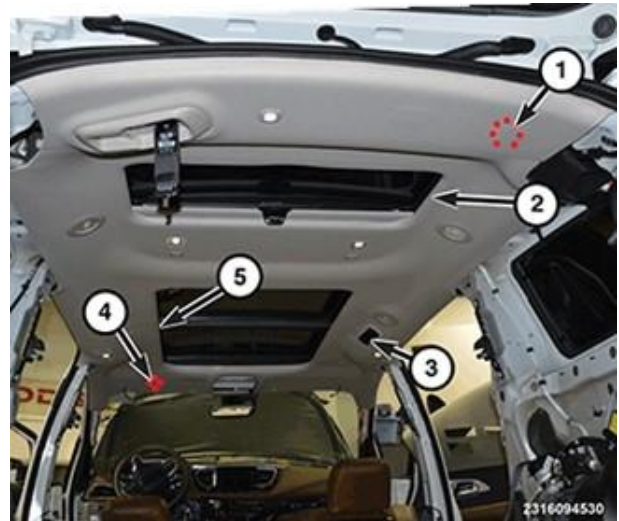
**Figure 23 – Headliner**

49. Using a trim stick or equivalent, release the push fastener at the location at the rear of the headliner (Figure 23).
50. With the help of an assistant starting at the rear of the vehicle, release the hook and loop fasteners by hand, then around the sunroof openings, if equipped (Figure 24).
51. Using a long trim stick, reach up above the headliner and release the three steel retainers that retain the rear heater controls bracket to the roof panel (Figure 23).

- 1 - Push Fastener
- 2 - Sunroof Opening
- 3 - Rear Heater Controls
- 4 - Push Fastener
- 5 - Sunroof Opening

70. Connect the rear window washer hose (Figure 24).
71. Attach all the hook and loop fasteners (Figure 24).
72. Attach the three steel retainers that retain the rear heater controls bracket to the roof panel (Figure 23).
