# SAFETY RECALL

## Side Curtain Airbag

Reference: 06D / NHTSA 26V-189

2022-2026 (RU) Chrysler Pacifica  
2022-2026 (RU) Chrysler Voyager

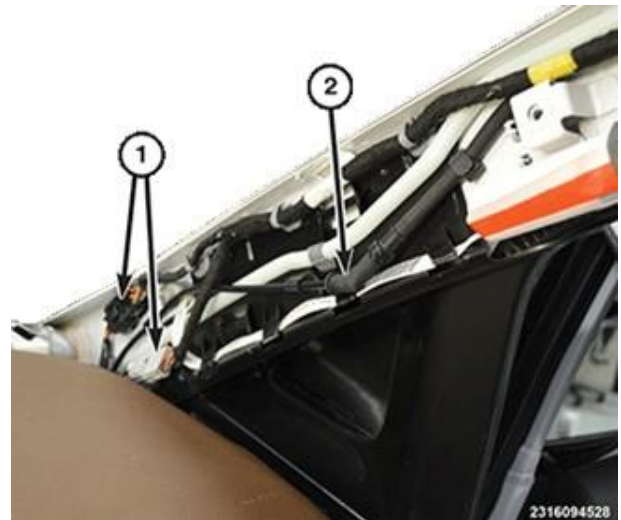
**Figure 3 – A-Pillar**

10. Disconnect the wire harness connectors and unclip the wire harness from the passenger side A-pillar (Figure 3).
11. Disconnect the rear washer hose (and unclip the hose from the passenger side A-pillar, if equipped (Figure 3).

- 1 - Wire Harness Connectors  
2 - Washer Hose

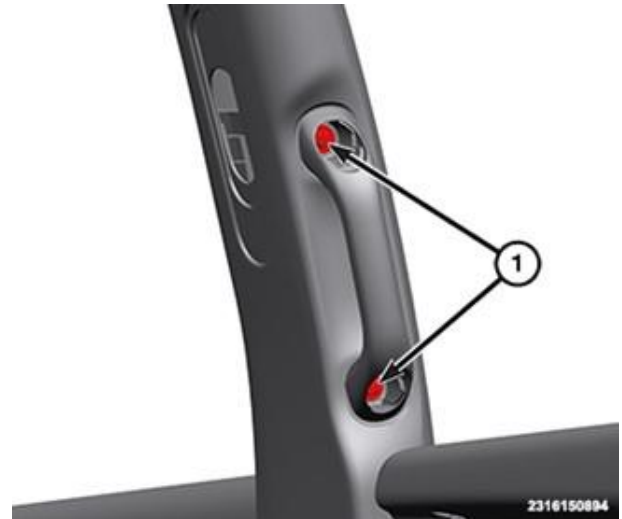
**Figure 6 – Grab Handle**

16. Using a small flat bladed tool, remove the bolt covers then the grab handle bolts (Figure 6).

1 - Grab Handle Bolts

92. Tighten the grab handle bolts securely (Figure 6).
93. Install the B-pillar extension and engage the remaining clips (Figure 5).
