**SAFETY RECALL**  
NORTH AMERICA  
**Side Curtain Airbag**

Reference: 11D / NHTSA 26V-189

2022-2026 (RU) Chrysler Pacifica  
2022-2026 (RU) Chrysler Voyager

Replace the right side (passenger side) curtain airbag.

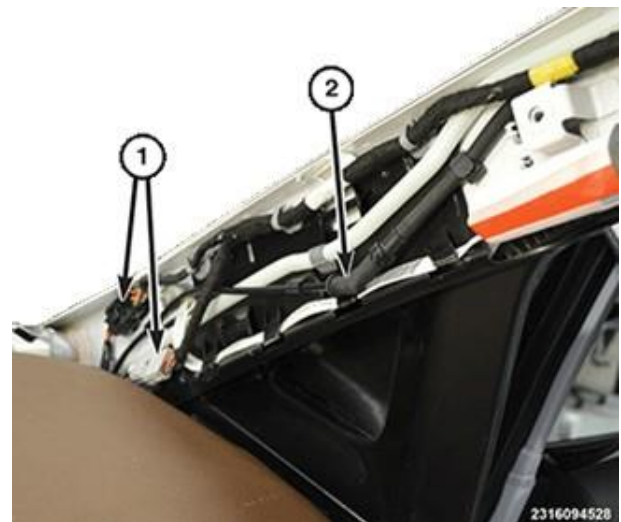
**Figure 3 – A-Pillar**

10. Disconnect the wire harness connectors and unclip the wire harness from the passenger side A-pillar (Figure 3).
11. Disconnect the rear washer hose (and unclip the hose from the passenger side A-pillar, if equipped (Figure 3)).

- 1 - Wire Harness Connectors  
2 - Washer Hose

99. Connect the rear washer hose (and unclip the hose from the passenger side A-pillar, if equipped (Figure 3).
100. Connect the wire harness connectors and unclip the wire harness from the passenger side A-pillar (Figure 3).

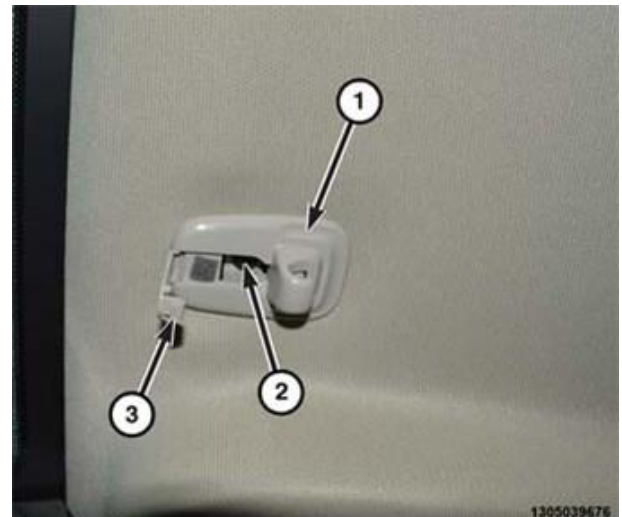
**Figure 18 – Sun Visor Support**

42. Using a small pry tool, open the sun visor support screw cover (Figure 18).
43. Remove the screw and the sun visor support (Figure 18).

- 1 - Visor Support
- 2 - Screw
- 3 - Screw Cover

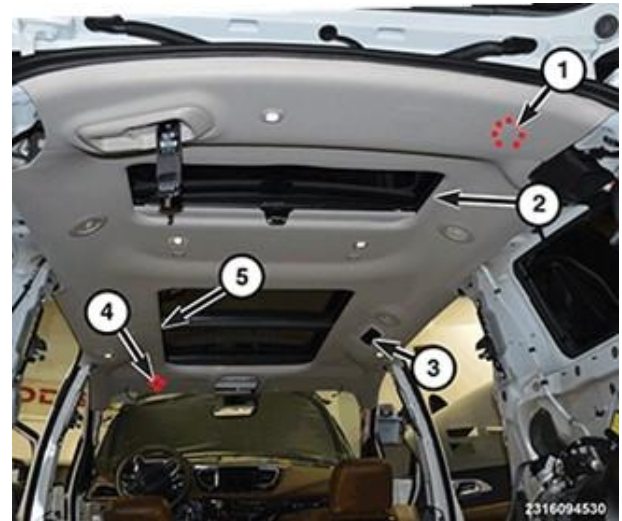
**Figure 23 – Headliner**

49. Using a trim stick or equivalent, release the push fastener at the location at the rear of the headliner (Figure 23).
50. With the help of an assistant starting at the rear of the vehicle, release the hook and loop fasteners by hand, then around the sunroof openings, if equipped (Figure 24).
51. Using a long trim stick, reach up above the headliner and release the three steel retainers that retain the rear heater controls bracket to the roof panel (Figure 23).

- 1 - Push Fastener
- 2 - Sunroof Opening
- 3 - Rear Heater Controls
- 4 - Push Fastener
- 5 - Sunroof Opening

70. Connect the rear window washer hose (Figure 24).
71. Attach all the hook and loop fasteners (Figure 24).
72. Attach the three steel retainers that retain the rear heater controls bracket to the roof panel (Figure 23).
