# Safety Recall

## N262555280 Chassis and Cab Wire Harness Contact Damage

**Release Date:** June 2026

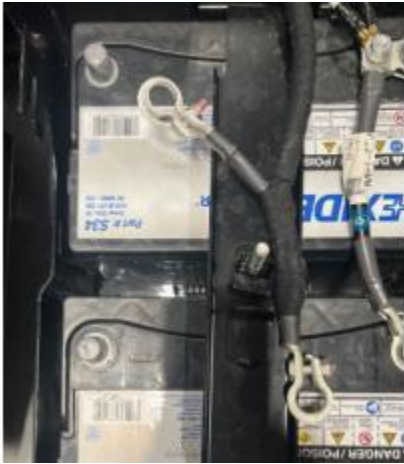
7165488

1. Set the parking brake and block the wheels.

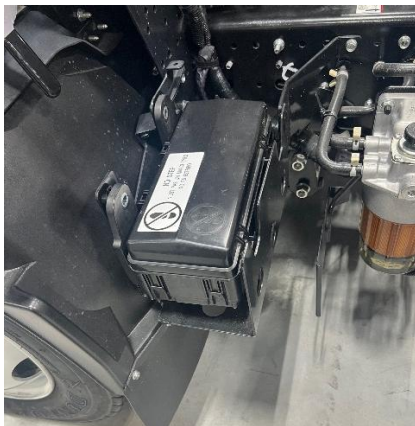
7165489

2. Remove the battery cover and disconnect both 12v negative battery terminals. Secure the loose cable to prevent reconnection.

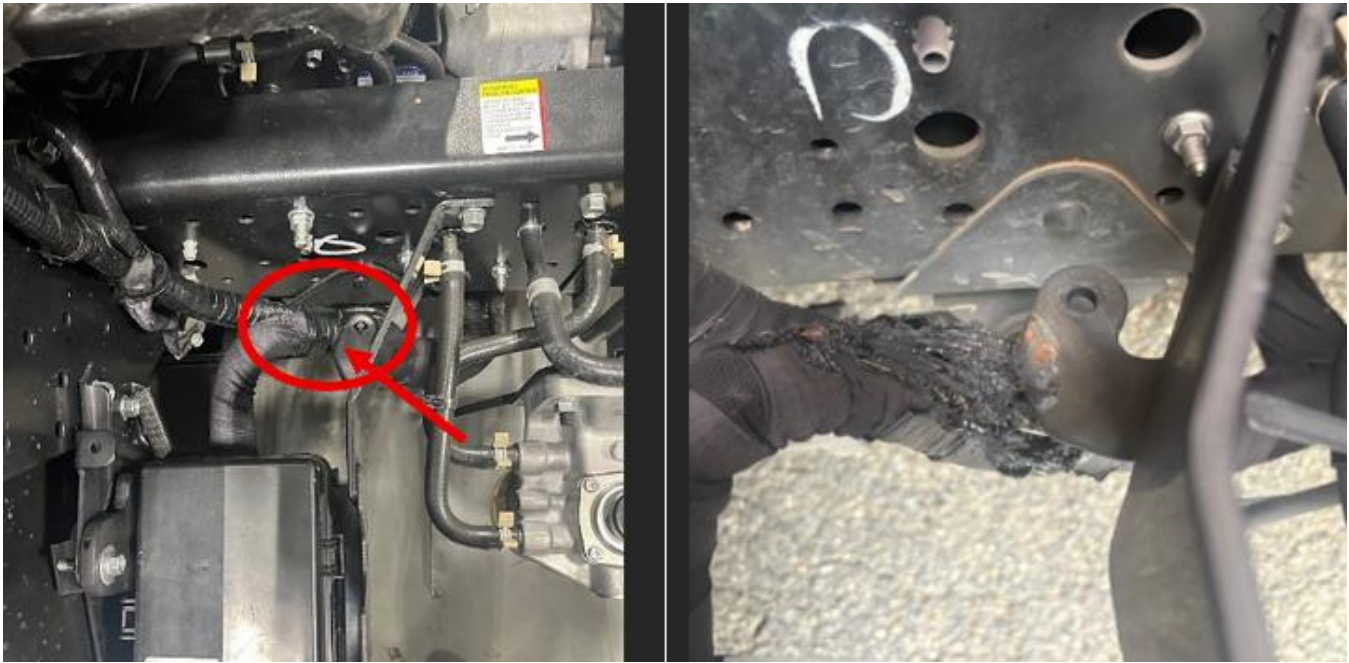
7165490

4. Inspect the harness for rubbing on the harness bracket. On single cab models, the wiring harness is under the harness bracket tab. On Crew Cab models, from the side view, look past and between the fuse box and fuel sedimenter to locate the harness under the harness bracket tab. Use a telescoping mirror and a flashlight to check for damage. On both models:
  - If any rubbing has only worn or damaged the outer covering of the harness, OR if the harness is undamaged, wrap the affected area (the area that may rub on the bracket) with Tesa tape and continue to the next step
  - If bare wire or burning exists (right hand graphic above), refer to document ID 5214974 for wire-to-wire repair instructions. Repair the damaged wires, being sure to stagger any butt connectors used so that the harness thickness is not increased too much.

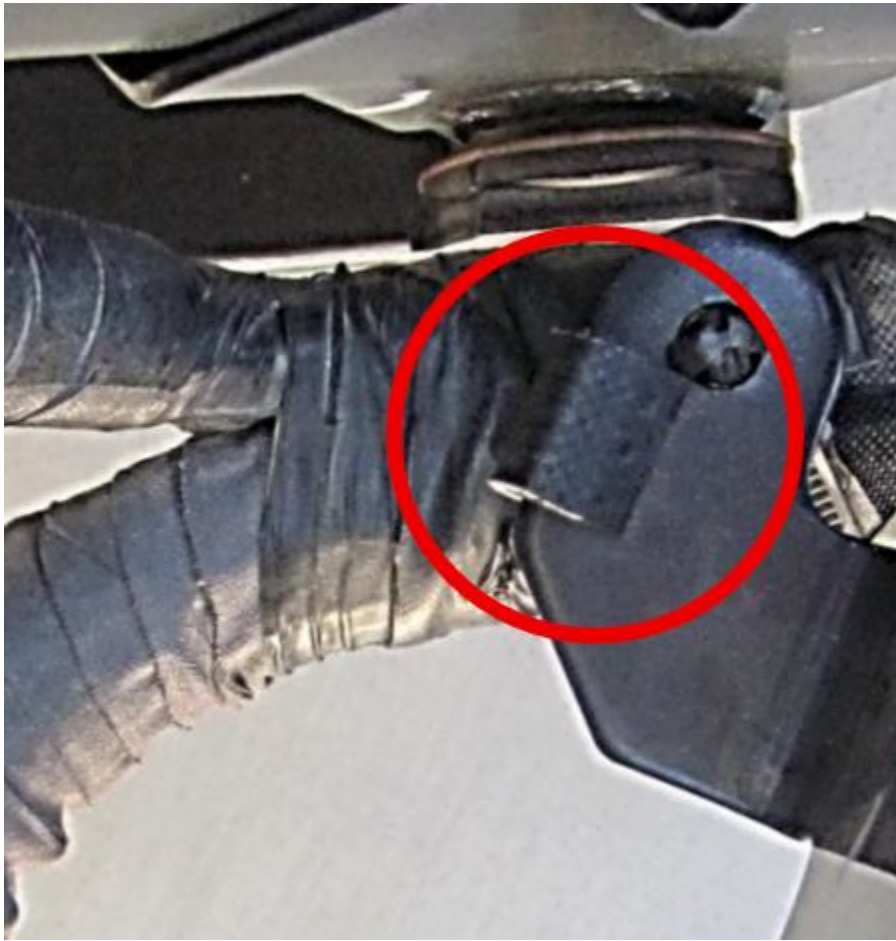
7165491

5. Push the Harness Protector onto the Harness Bracket as shown above until it is completely seated. Ensure you place it in exactly the spot indicated.

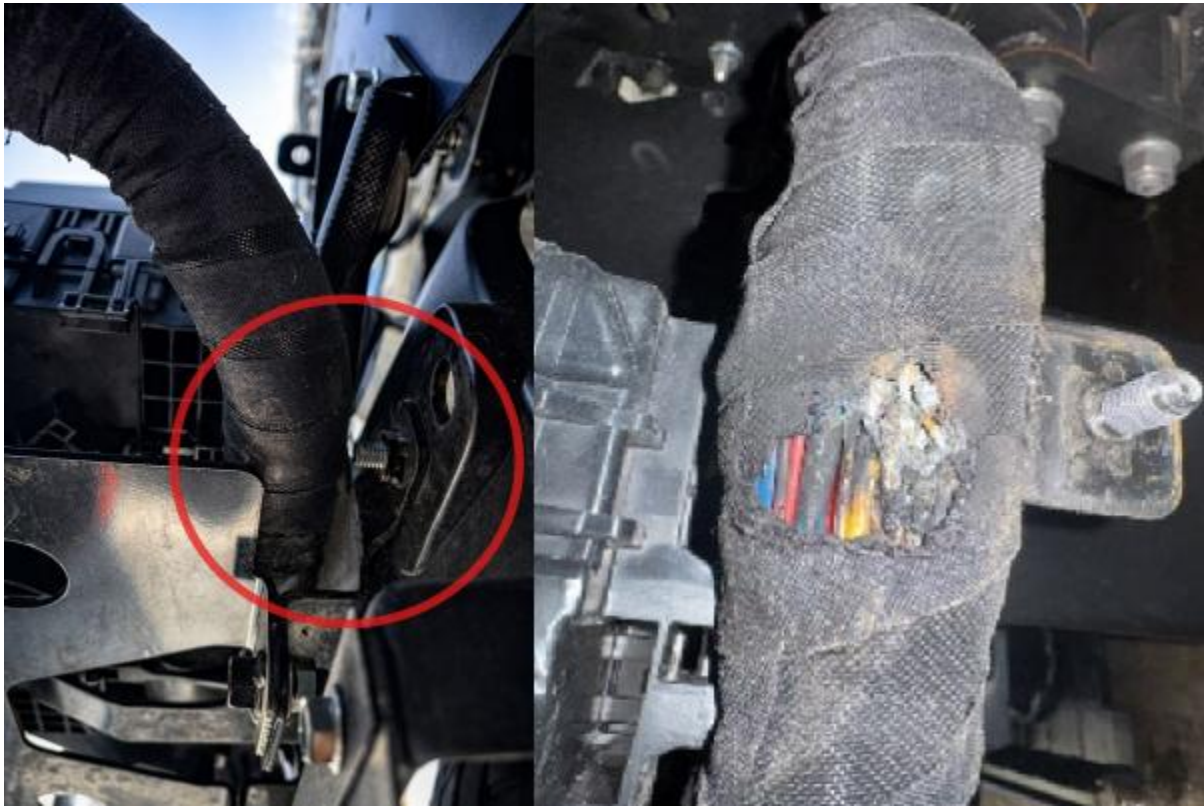
7165492

6. From underneath the fuse box, locate the wiring harness near the mud flap bolt and check for any damage.
  - If the harness is chafed but has not exposed any wiring, OR if the harness is undamaged, wrap the affected area (the area near the mud flap bolt) with TESA tape and continue to the next step.
  - If bare wire or burning exists (right hand graphic above), refer to document ID 5214974 for wire-to-wire repair instructions. Repair the damaged wires, being sure to stagger any butt connectors used so that the harness thickness is not increased too much.

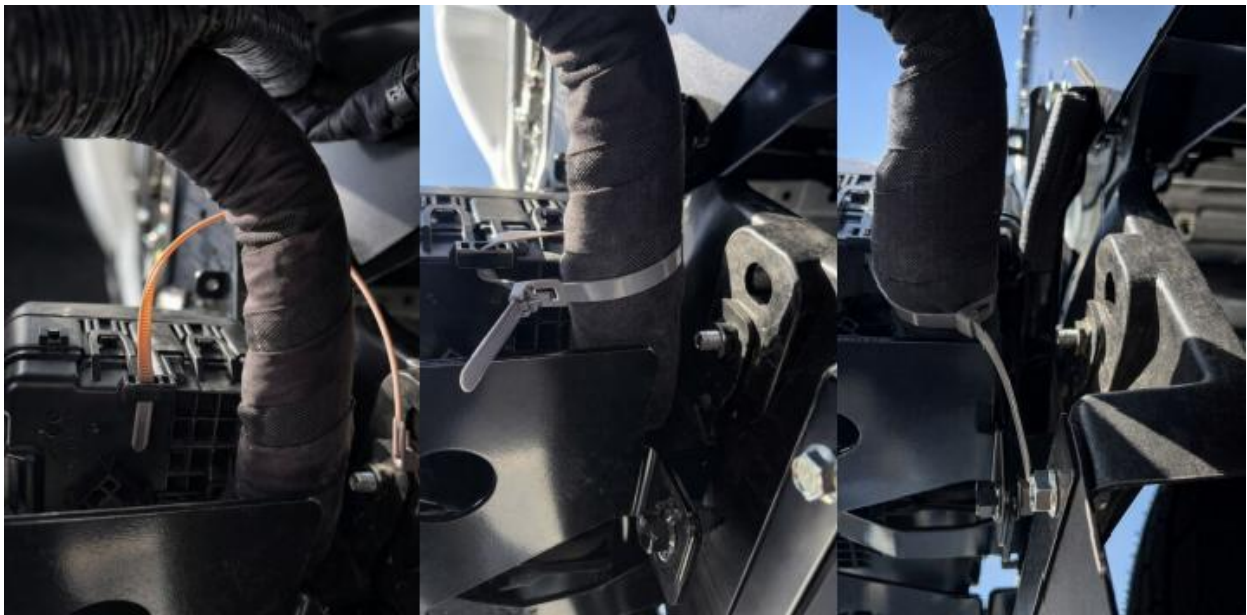
7165493

7. Insert the tie strap into the center tab of the bottom of the fuse box in the exact orientation shown. Wrap the tie strap around the outside of the harness, route it back, and insert the end into the tie strap clip, and cinch tight. Ensure the tie strap is pointing downwards when cinched tight as shown.
8. For non-crew cab models, remove the safety pin, lower the cab, and properly lock it in place per the instructions in SI.
9. Enter the cab and tilt the steering wheel all the way up.
10. Place a protective sheet or cloth over the dashboard completely covering the defroster vents to ensure loose parts do not fall into them or damage the dashboard.

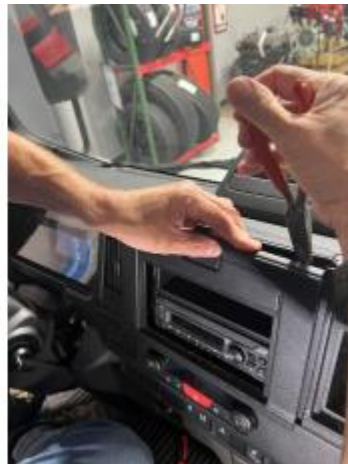
7165495

12. Squeeze the white plastic clips holding the bezel on the center cluster with needle nose pliers to completely remove the bezel.

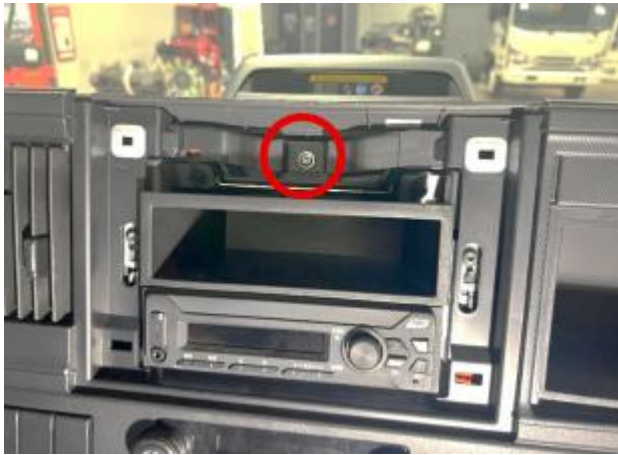
7165496

13. Remove the screw from the center cluster.

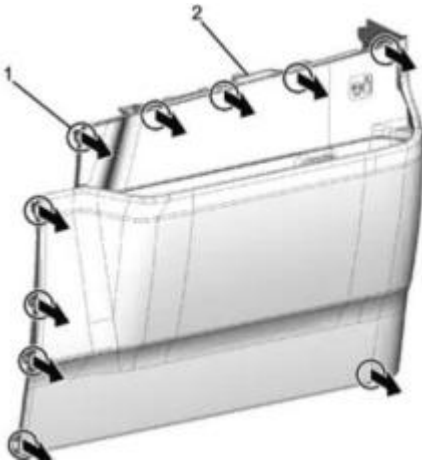
7165499

17. Remove the side under cover/pocket on the right side of the instrument panel.
18. Disconnect the connector from the passenger air bag cut off switch.

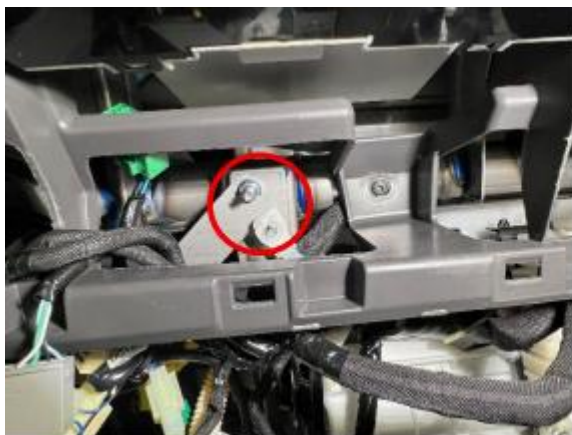
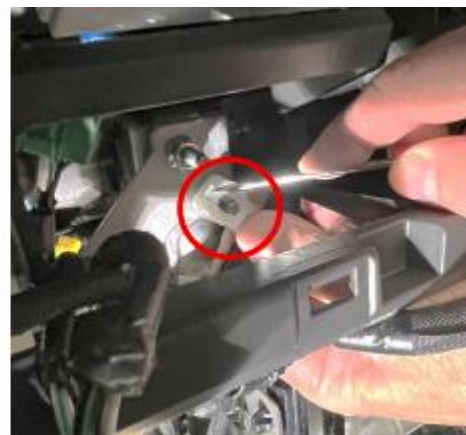
7165501

21. Locate the H98 and H99 connector bracket bolts. Unclip the white harness clamp from the bottom nut/stud by pushing up on the tab with a small screwdriver and pulling the clamp outward.
22. Remove the two nuts holding on to the H98 and H99 connector bracket.

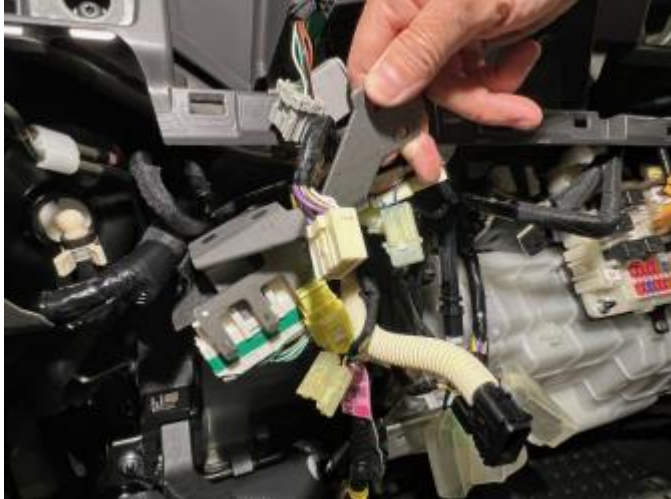
7165502

23. Move the H98 and H99 connector bracket to the left and downward for easier access to the connectors.

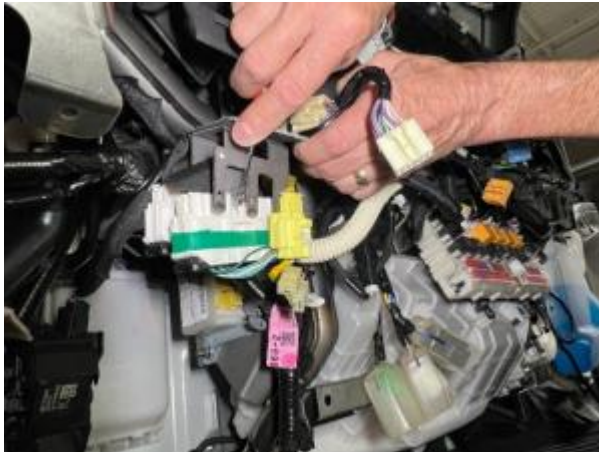
7165503

24. Remove the H98 connector by carefully lifting the white tab on the connector and sliding it off on the bracket.

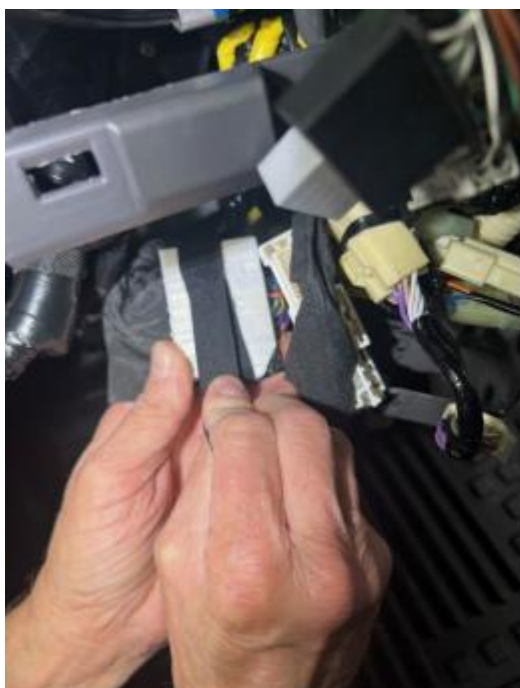
7165506

28. Use a strip of TESA tape to tape the black wiring harness going to H99 to the right side of H99.

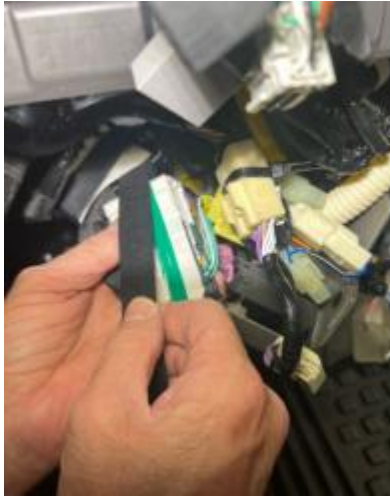
7165507

29. Use a strip of TESA tape to tape the black wiring harness going to H98 to the right side of H98.
30. Move the bracket back into it's mounting area and onto the mounting studs.
31. Install both nuts on the mounting studs and tighten to 5 lb ft (6.6 Nm). Install the white harness clamp removed in step 21 back onto the lower bracket stud over the nut.
32. Put the lower instrument panel under cover in place for installation, and connect the 12v accessory port and the HVAC temperature sensor housing.

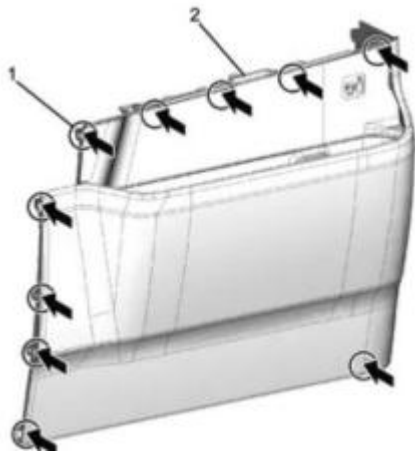
7165499

34. Connect the passenger airbag cut off switch connector and install the side under cover.

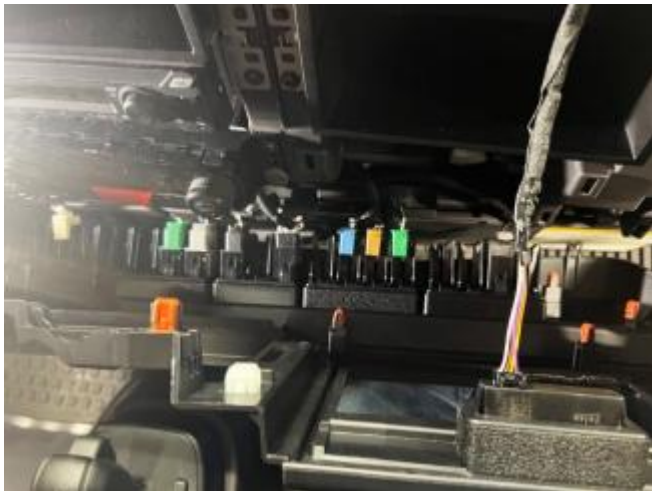
7165508

35. Hold the center cluster in place and connect all the connectors that were disconnected.

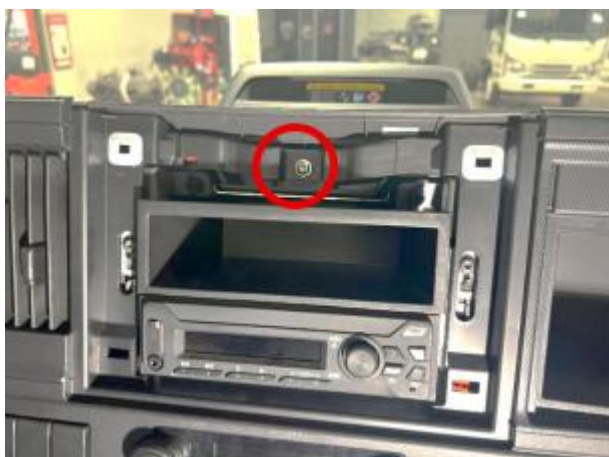
7165496

37. Install the screw into the center cluster.

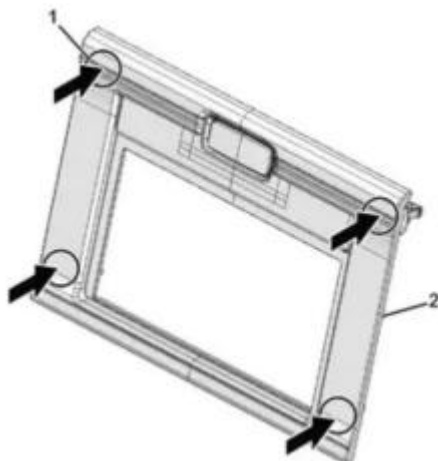
7165494

38. Install the bezel to the center cluster.
