Technical Service Bulletin

GROUP	NUMBER
RECALL	26-01-042G
DATE	MODEL(S)
MAY 2026	G90 (RS4)

SUBJECT: FRONT SEAT BELT ANCHOR RETAINER CLIP INSTALLATION
(RECALL 032G)

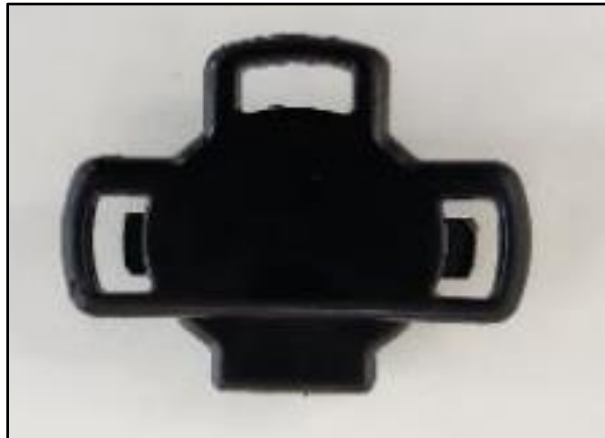
Description: For certain G90 (RS4) vehicles, the front seat belt may not be properly secured to the seat frame due to a damaged snap-on anchor(s), which could increase the risk of injury to occupants in the event of a crash. This bulletin provides instructions to install reinforcement clips on the snap-on lower seat belt anchor(s) and if necessary, replace the seat belt.

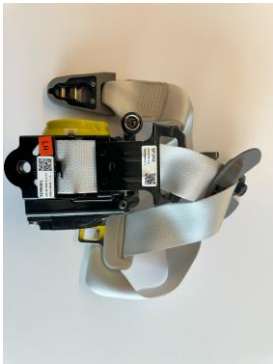
Model	Part Name	Part Number	Figure	Remarks
G90 (RS4)	Stopper (Clip) – S/Belt	88815-XX000QQH

QTY: 2 per vehicle (clips sold in packs of 10)
	S/Belt Assy – FR LH	888A0-XXXXX

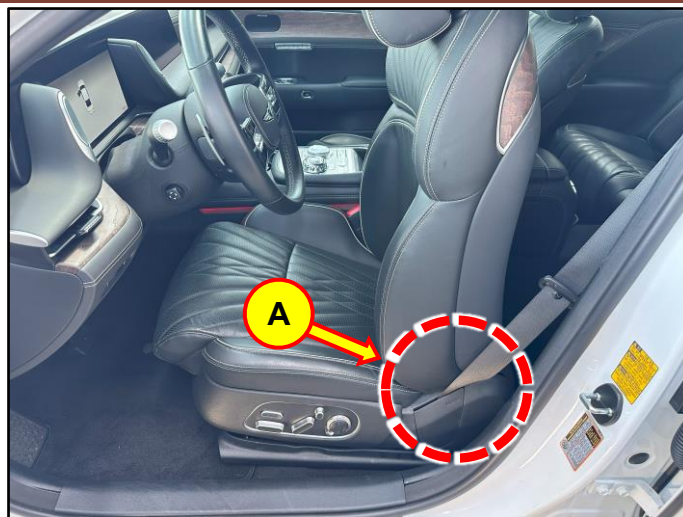
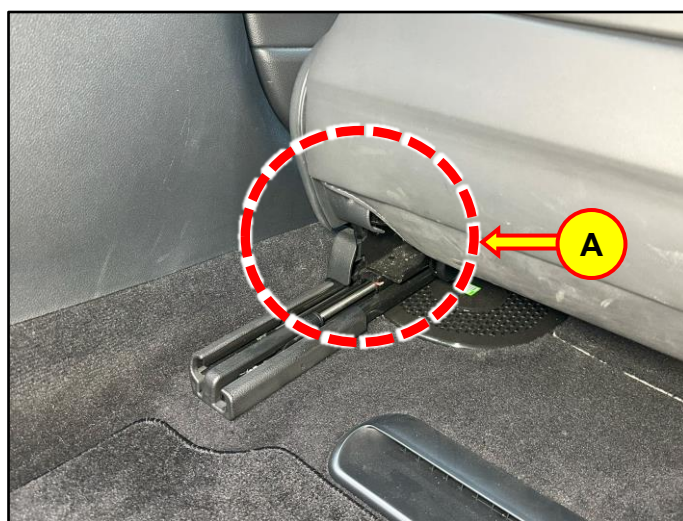
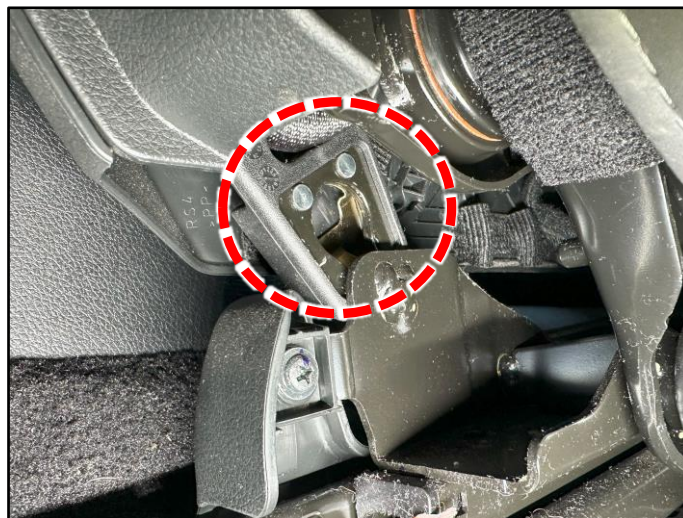
1. Move the front seat to the most forward and upward position to locate the snap-on lower seat belt anchor (A).

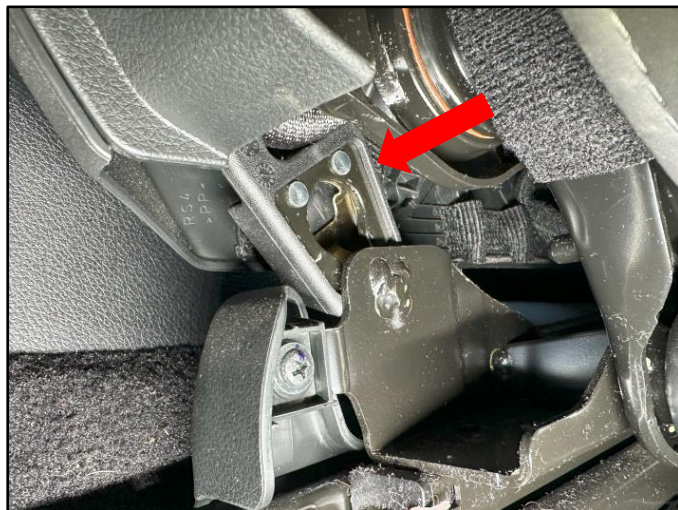
2. Push the snap-on lower seat belt anchor towards the back of the vehicle as shown to ease the installation of the retainer clip.

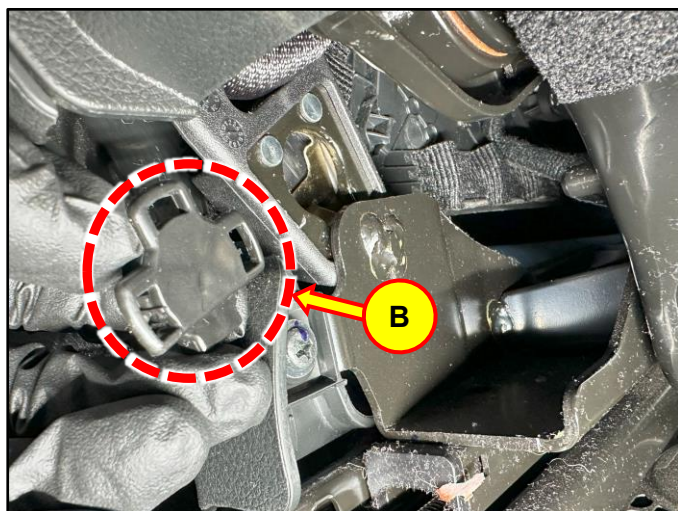
3. Install the retainer clip (B) by inserting it into the circular anchor opening and firmly pushing until fully seated.

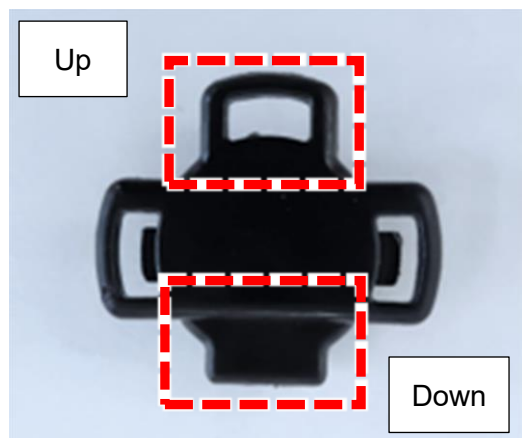
The retainer clip has a vertical direction, so ensure that it is mounted accordingly.

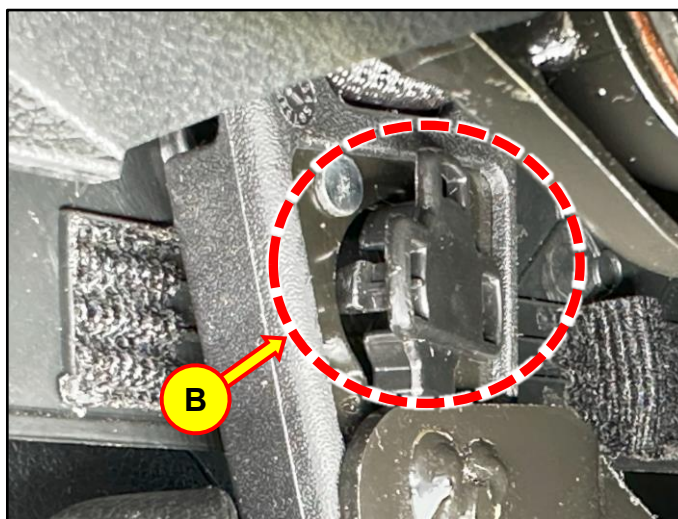
Ensure that the retainer clip does not roll outward from the bracket hole during mounting.

Even if the metal tab from inside the seat belt anchor is broken or bent, proceed with clip installation.

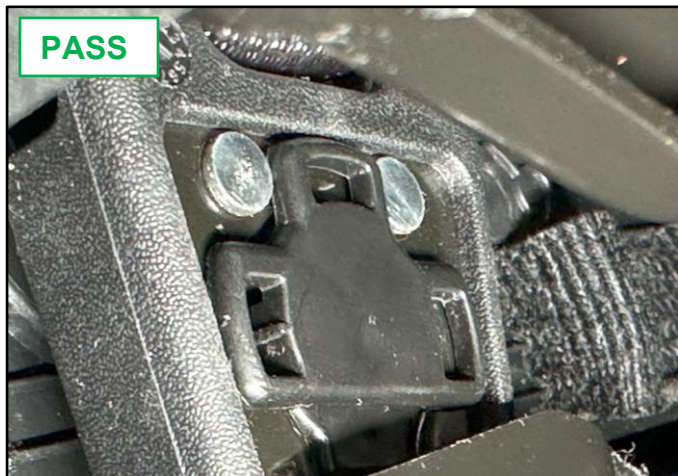
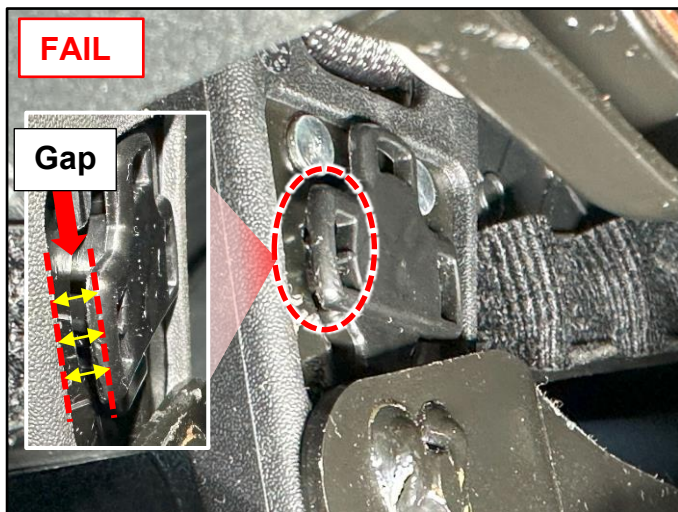
4. Push the retainer clip into the snap ring anchor until it is completely seated against the anchor surface.

If a gap is present, reinsert the retainer clip and push again until it is fully seated.

- **PASS:** If the retainer clip is fully seated, proceed to **step 5**.
- **FAIL:** If the retainer clip **CANNOT** be seated flush after reinserting, proceed to the [Front Seat Belt Replacement](#) section.

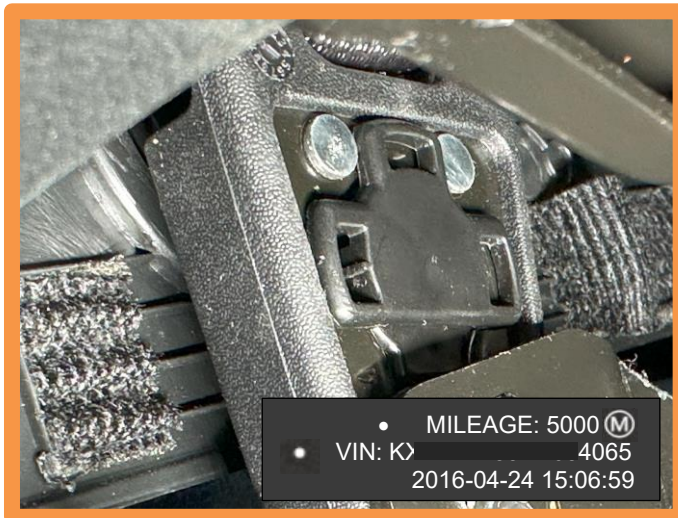
Using the STUI camera function, take a photo of the installed retainer clip.

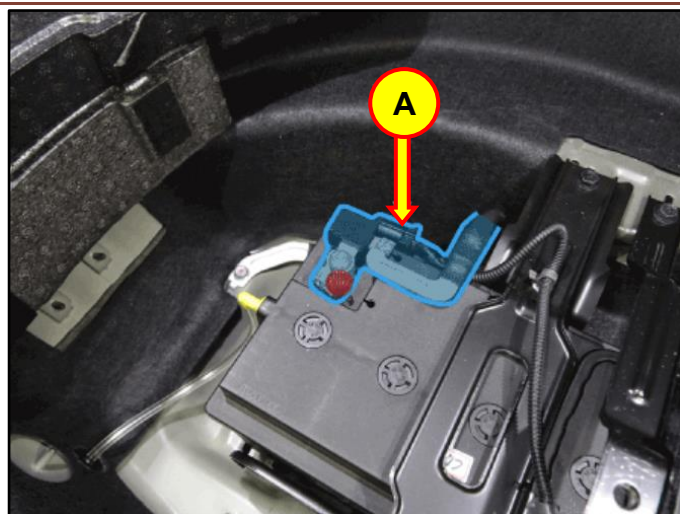
1. Disconnect the **12V** negative (-) battery terminal (A):

lb-ft	7.2
lb-in	86
N.m	8.8

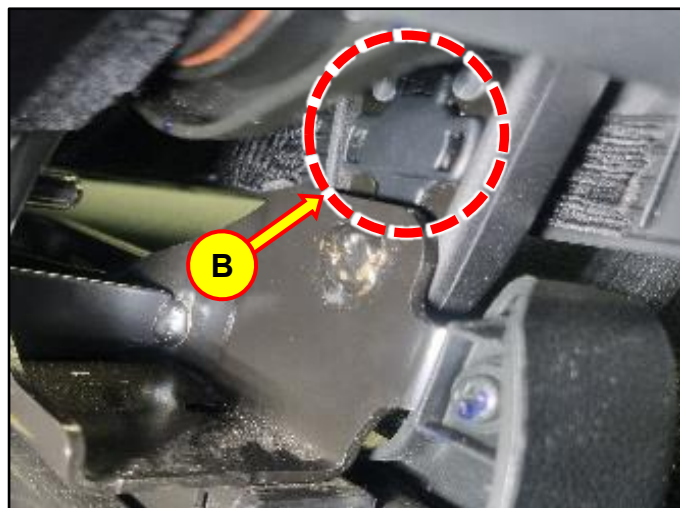
4. Install the retainer clip (B).

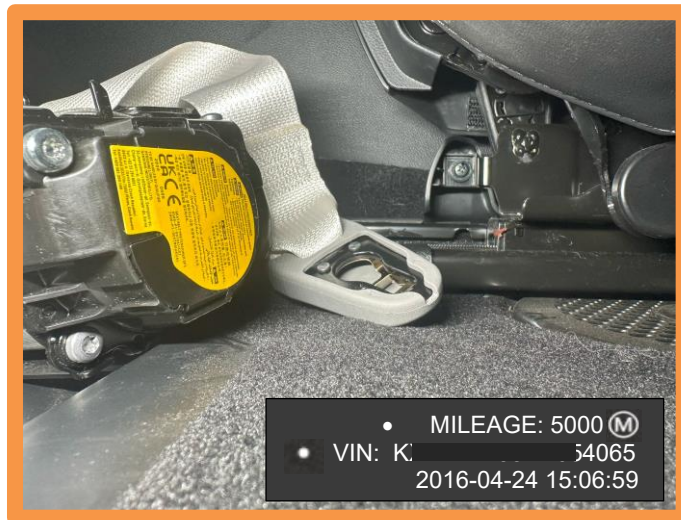
Using the STUI camera function, take a photo of the faulty seat belt next to the new seat belt with the retainer clip installed.
