## Technical Service Bulletin

26-01-056G

FUEL LEAK & FLARE NUT TORQUE INSPECTION -  
CROSSOVER PIPE REPLACEMENT (RECALL 033G)

**Description:** Certain vehicles equipped with the 3.5L T-GDI Lambda III engine crossover fuel pipe connecting the left and right fuel rails of the engine may have been installed with retention fasteners that can gradually loosen over time. A fuel pipe with loose connections could allow fuel to leak, increasing the risk of an engine compartment fire. This bulletin provides instructions to inspect and retighten the crossover fuel pipe, as necessary. If a fuel leak is found, the crossover pipe will need to be replaced and tightened to specification.

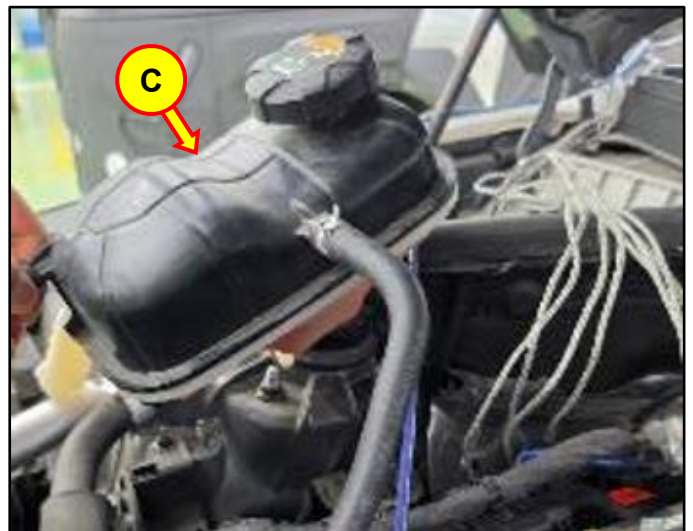
4. Remove the reservoir tank (C) by referring to the shop manual:
  - **Engine Mechanical System > Cooling System > Reservoir Tank > Repair procedures**

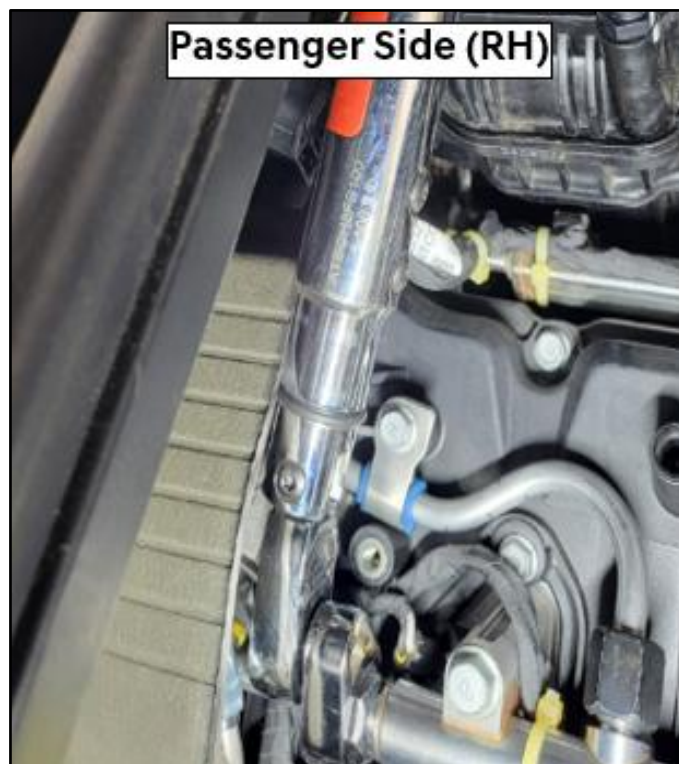
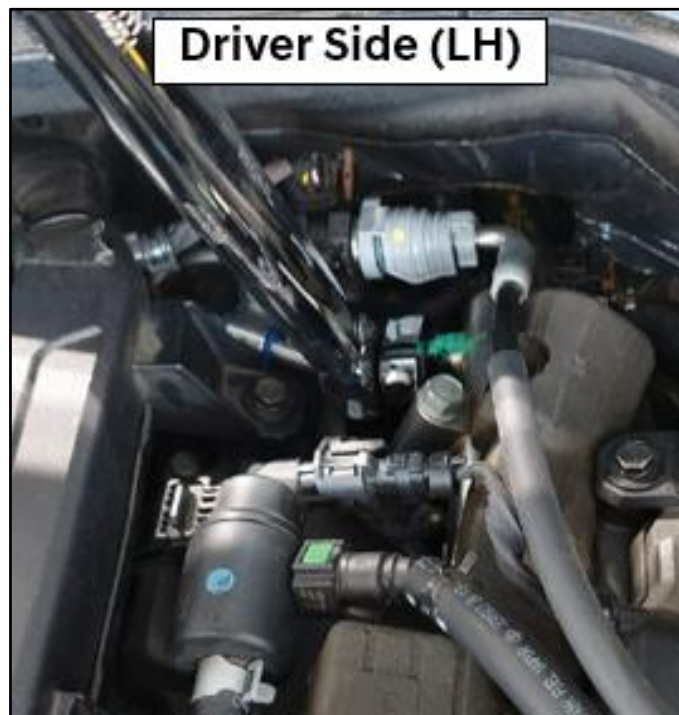
7. Tighten the RH and LH crossover pipe nuts, then mark them with a paint pen.

**Tightening Torque:**

| lb-ft | 27 |
| N.m | 37 |

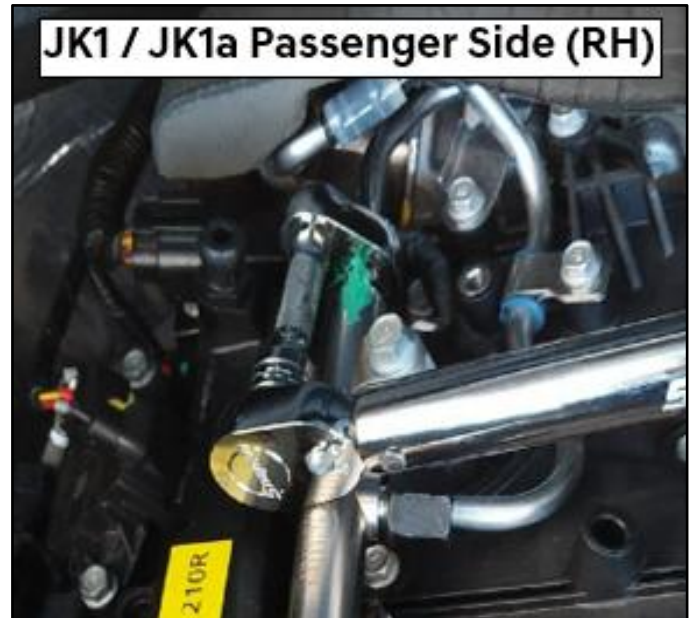
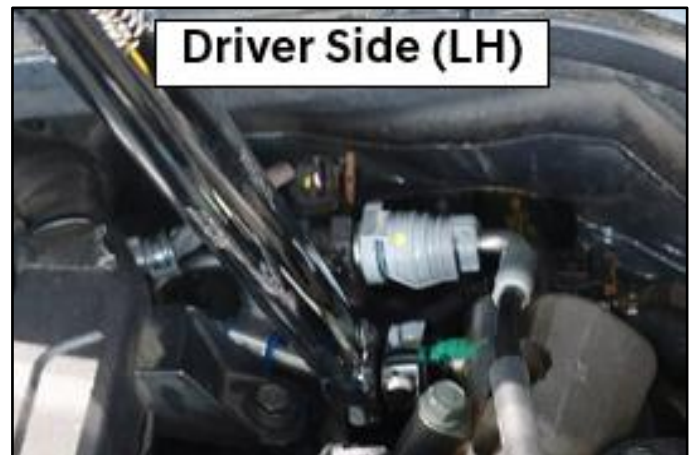
8. Tighten the RH and LH crossover pipe nuts, then mark them with a paint pen.

**Tightening Torque:**

| lb-ft | 27 |
| N.m | 37 |

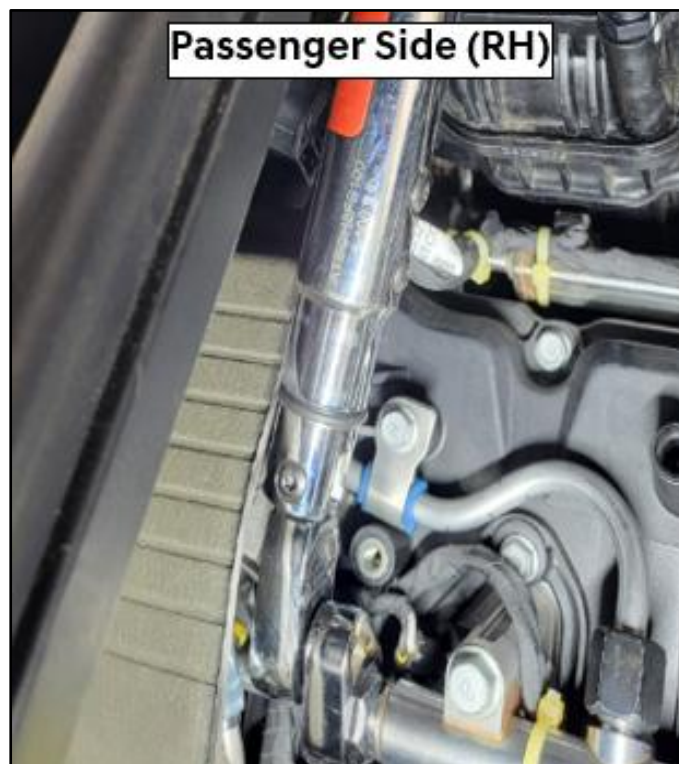
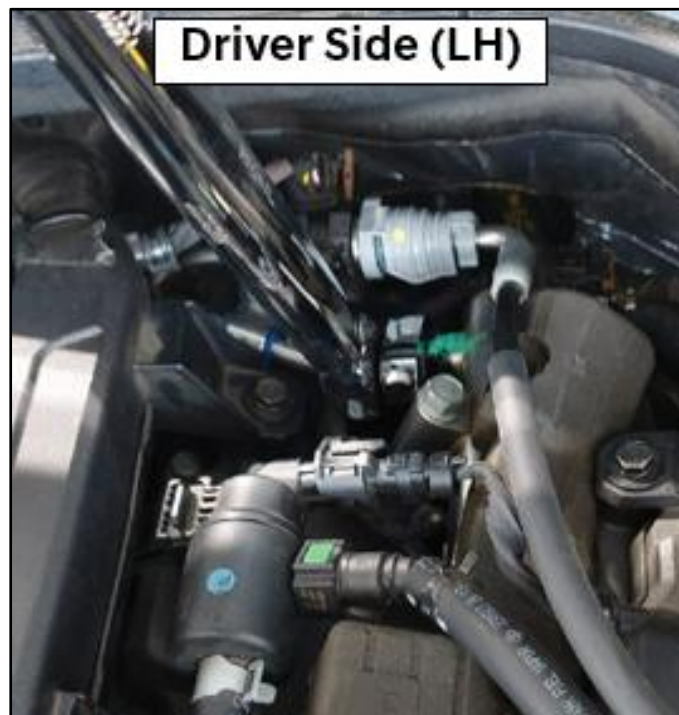
12. Tighten the RH and LH crossover pipe nuts, then mark them with a paint pen.

**Tightening Torque:**

| lb-ft | 27 |
| N.m | 37 |

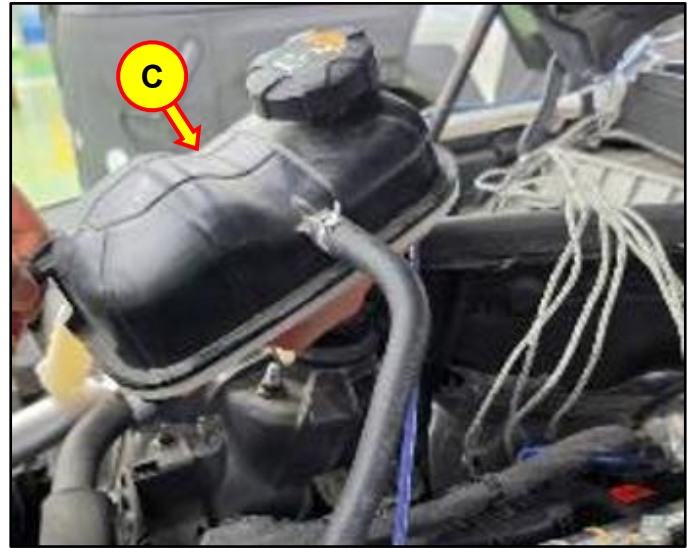
4. Remove the reservoir tank (C) mounting fasteners and reposition the tank aside, as shown in the illustration. Refer to the shop manual:

- **Engine Mechanical System > Cooling System > Reservoir Tank > Repair procedures**

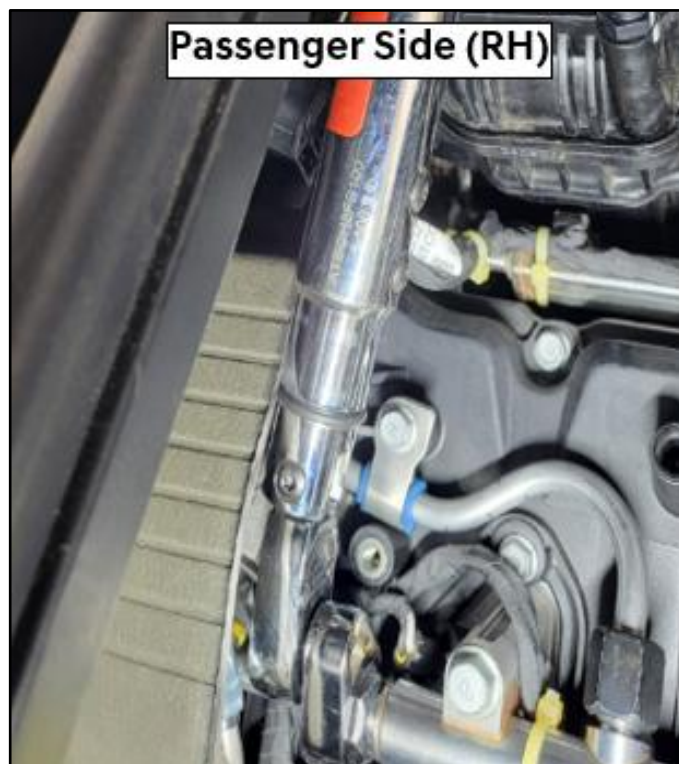
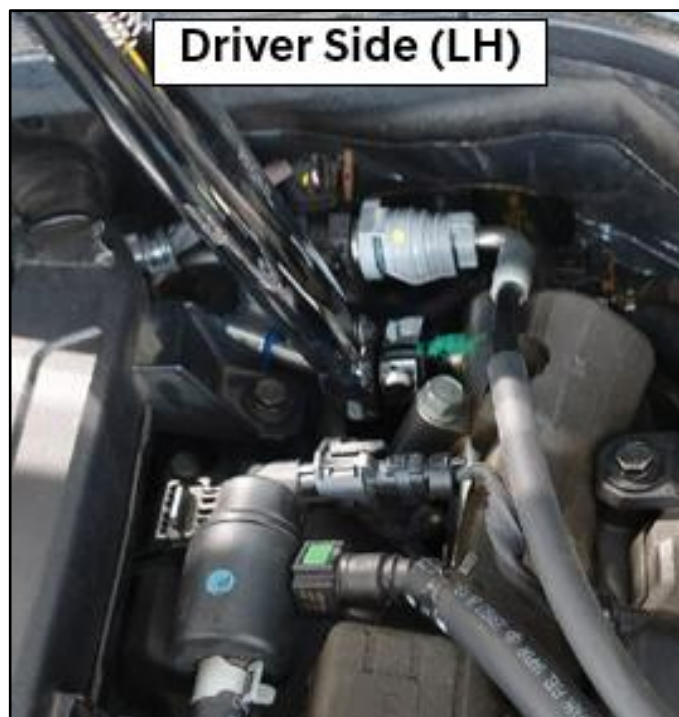
7. Tighten the RH and LH crossover pipe nuts, then mark them with a paint pen.

**Tightening Torque:**

| lb-ft | 27 |
| N.m | 37 |

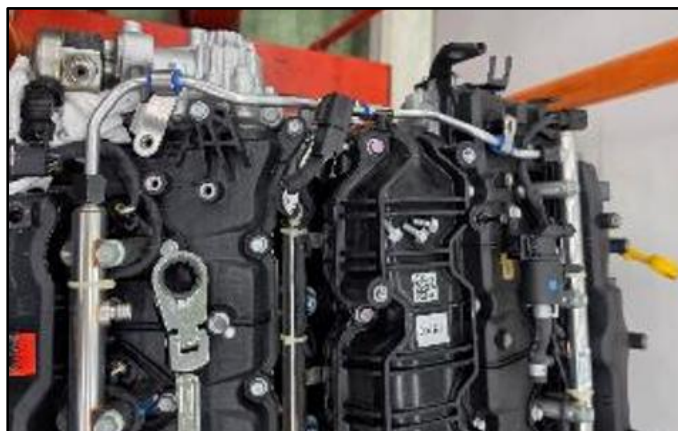
7. Install the new crossover fuel pipe.

**Tightening Torque:**

| lb-ft | 6.5 |
| lb-in | 78 |
| N.m | 8.9 |

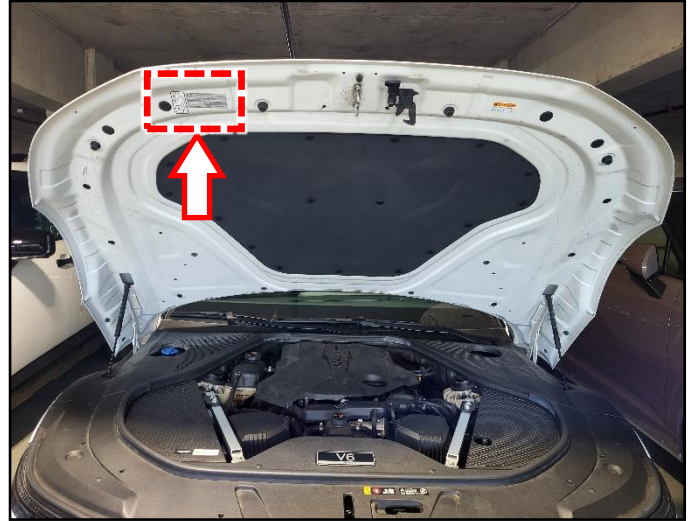
1. Fill in the Campaign ID, Dealer Code, and Date on the emissions label, and apply adjacent to the existing label, on the underside of the hood, as shown.

Be sure to clean the mounting surface to ensure proper label adhesion.

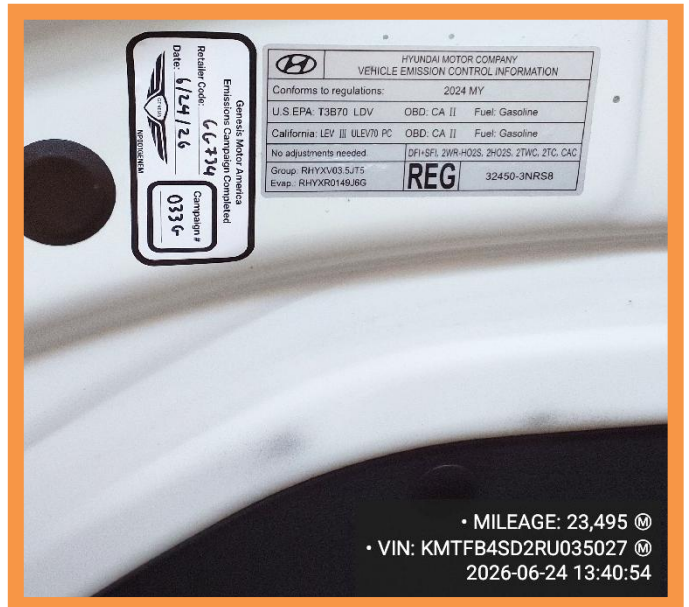
Upload the photo to STUI.

**NOTE:** If the STUI camera function is **NOT** used, write the last 6 digits of the VIN and date of repair on a piece of paper to include in the photo.
