Safety Recall Campaign

2022-2026MY  
Carnival (KA4)

SC368 (Rev 1, 09/28/2026)

HIGH-PRESSURE CROSS-OVER FUEL PIPE TORQUE  
INSPECTION / REPLACEMENT (SC368)

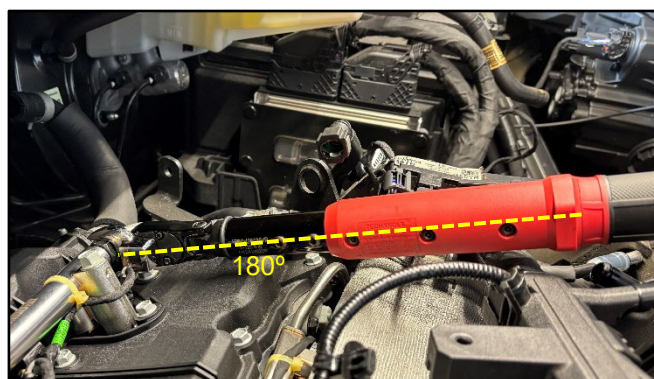
8. After tightening **both** Bank 1 and Bank 2 fuel pipe flares (F & G), reinstall all removed parts in the reverse order of removal.

**Note:** Replace the intake manifold gasket (H) 'non-reusable', to surge tank assembly with a new part.

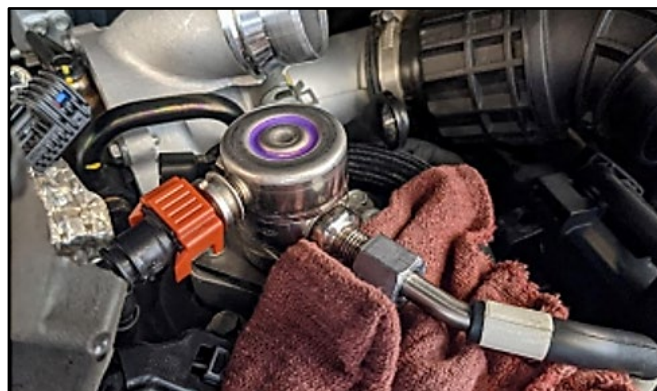
- 1b. • Using the crowfoot wrench, loosen the two (2) Bank 1 and Bank 2 flare nuts (B).
- 1c. • Loosen the three (3) cross-over fuel pipe assembly retaining bolts (C).

Thoroughly clean the any contaminated area from fuel residue.

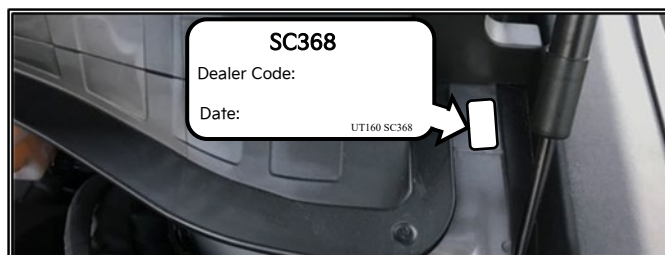
**CA and S.177 States Only:** Apply SC368 Campaign Completion Label onto the body in the area next to the shock tower, as shown. **NOTE: Be sure to clean the mounting surface to ensure proper label adhesion.**
