Mitsubishi Motors North America, Inc.

## ***SAFETY RECALL BULLETIN***

### **Liftgate Gas Springs - Safety Recall**

No: SR-26-001

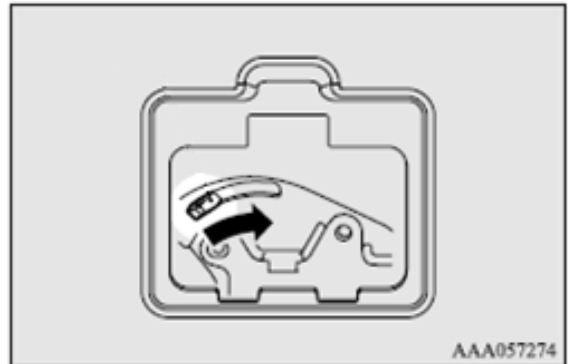
- a. **Manual Liftgate** - Enter the cabin from the rear seat and operate the inside release lever to unlock the liftgate. Then, gently push it open.

- Due to potential rupture of a gas cylinder, the liftgate should be opened from the inside as described above. Additionally, technicians in the area should keep safe distance away from the rear of the vehicle while opening the liftgate.

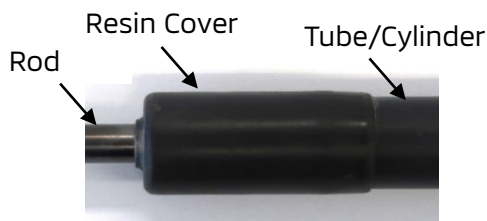
Visually inspect the resin covers on both the left and right Gas Springs for detachment, cracks, or bulging.

New part

Detachment

Crack

Bulging

- If detachment, cracks, or bulging are found, take clear photos showing the abnormal condition for submission into the "PRC" (Photos Required Condition) so that MMC can check the condition later, then proceed to Step "3: Protect the Gas Spring".
- If no abnormalities are found, proceed to Step "4: Remove the Gas Spring".
- If unsure, proceed to Step "3. Protect the Gas Spring".

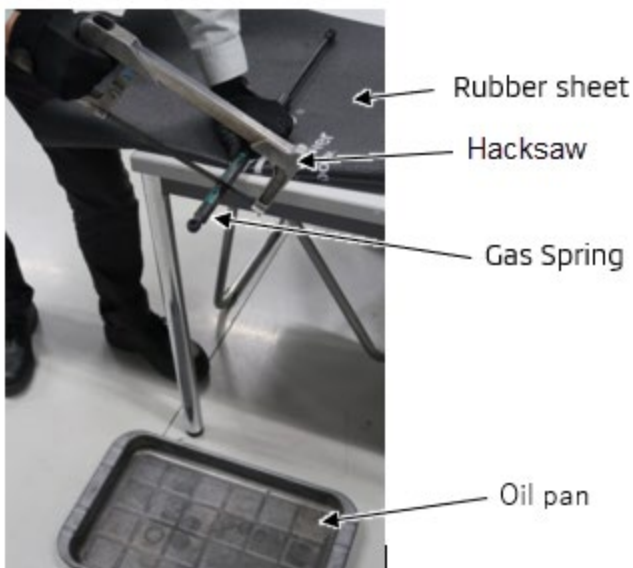
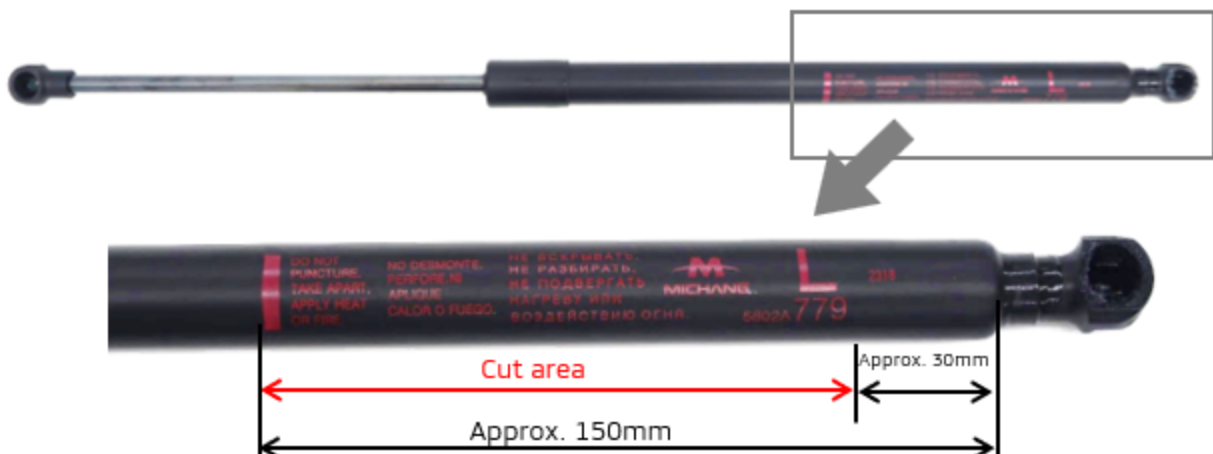
- a. During the procedure, prepare an oil tray as oil may leak from inside the gas spring. Placing a rubber mat or other soft material under the gas spring will help stabilize it and make the work easier.
- b. When releasing the gas, hold the gas spring by hand and, following the diagram below, use a hacksaw to make a cut in the labeled area. Once the gas begins to escape, cover the cut area with a cloth to prevent the gas and oil from scattering.  
Note: The wall thickness at the cut location is approximately 1 mm.
- c. After confirming that the gas has been completely released, dispose of the gas spring.

- Applying force to the cylinder increases the risk of rupture, especially when the gas spring is corroded. Therefore, do not apply any bending force or impact.
- When releasing the gas inside the gas spring, do not use a vise or other clamping tools, as they may apply load to the gas spring body and increase the risk of rupture if corrosion is severe. Also, do not use power tools such as grinders.
