# Recall Bulletin 260422REV

| <b>NHTSA 26V264<br/>TC # NA</b> | <p>The purpose of this Recall Service Bulletin is to inform REV Recreation Group (RRG) dealers of the need to inspect and perform needed repairs to 2026 Fleetwood Bounder, Flair, Fortis and Holiday Rambler Admiral and Vacationer motorhomes. A list of 12 affected motorhome serial numbers appears at the end of this Recall bulletin.</p> |
| <b>SUBJECT:<br/>GENERATOR</b> | |

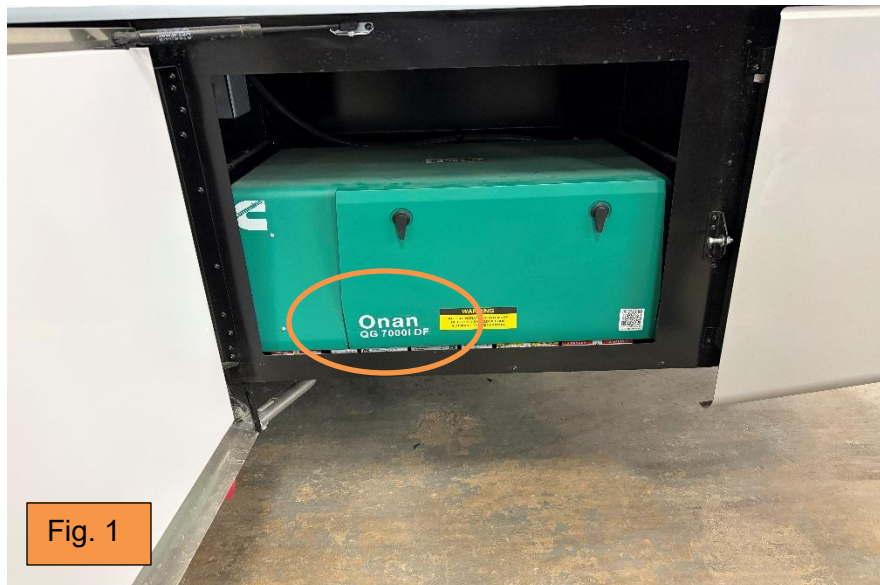
1. Locate the generator compartment and verify the labeling on the generator is a 7000I model. Other generator models are not part of this campaign.

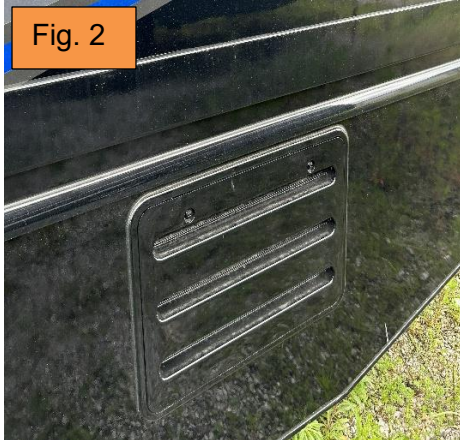
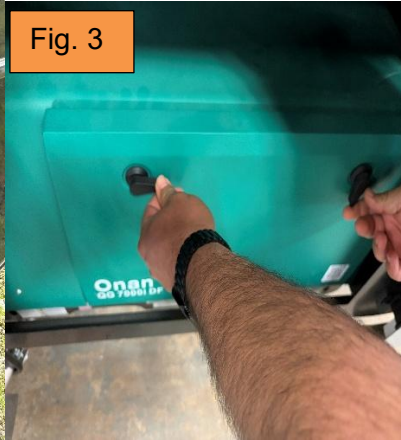
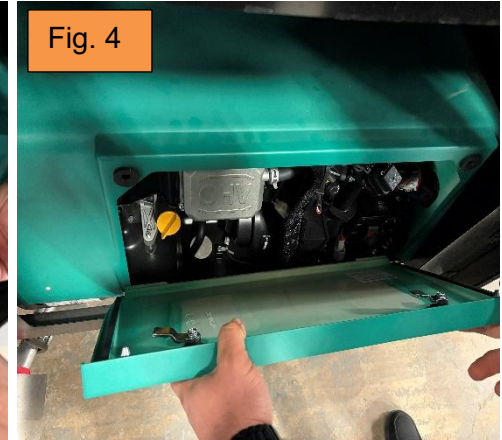
8. Open the generator compartment door or remove the access panel exposing the genset. Note: Some models have a sidewall access panel versus a compartment door.

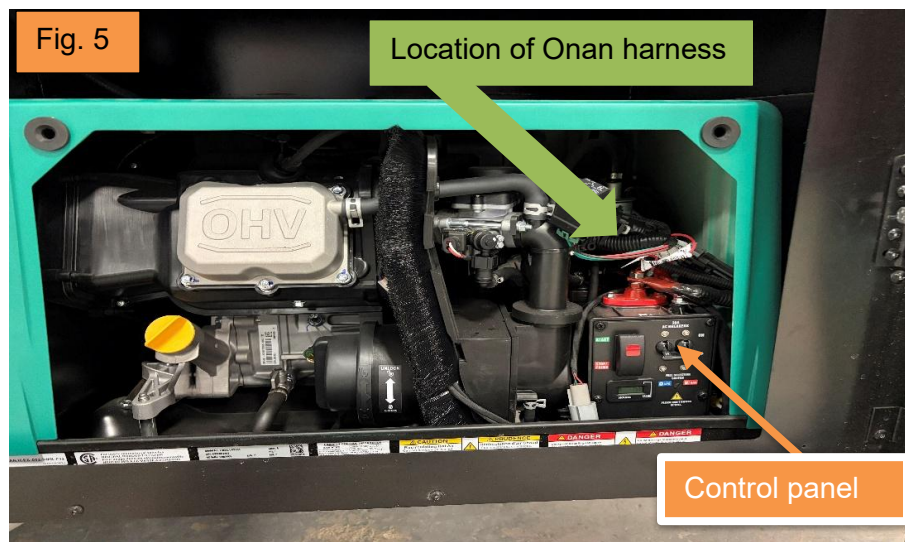
9. Remove the generator access panel, pull out and upward to remove the compression clips on the access panel.
10. Once the panel is removed, set it aside for reinstallation later.
11. Locate the original Onan harness just above the start/stop switch.

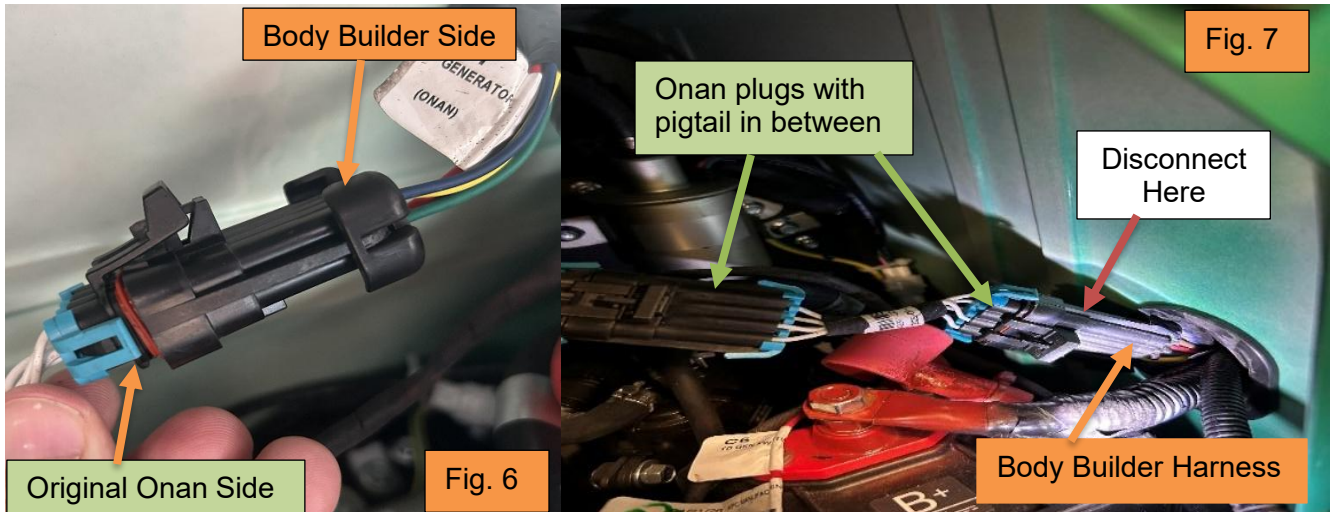
12. Attached to the original Onan harness is an 8-pin connector and harness from the body builder. Carefully disconnect the body builder section from the Onan section in preparation of adding a new inline harness. Note: Some of the original harnesses looked like Fig. 6 straight Onan to body builder harness and others have a short Onan pigtail harness as shown in Fig. 7. Do not remove the pigtail harness. Only disconnect the body builder plug from the Onan harness.

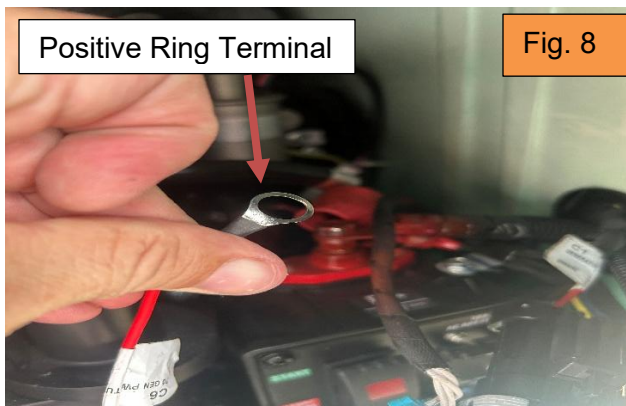
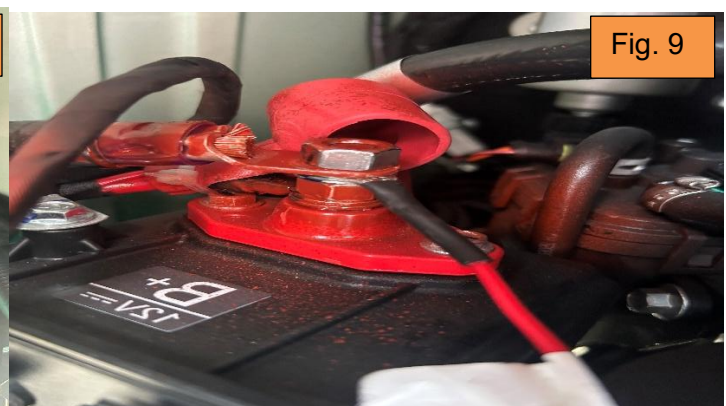
13. You should have ordered the recall kit including the new harness from REV Parts (Note: This harness is not supplied by Onan but is an Onan approved design).
14. On the new harness, locate the red wire tagged C6. See Fig. 8.
15. Above the start/stop switch of the genset, locate the positive terminal post (named B+) shown in Fig 5 and Fig. 8.
16. With a ½ inch wrench, remove the nut, and remove the existing cable from the post.
17. Install the red wire ring terminal C6 from the new harness to the B+ post, followed by the battery cable and then the nut. Tighten to 11-15ft-lbs.

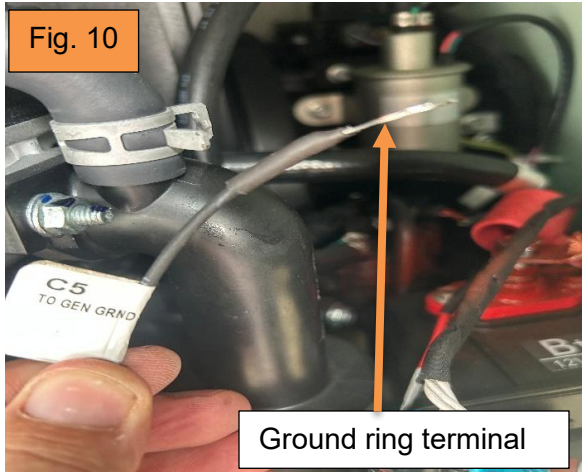
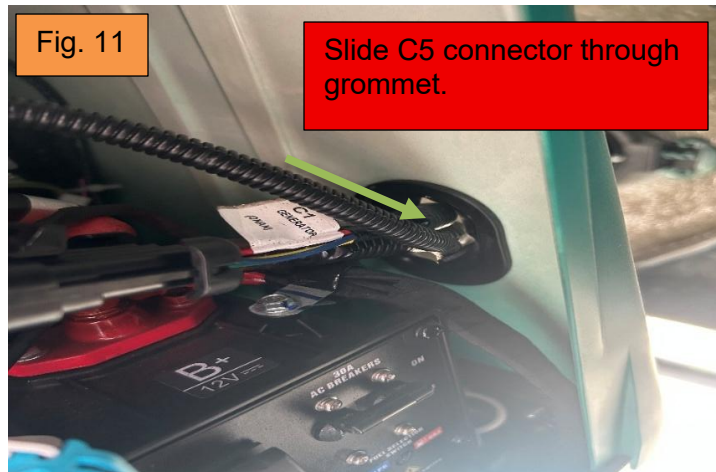
18. On the new harness locate the **black ground ring terminal tagged C5**.

19. With the black ground ring terminal in hand, locate the rubber grommet next to the positive terminal post. Push the black wire through the rubber grommet. This is the same grommet that the main body builder harness goes through.

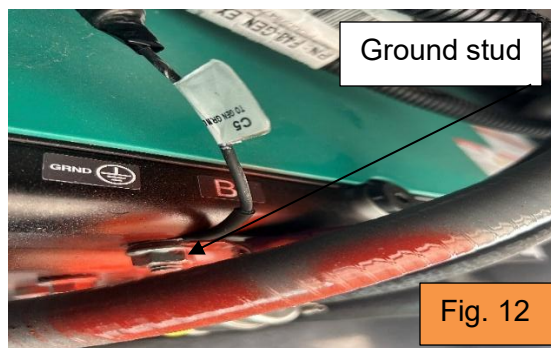
20. Next locate the ground stud under the generator (marked GND B).
21. With a ½ inch wrench, remove the nut, the existing ground cable from the stud.
22. Next install the black wire terminal from the new harness onto the ground stud. Reinstall the ground cable and nut. Tighten to 11-15ft-lbs

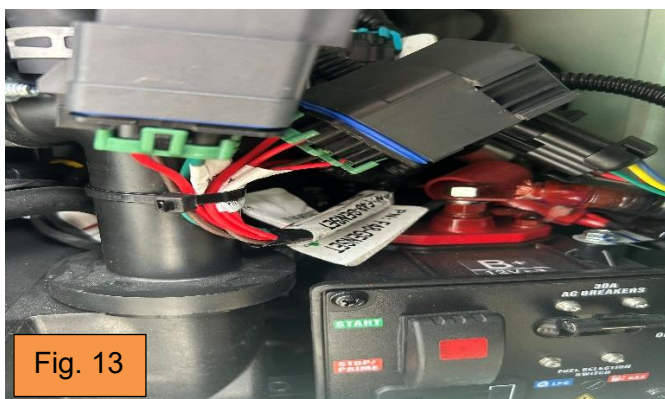
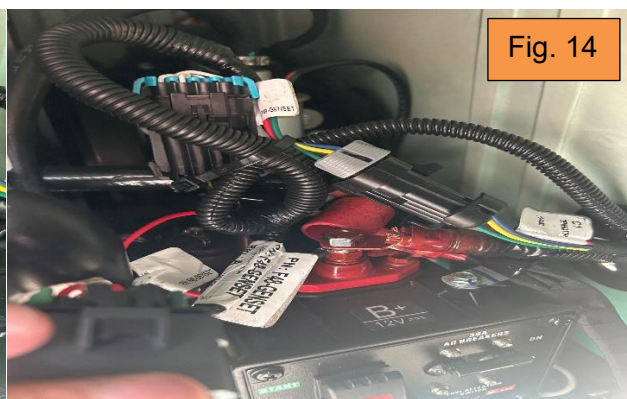
23. Next install the new main harness section to the mating (2) connectors of the original harness.
24. With the new harness section added, make sure to wire tie the harness in a secure manner. Note: Secure so the relay heads are upward and the terminals are downward. These relays are weather tight, so this is for added precaution.
