RECALL: NHTSA 26V271

SUBJECT: Pop-Top Latch not Engaging Properly and Straps Fraying

APPLIES TO: All Roadtrek/Westfalia Pop-Top Models

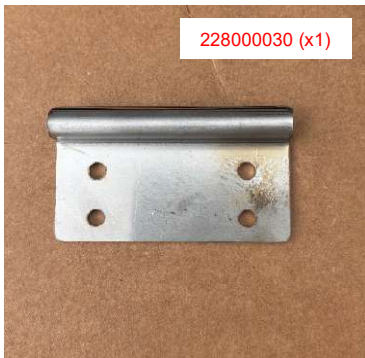
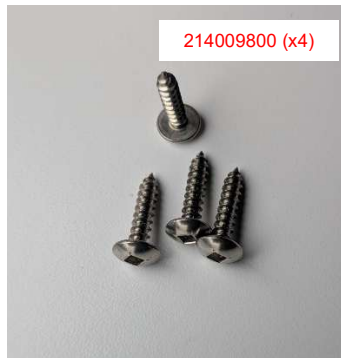
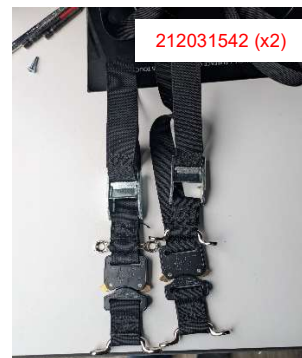
Qty.	Part Number	Description
1	228000030	Keeper Plate
2	212031542	Secondary Locking Straps
4	214009800	#8x3/4" Truss Head Screw

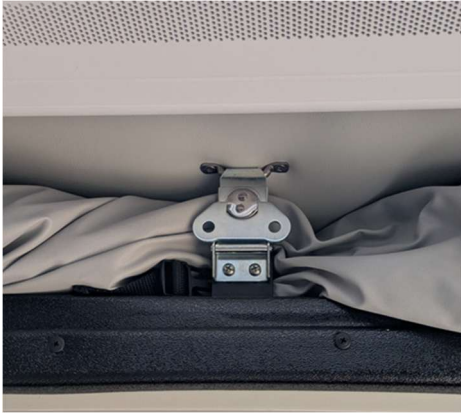
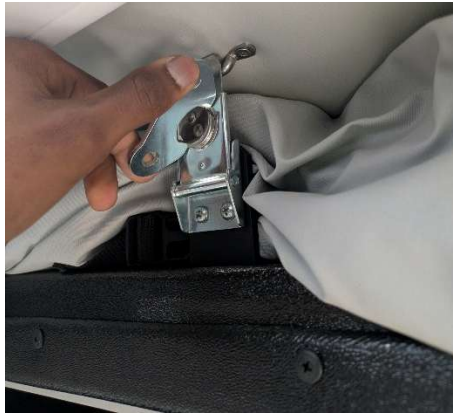
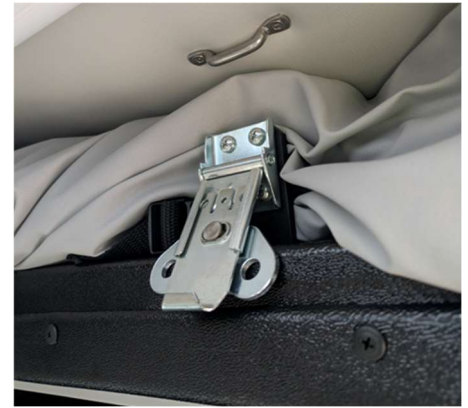
RECALL: NHTSA 26V271**STEP-BY-STEP INSTRUCTIONS:****STEP 1.**

Unhook the butterfly latch from the footman loop by flipping the latch upwards and rotating it counterclockwise.

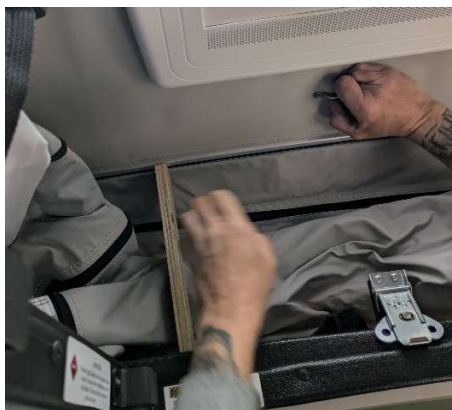
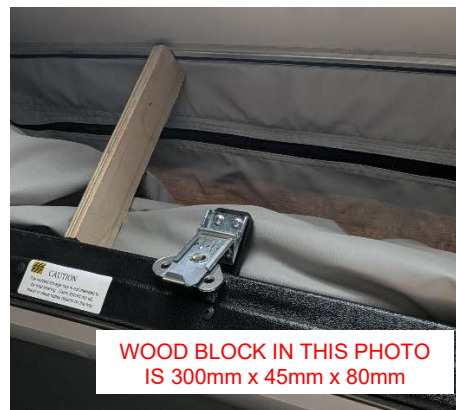
**STEP 2.**

Using your hand, push up on the roof to lift and hold the pop-top. For easier access and added stability, it is recommended to use a wooden plank or similar ridged object to prop up the pop-top.

NOTE: While having the pop-top propped, ensure that the strap handle supports on both sides are tightened to ensure that the Pop Top does not pop open when working. Failure to do so may result in the pop-top opening while working resulting in potential damage to the vehicle.

**WOOD BLOCK IN THIS PHOTO
IS 300mm x 45mm x 80mm**

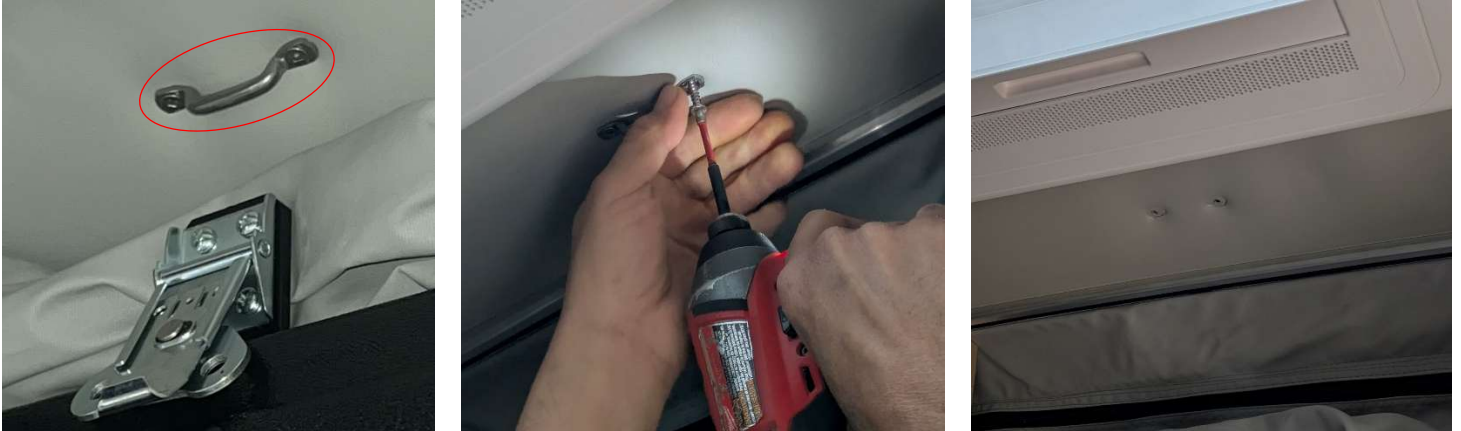
RECALL: NHTSA 26V271**STEP 3.**

Using a #2 Robertson drive bit, remove the two countersink screws from the butterfly latch footman loop.

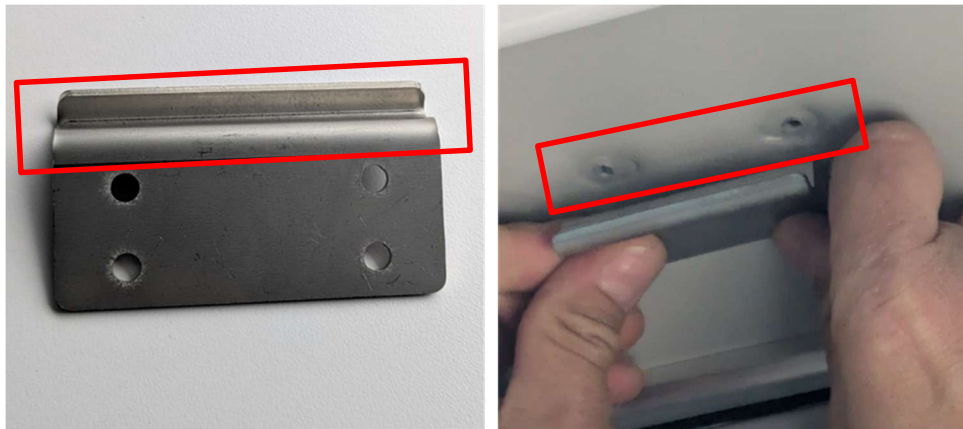
**STEP 4.**

Line up the top section of the new keeper plate (228000030) with two holes left behind from the old catch plate.

Note: The old holes should be covered by the top section of the new keeper plate, NOT by any of the 4 holes

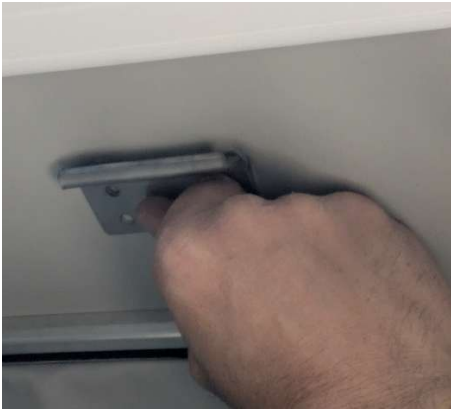
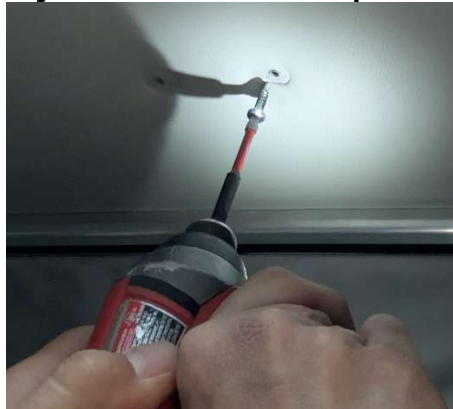
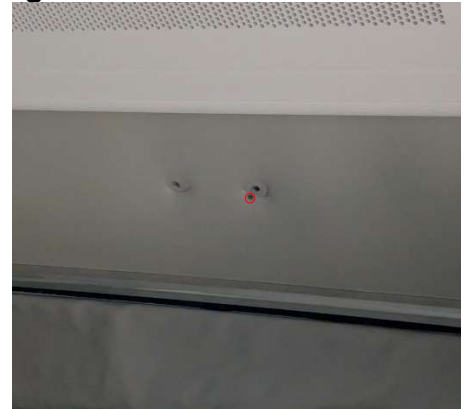
RECALL: NHTSA 26V271**STEP 5.**

Once the catch is lined up, ensure that it is straight. Using a marker, mark one of the 4 holes for reference. With a #8 x 3/4" self-tapping screw, create a pilot hole where you have marked. Once the pilot hole is created remove the screw.

Note: Be care when drilling through the roof, drill until screw is flush with the roof, not until you are unable to drill further which may result in the screw puncturing the exterior of the roof.

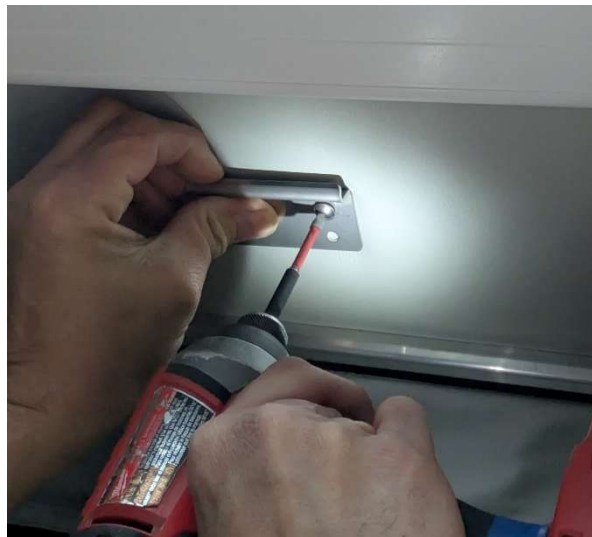
**STEP 6.**

Using the pilot hole you just created, fasten the new keeper plate to the roof using one of the #8 X 3/4" SS square-drive truss-head screw (214009800).

NOTE: Be careful when drilling through the roof, drill until the bracket is securely fasten, not until you are unable to drill further otherwise the screw may puncture the exterior of the roof.

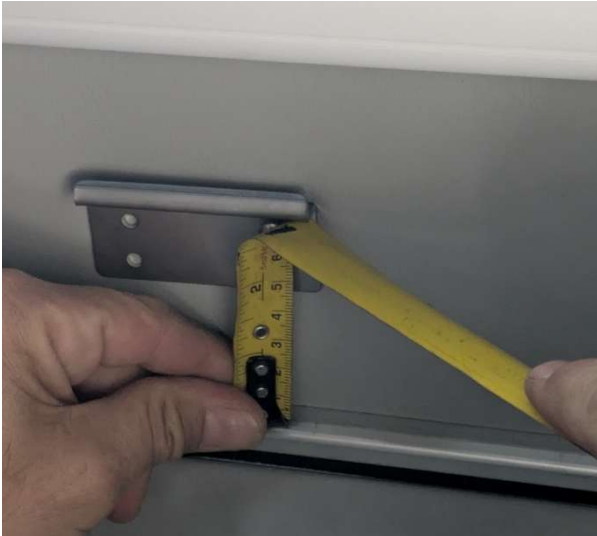
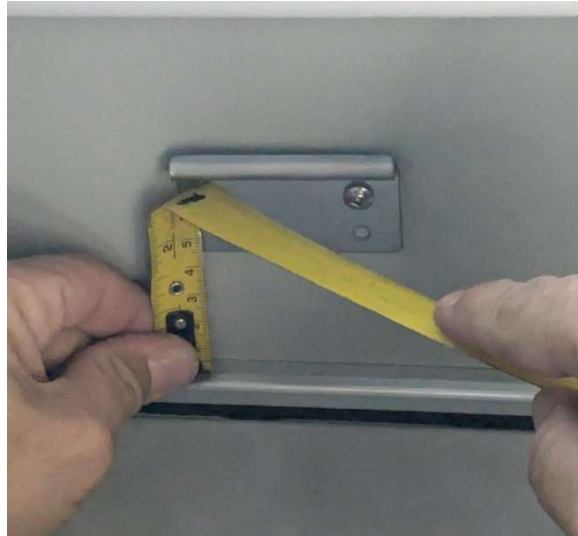
RECALL: NHTSA 26V271**STEP 7.**

Align the new keeper plate so that is straight relative to the edge below. A measuring tape can be used to ensure the alignment of the plate.

NOTE: measurements may vary but should be around 40-45mm.

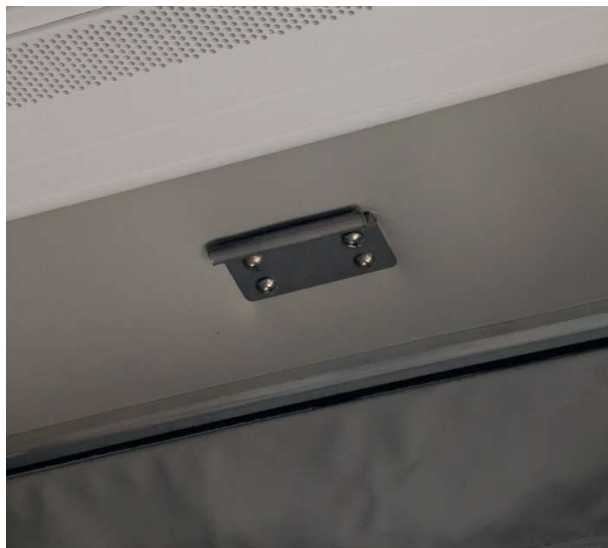
**STEP 8.**

Once the plate is aligned, install the other 3 #8 X 3/4" SS square-drive truss-head screw in the new keeper plate and ensure that the plate is fully fastened and secured to the roof.

NOTE: Be careful when drilling through the roof, drill until the bracket is securely fastened, not until you are unable to drill further otherwise the screw may puncture the exterior of the roof.

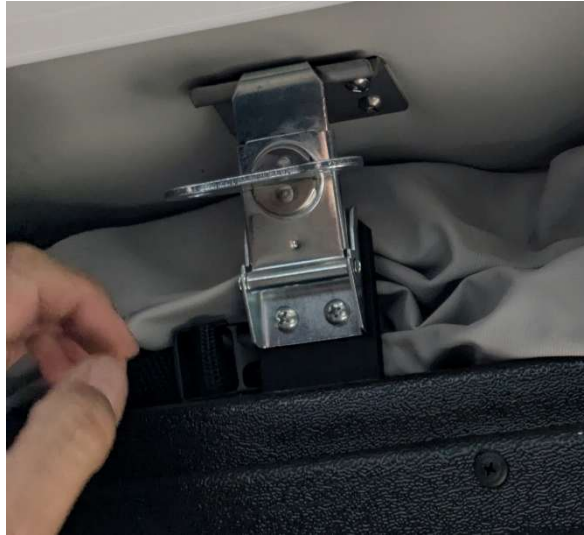
RECALL: NHTSA 26V271**STEP 9.**

Unprop the Pop Top and check to see if the butterfly latch can reach the new keeper plate.

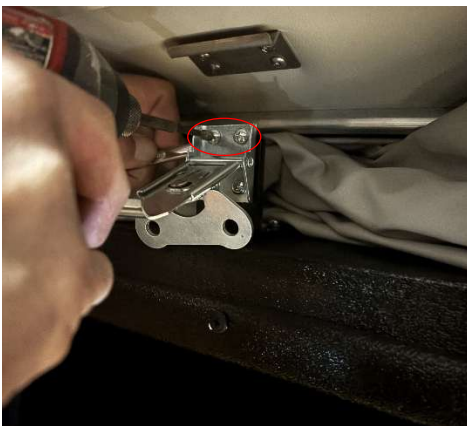
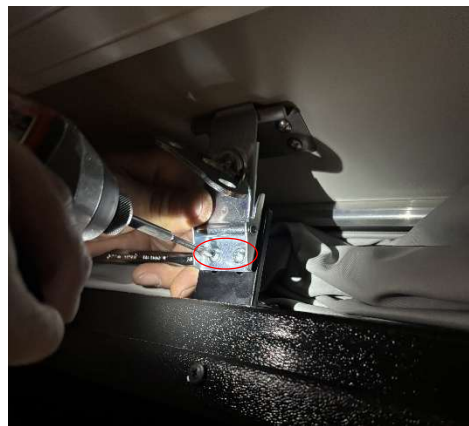
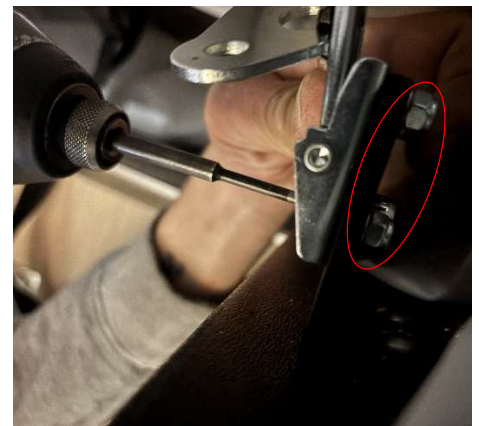
**STEP 10.**

If the butterfly latch reaches the new catch plate and can close, jump to **STEP #13**. If the latch cannot reach or is overshooting the catch plate, slightly loosen the 4 screws on the butterfly latch while using a 3/8" wrench to secure the 4 nuts at the back.

NOTE: Do not fully loosen the screw, only enough to be able to slide the butterfly latch.

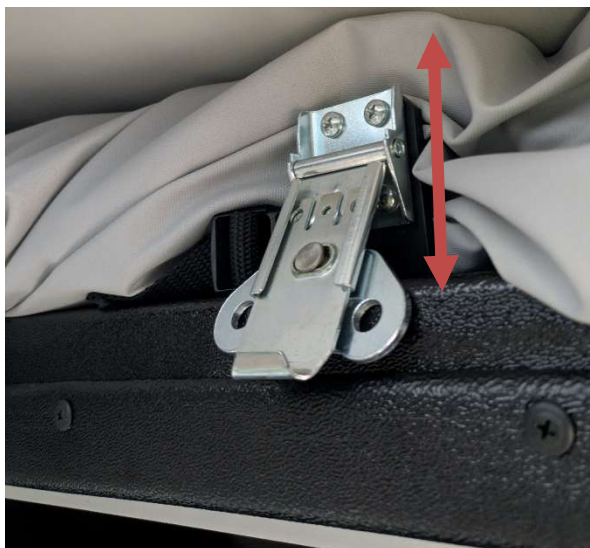
RECALL: NHTSA 26V271**STEP 11.**

Adjust the butterfly latch by sliding it up or down, moving it closer or further from the catch plate as needed.

Re-check if the latch can now reach the new keeper plate. If it still does not reach it, go back to STEP #11. If the latch reaches the keeper plate, retighten the 4 screws on the butterfly latch so that the latch is securely fastened with no movement.

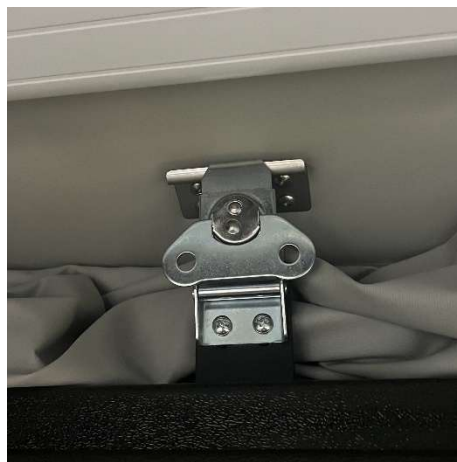
STEP 13.

Close the latch and twist it clockwise to securely close the pop top.

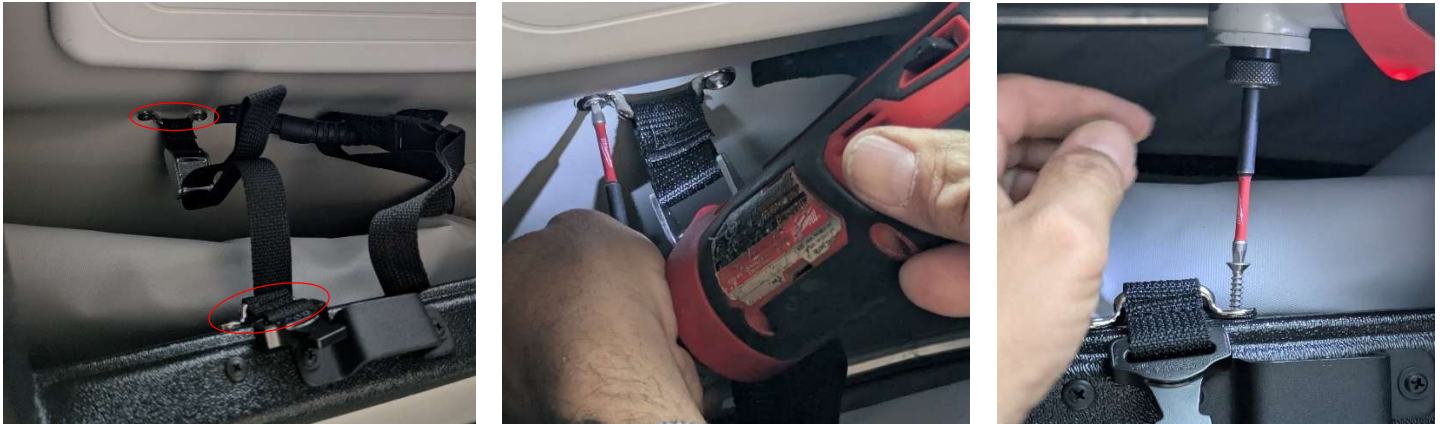
RECALL: NHTSA 26V271**STEP 14.**

Remove both #10 x 1" SS square-drive countersink screws fastening the secondary locking strap footman loop to the roof. Repeat with the 2 screws on the bottom footman loop.

NOTE: Keep these 4 screws as you will reuse them to install the new strap handle supports. If needed, prop up the Pop top again as shown in STEP #2.

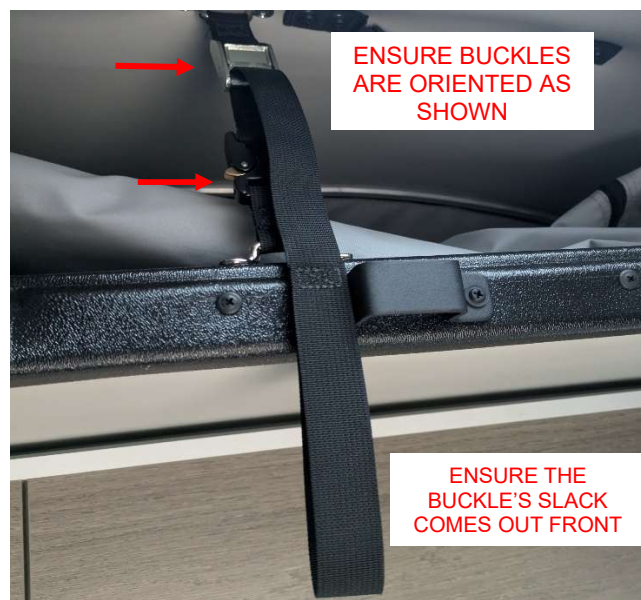
**STEP 15.**

Install the new secondary locking strap (212031542) by fastening the footman loop to the roof using the same 2 of the #10 x1" countersink screws from the old secondary locking strap footman loop. Repeat for the bottom footman loop, then for the strap on the other side.

NOTE: Be careful when drilling through the roof, drill until support handles are securely fastened NOT until you are unable to drill further as the screw may puncture the exterior of the roof.

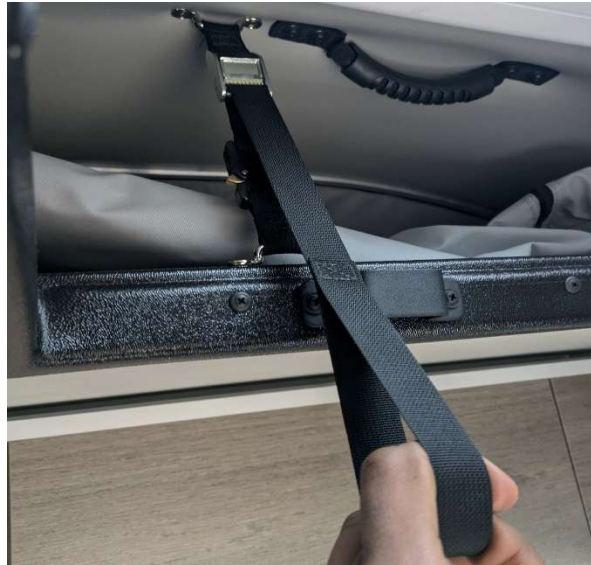
STEP 16.

Pull the slack from the strap to tighten it.
