LP Hose Routing			
Classification		Parts Kit Required			
Recall # 206		Part #	NA	Description	NA
Condition					
On certain Winnebago vehicles, the LP hose may have been incorrectly routed over (rather than behind) the exhaust heat shield.					
Correction					
Inspect the LP hose is correctly routed behind the heat shield. If inspection indicates the LP hose is not correctly routed behind the heat shield, do NOT submit a claim and contact Tech service at techservice@wgo.net					
WGO Model Year	Revision	Make	Model	Model Code(s) (Floorplan)	WGO Built/Manufacturing Dates Impacted
2026	2	Winnebago	Solis	BUT36A, BUT59P, BUT59PX	12/16/2025 – 4/3/2026
2027	1				
Disclaimer: Read the entire instructions carefully before starting the procedure. If you have any questions, please contact the Winnebago Industries Technical Service Department by calling 1-866-653-4329 or by email: techservice@wgo.net . This document is confidential and is intended for dealer use only.

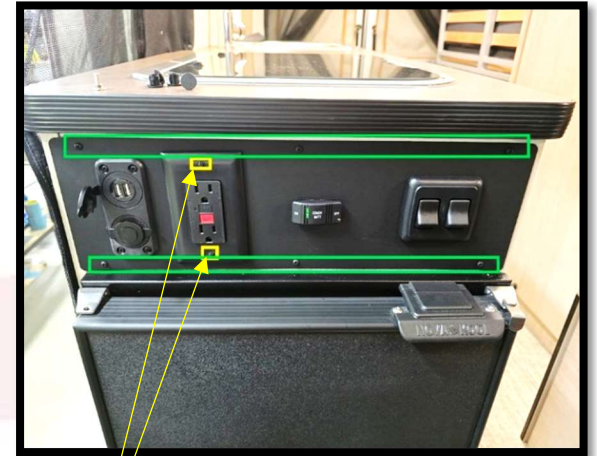
Step 2 – Access the Galley End Panel

- Open the slider door.
- Locate the galley end panel above the refrigerator.
- Using a Phillips head screwdriver or screw gun with a Phillips head screw tip, remove the 6 mounting screws indicated in the **green** boxes. Retain the screws for installation.

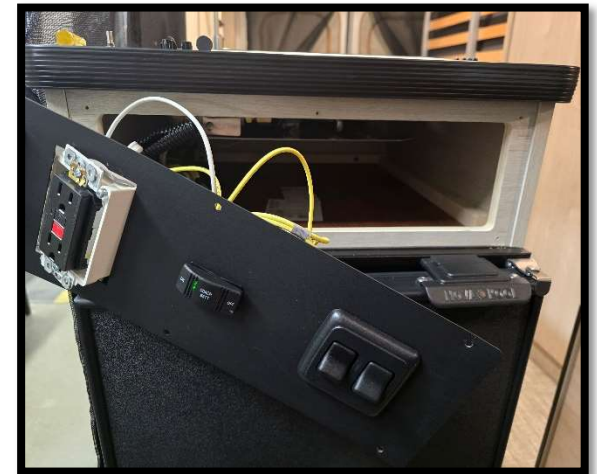
Step 5 – Move Panel Aside

- Using a small flat-blade screwdriver, remove the GFCI cover plate screws indicated in the **yellow** boxes.
- Remove the cover plate and set it aside.

- Loosen the two screws indicated in the green boxes using a Phillips head screwdriver.
Important: DO NOT fully remove these screws. Fully loosening them may cause the wing clips on the back of the electrical box to fall off.

- Gently pull the electrical panel forward
- Shift the panel aside just enough to gain visual access behind the stove area.
Important: DO NOT disconnect or remove any electrical wiring or components

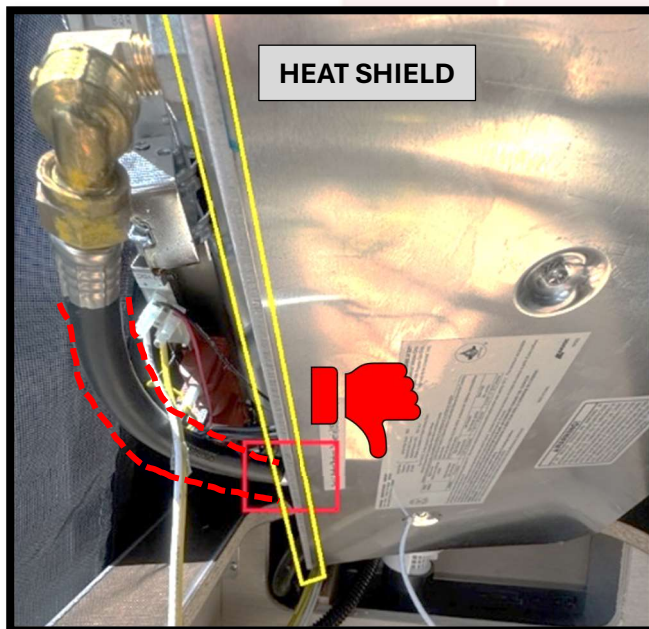
Incorrect Routing

LP hose routed **over the top** of the stove heat shield. The heat shield edge is marked in Yellow, and the hose is marked in red. See image bellow.

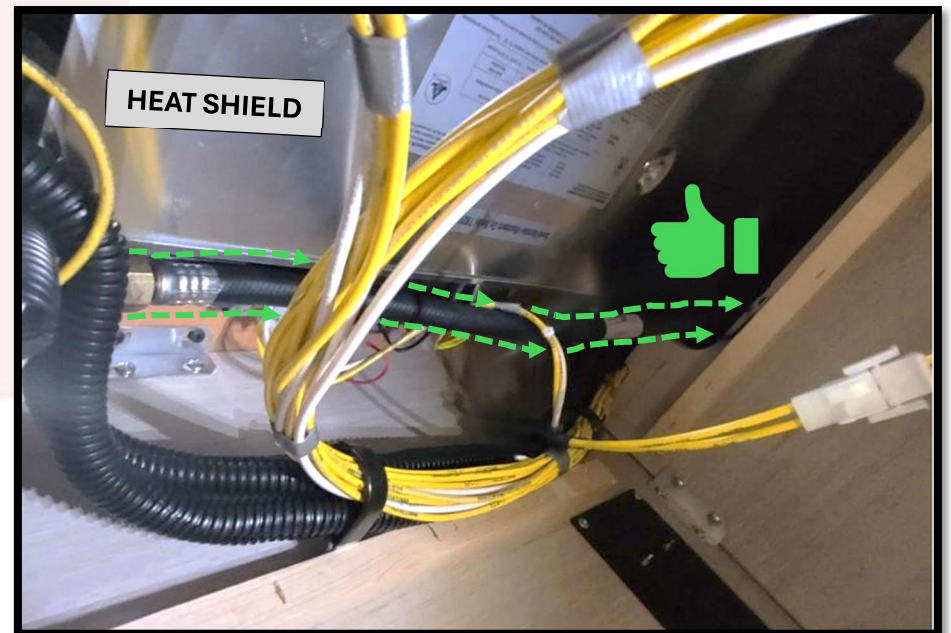
Correct Routing

LP hose routed **underneath** the heat shield (NOT OVER IT) . The hose is marked green. See image bellow.
