**HYUNDAI**  
**Technical Service Bulletin**

| GROUP<br><b>RECALL</b> | NUMBER<br><b>26-01-067H</b> |
| DATE<br><b>AUGUST 2026</b> | MODEL(S)<br><b>ELANTRA GT (GD)<br/>ELANTRA (MD, UD)</b> |

**SUBJECT:** DRIVER AIRBAG (DAB) MODULE INFLATOR INSPECTION & REPLACEMENT (RECALL 300)

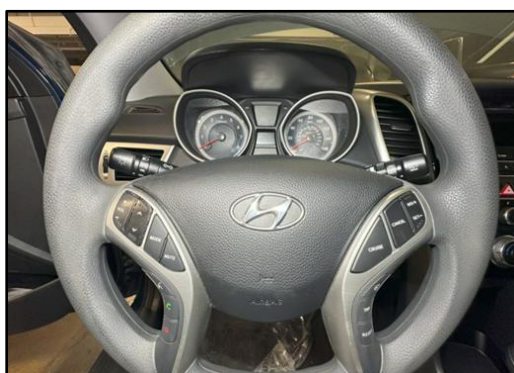
**Description:** Certain Elantra (MD, UD) and Elantra GT (GD) vehicles may be equipped with hybrid airbag inflators that contain propellant outside of density specifications. Lower-density propellant can cause increased internal inflator pressures, potentially leading to rupture of the inflator during airbag deployment. An airbag inflator rupture increases the risk of severe injury or fatality to the driver, passengers, or both. This bulletin provides instructions to inspect and, if necessary, replace the Driver Airbag (DAB) module inflator.

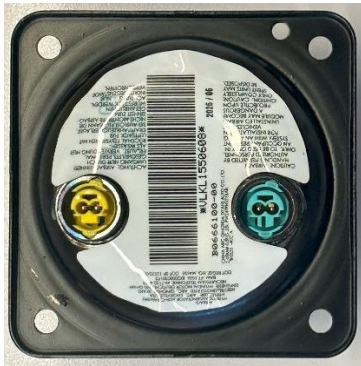
| Model | Part Name | Part Number | Figure | Remarks |
|---|---|---|---|---|
| Elantra GT (GD) & Elantra (MD, UD) | Driver Air Bag Inflator | 3Y569-30010QQH | | Qty: 1 |

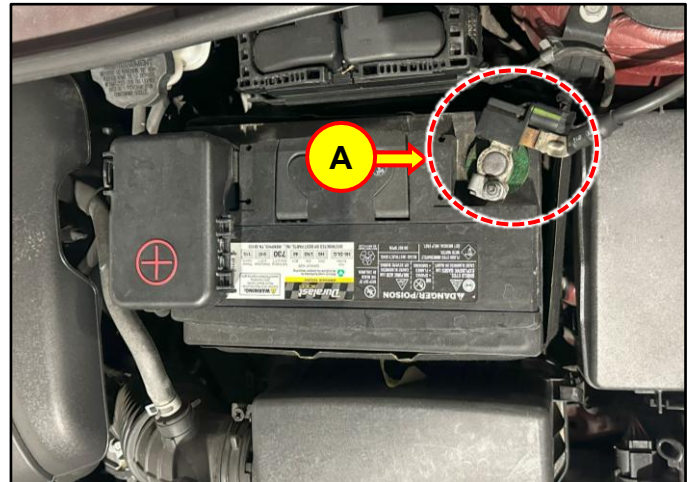
1. Disconnect the negative (–) battery terminal (A).

**Tightening Torque:**

| lb-ft | 4.4 |
| lb-in | 53 |
| N.m | 6.0 |

Wait at least **3** minutes before continuing with the procedure.

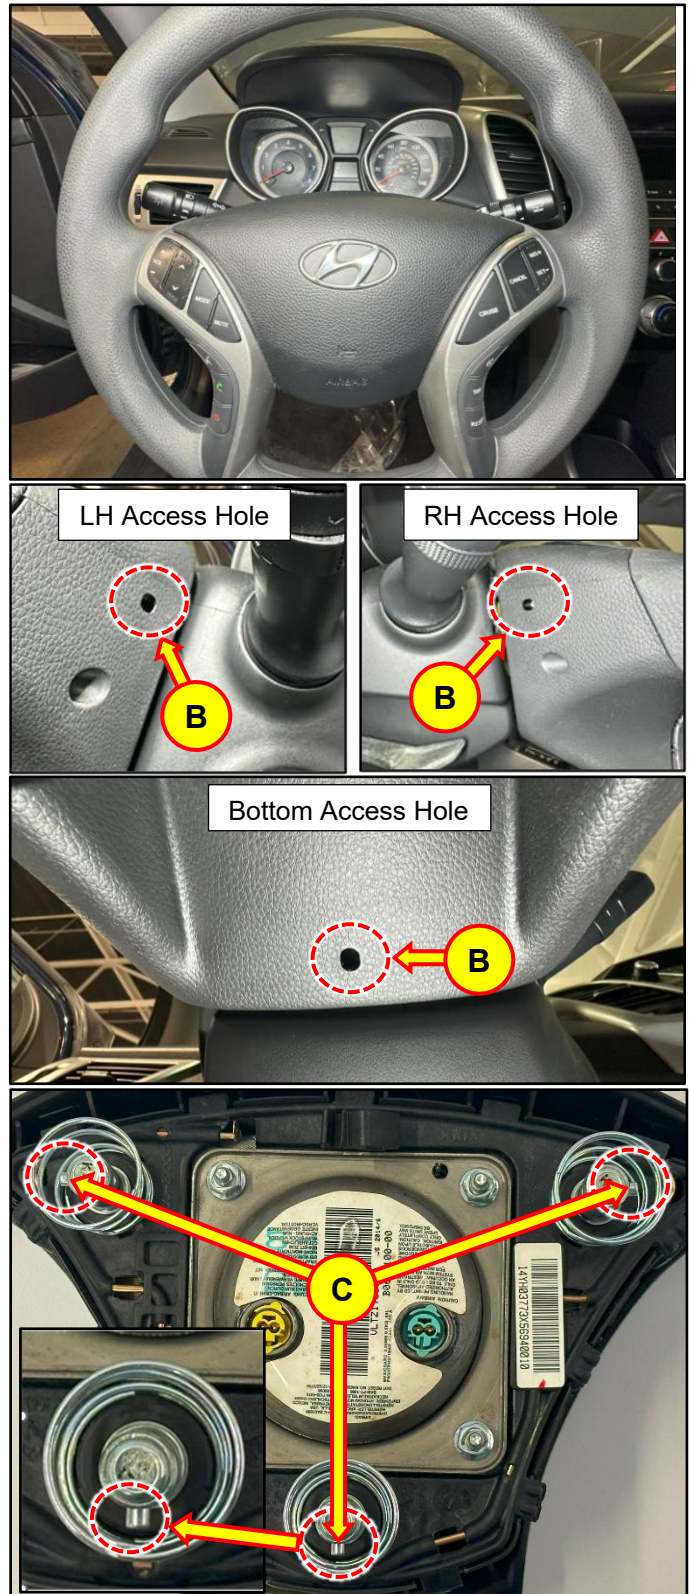
2. Insert a small Torx/Flathead screwdriver or Allen wrench ( $\geq 3$  inches long) into each of the **3** access holes (B) behind the steering wheel controls to depress the locking pins (C), then remove the DAB module.

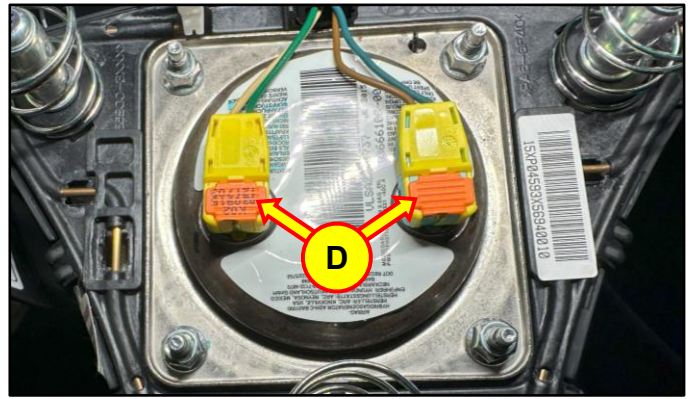
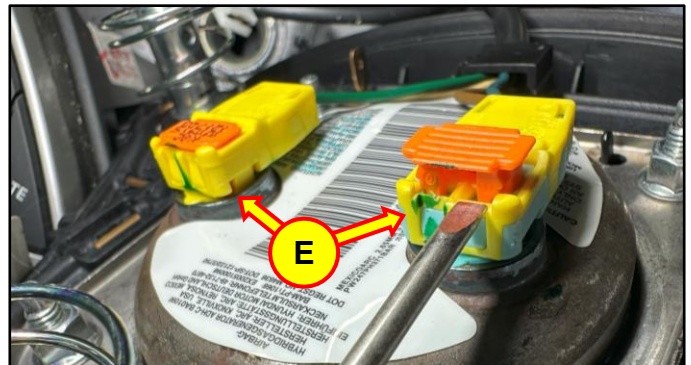
3. Use a small flathead screwdriver to lift the orange locking tabs (D), then disconnect the 2 yellow connectors (E).

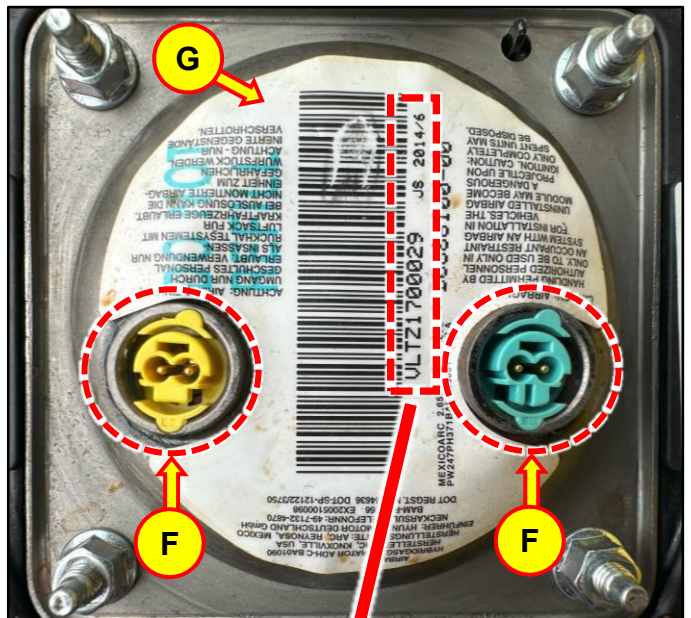
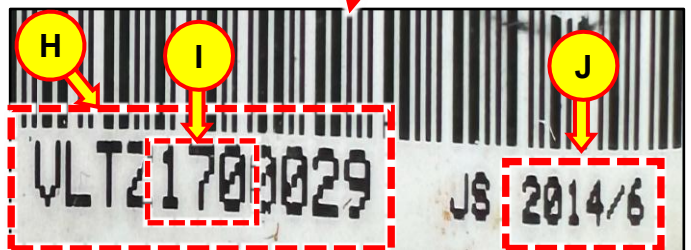
4. Inspect the DAB module inflator to confirm if it is original equipment or aftermarket:

- If the DAB module inflator is the original equipment, then proceed to the [DAB Module Inflator Replacement](#) procedure.
- If the DAB module inflator is aftermarket, then proceed to **step 5**.

**Original Equipment Identification Criteria:**

- **Connector color (F):**
  - Yellow and Turquoise
- **Label color (G):**
  - White
- **Inflator barcode format (H):**
  - First 4 digits: **Alphanumeric**
  - Last 7 digits: **Numeric**
  - Digits 5–7 represent the **Julian date (I)**. Refer to the [Julian Calendar](#) section on page 12.
- **Production Date (J)**
  - Julian date must be within the production month
  - 2014/6 = June 2014
  - Julian date 170 = June 19

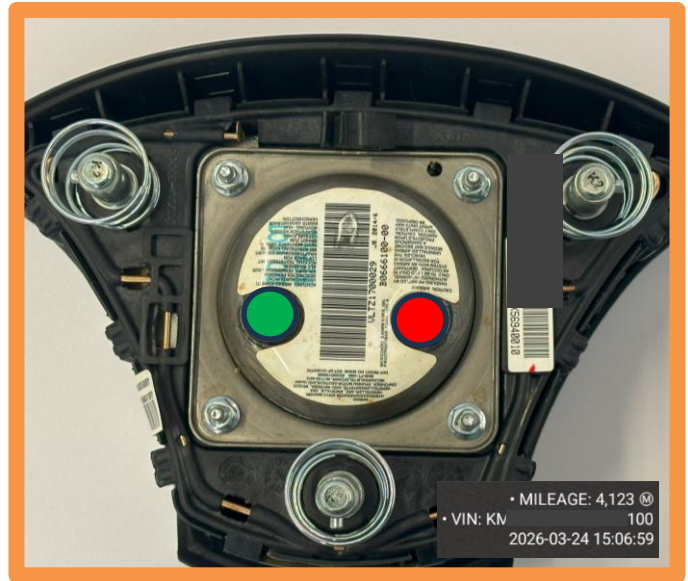
Using the STUI camera function, take a photo of the **NOT** original DAB module inflator label.

Aftermarket parts, connector colors, and labels will vary.

If an aftermarket part is detected, please review the following posting:

**Hyundai Tech Info > Service News > IMPORTANT ALERT - Dangerous Counterfeit Airbag Inflators.**

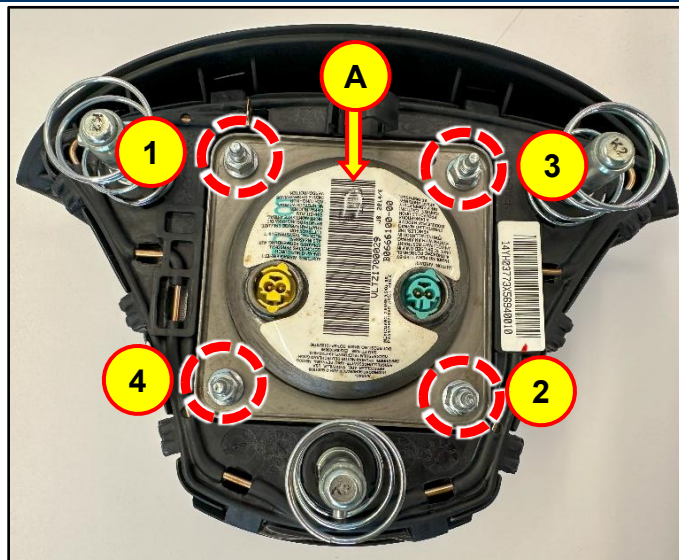
1. Remove the **four 6 mm** inflator mounting nuts in order **(1-4)**, then remove the inflator (A) from the DAB module.

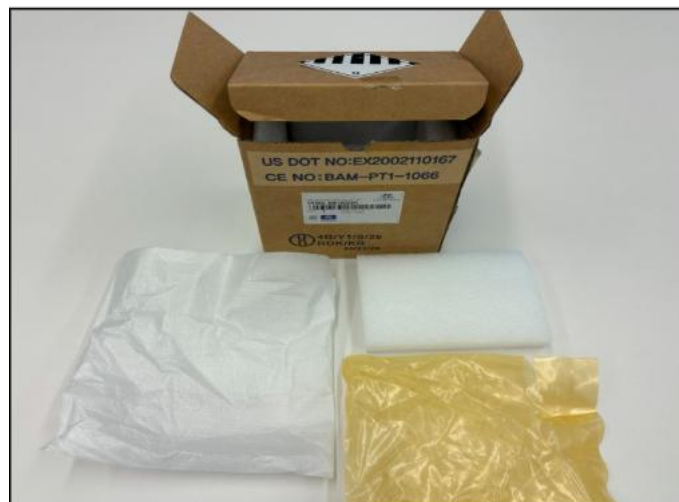
2. Carefully remove the new inflator from the packaging box and keep all of the box's contents.

The part's box and packaging foam will be used for the return.

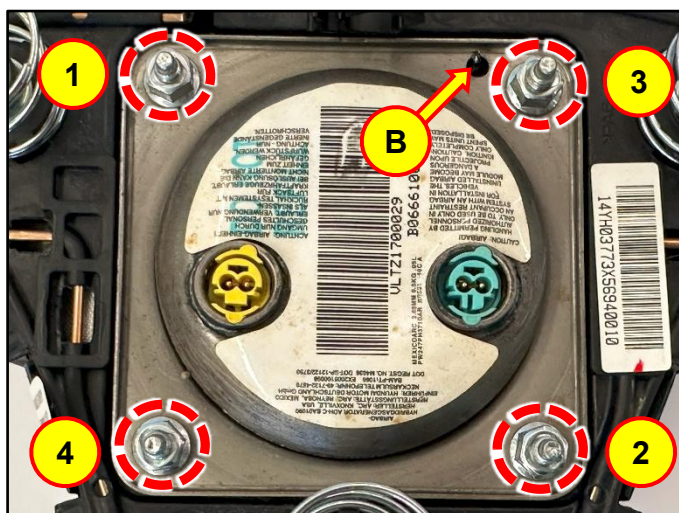
3. Install the new inflator, then reinstall the mounting nuts in order **(1-4)**.

**Tightening Torque:**

| lb-ft | 4.7 |
| lb-in | 56 |
| N.m | 6.4 |

Confirm that the hole (B) of the new inflator lines up with the guide tab of the DAB module.

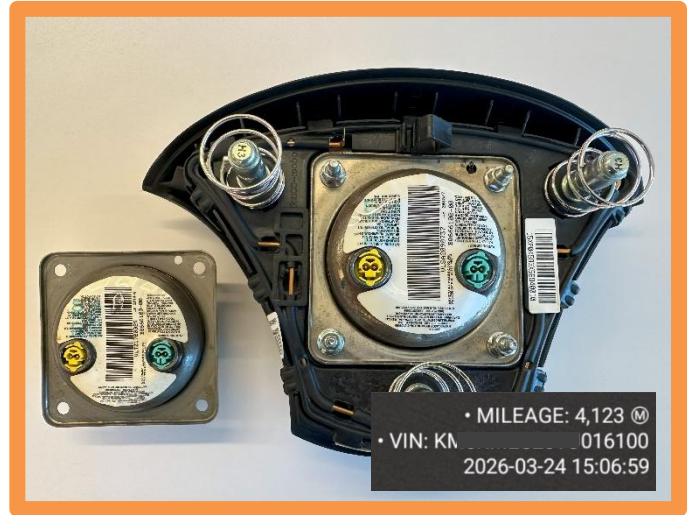
Using the STUI camera function, take a photo of the original inflator next to the new, installed inflator.

5. Reinstall all parts in the reverse order of the removal process.
6. Confirm the proper operation of the vehicle and that the airbag light does **NOT** display on the instrument cluster.
7. The service procedure is now complete.

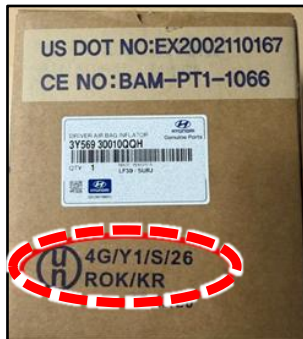
- A contact name and phone number
- A photo(s) of the sealed packaged part with the below clearly visible
  - Hazmat package UN Rating begins with "4G/Y..."

- Hazard Classification label (Class 9)
