CURT® TOURING COIL SUSPENSION (TCS) SHOCK BOLT REPLACEMENT

RECALL:	900012 REC-2602 CURT®Touring Coil Suspension (TCS) Shock Bolt Replacement				
PRODUCT:	Model Z	VIN Range:	Any unit (production or aftermarket) with TCS installed up to VIN #013017	REVISION:	REV-A
DATE:	May 28, 2026	LABOR RATE:	Confirm at Pre-Auth Stage

TOURING COIL SUSPENSION SHOCK BOLT REPLACEMENT

Recall Number	26E-032		
Product:	Curt Touring Coil Suspension		
Date:	05/27/2026	Labor Rate:	Tandem Axle - 0.8 hrs Triple Axle - 0.9 hrs

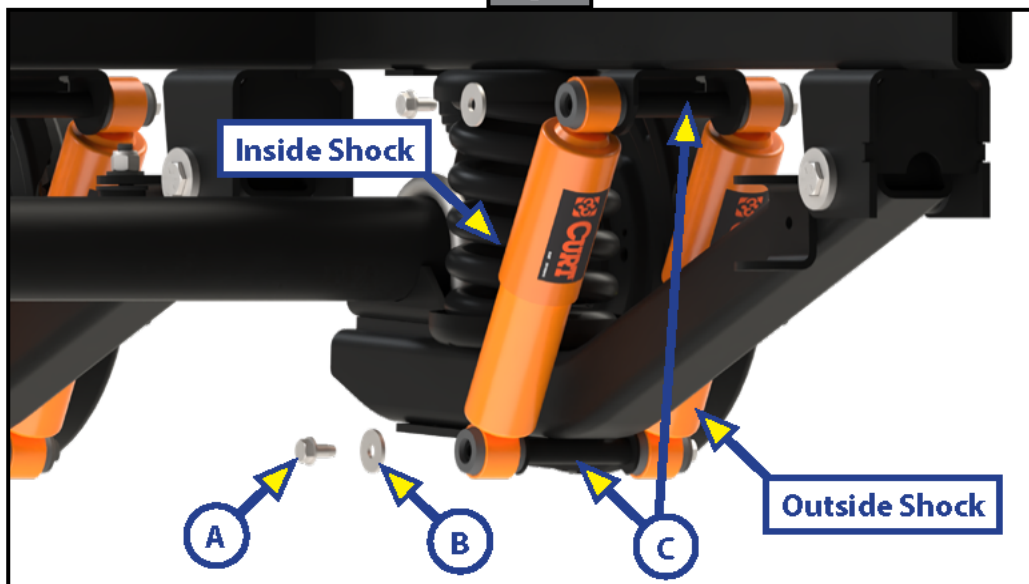
Fig. 1

1. Starting with the inside shocks, loosen and remove the two existing $\frac{3}{8}$ "-16 x $\frac{3}{4}$ " thread forming screws (Fig. 1A) and washers (Fig. 1B) securing each shock absorber onto its posts (Fig. 1C). Retain washers (PN 249853) for reinstallation in Step 2.

2. Reinstall previously-removed washers onto two new $\frac{3}{8}$ " - 16 x $\frac{3}{4}$ " Grade 8 hex head bolts.

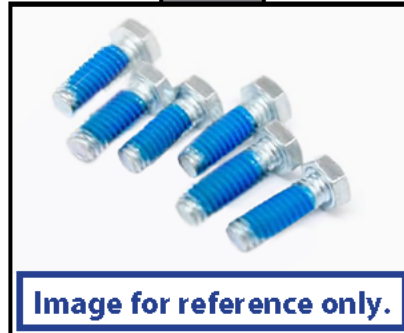
Fig. 2

NOTE: Some kits will come with bolts pre-coated with threadlocker instead of 0.02oz capsules of Loctite. If the bolts are pre-coated (Fig.2), skip step 3.

3. Apply two threads of Loctite® Blue 242® (or locally sourced equivalent) to the Grade 8 bolt threads (Fig. 2).
4. Install new bolt assemblies by hand for a minimum of three full threads (or three turns) before proceeding to Step 5.
5. Torque new Grade 8 bolts to 20-30 ft-lbs. Do not over-torque bolts.
6. Repeat procedure on all other inside and outside shock absorber bolts.

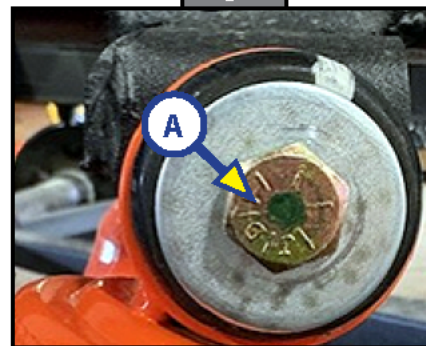
Fig. 4

- Photos of all replaced bolts with green or yellow paint marks (see Figure 4A).
