SAFETY RECALL

Volvo Trucks North America

Release Date	Number	Release	Page
05.2026	RVXX2606	01	1(5)

Wheel Mounting Interference VAH, VHD, VN, VN (4)

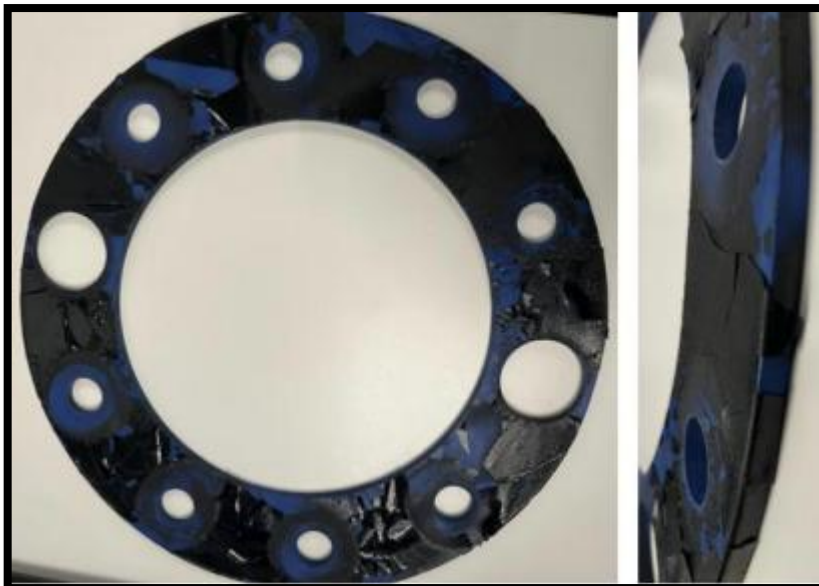
3. Raise wheel end.
4. Remove lug nuts and remove wheel.
5. Inspect for paint masking ring on all axles. Please note that masking ring may be painted with black axle paint as shown.

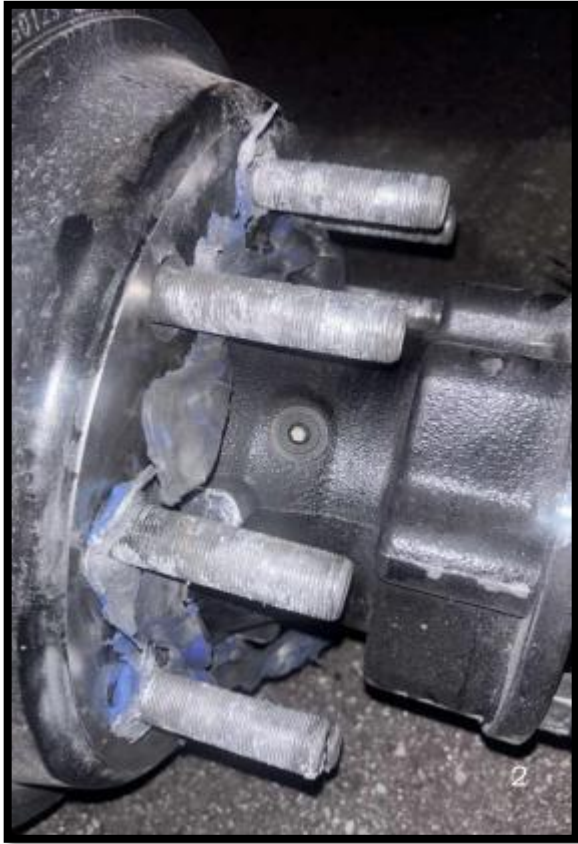
6. IF MASKING RING IS PRESENT:

- A. Remove all foreign material, if the vehicle has brake drums, remove drums and verify joints are free of debris.
- B. Inspect hub, studs, drums, and wheels for damage and replace if necessary.
- C. Reinstall wheel and secure lug nuts using standard tightening procedures.

Tightening Specifications
644±34 Nm (475±25 lb-ft)
