# SAFETY RECALL

Volvo Trucks North America

## Wheel Mounting Interference VAH, VHD, VN, VN (4)

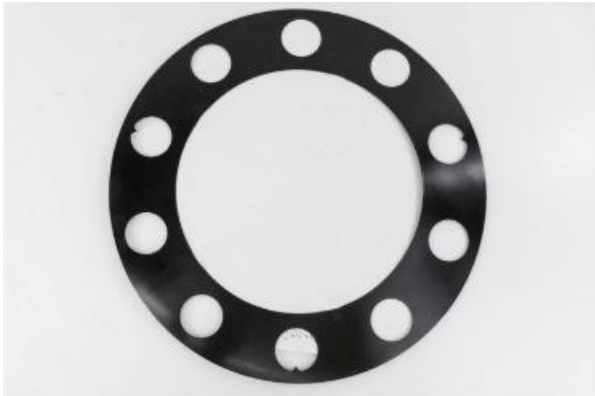
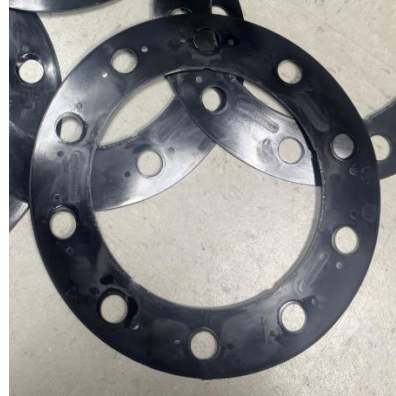
**THERE MAY BE "WHEEL GUARDS" PRESENT ON THE HUB. THESE ARE COMPOSITE SEPARATOR PLATES THAT HELP PROTECT AGAINST CORROSION AND EXCESSIVE WEAR.**

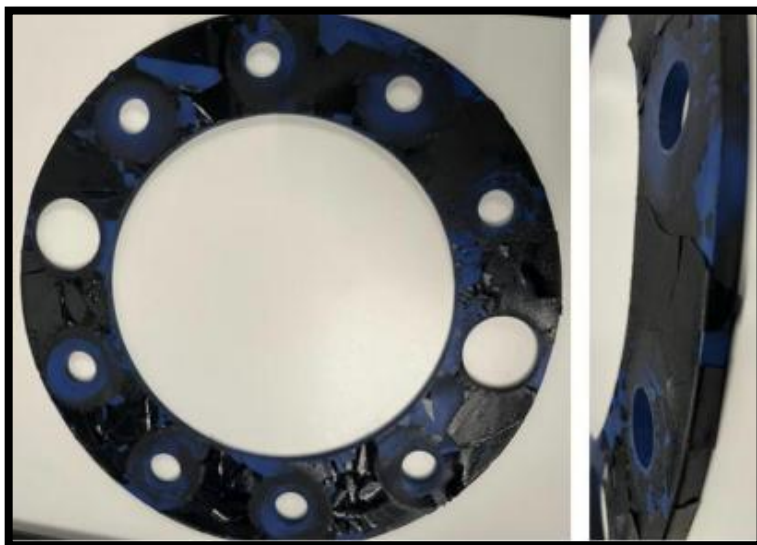
5. Inspect for paint masking ring on all axles. Please note that masking ring may be painted with black axle paint as shown. It is a thicker, malleable material.

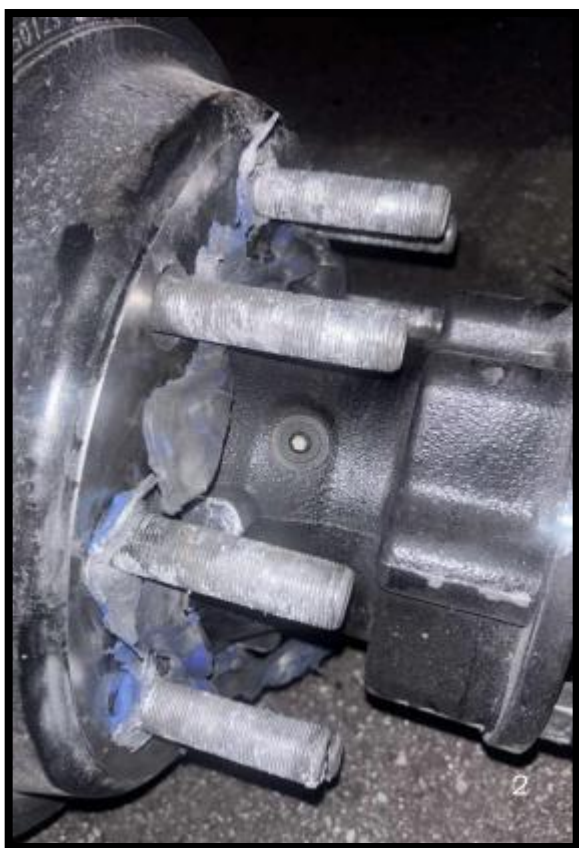
6. **IF MASKING RING IS PRESENT:**

- A. Remove all foreign material, if the vehicle has brake drums, remove drums and verify joints are free of debris.
- B. Inspect hub, studs, drums, and wheels for damage and replace if necessary.

C. Reinstall wheel and secure lug nuts using standard tightening procedures.
