# ***SERVICE PROCEDURE***

26508  
July 2026

## **SUBJECT: SAFETY RECALL**

**Q'Straint® wheelchair securement in certain 2027 IC Bus™ CE Series school buses models built 11/11/2025 thru 04/07/2026 equipped with Q'Straint® wheelchair securement configurations (feature codes):**

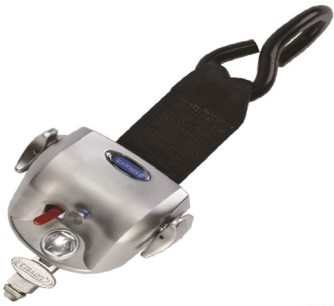
| Part Number | Part Description | Quantity | Image |
|---|---|---|---|
| Q011012 | QRT-360 Positive Lock Indicator (PLI) fitting | As Needed | A silver metal fitting with a black braided hose attached. It has a circular indicator window on the front. Part number 0000494926 is visible in the bottom right corner of the image. |

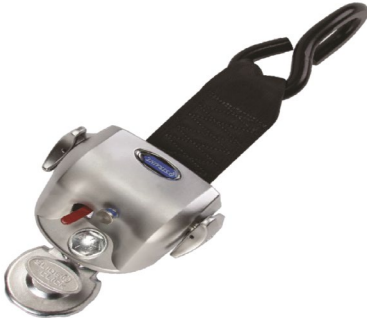
| Part Number | Part Description | Quantity | Image |
|---|---|---|---|
| Q011022 | QRT-360 Slide N Click (SNC) fitting | As Needed | A silver metal fitting with a black braided hose attached. It has a circular indicator window on the front. Part number 0000494927 is visible in the bottom right corner of the image. |

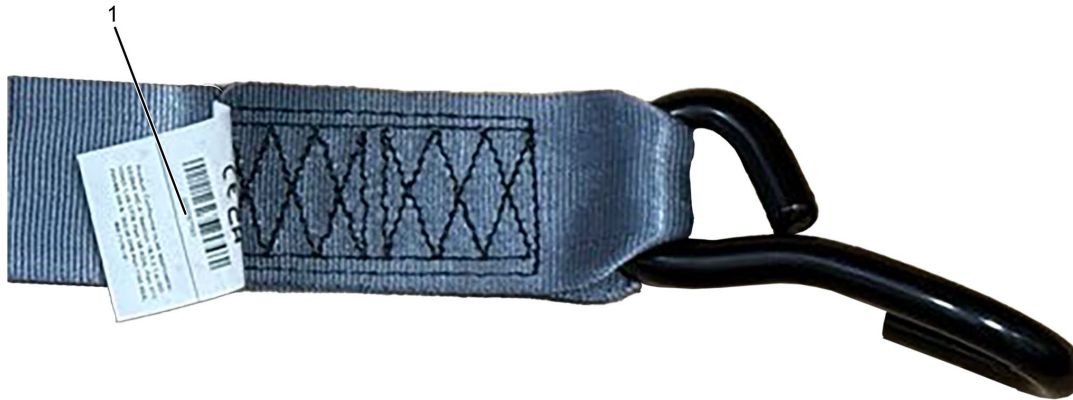
**Figure 1. Identification Tag Location**

**NOTE:** The Q'Straint® wheelchair securement retractors are located either in a pocket mounted to the interior wall of the bus where the wheelchair would be situated, or fastened to the bus floor.

1. Identification tag

5. Locate retractor identification tag (Figure 1, Item 1) on belt.

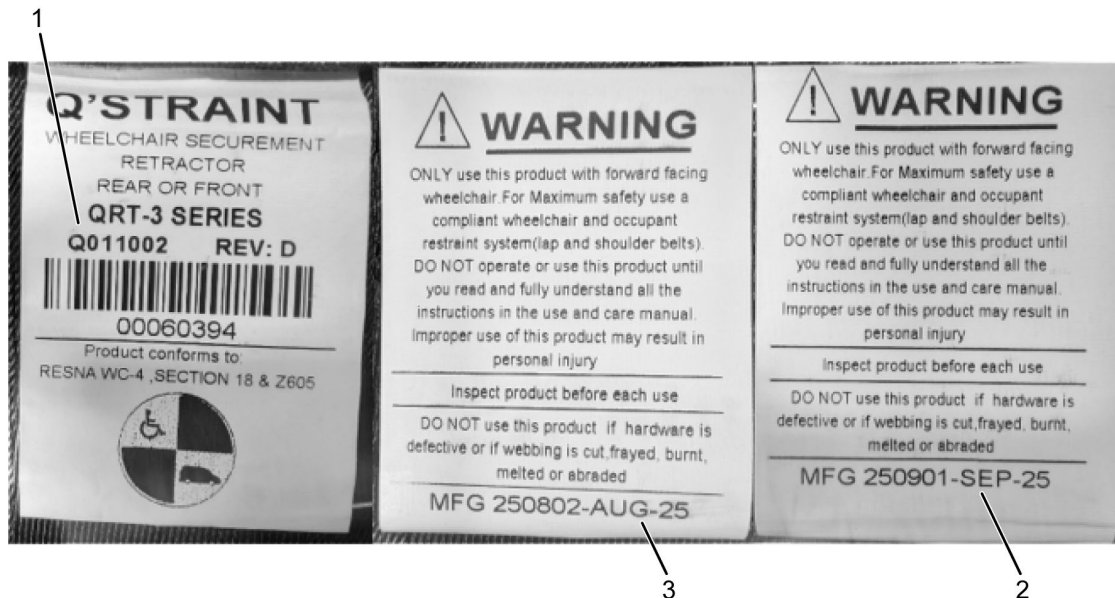
**Figure 2. Requirements With Retractor**

1. Part number Q011002
2. Date of manufacture SEP-25
3. Date of manufacture AUG-25

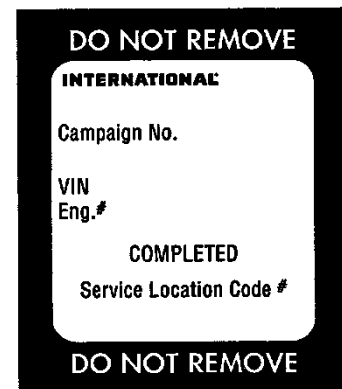
Each vehicle corrected in accordance with this campaign must be marked with a CTS-1075 Campaign Identification Label.

Complete the label and attach on a clean surface next to the vehicle identification number (VIN) plate.
