# SAFETY RELATED RECALL

Global Recall Action  
Number: D120

| Subject:<br><br><b>Driver's Airbag Potential Non-Deployment</b> | Publication No.: D120 |

A concern has been identified on 2020 to 2026 Model Year Defender, 2021 to 2026 Model Year Discovery and 2022 to 2026 Model Year Range Rover where the connector to the driver's airbag at the clockspring may experience fretting corrosion over time. This can lead to an increased resistance in the driver's airbag circuit, potentially resulting in the airbag failing to deploy when requested to do so.

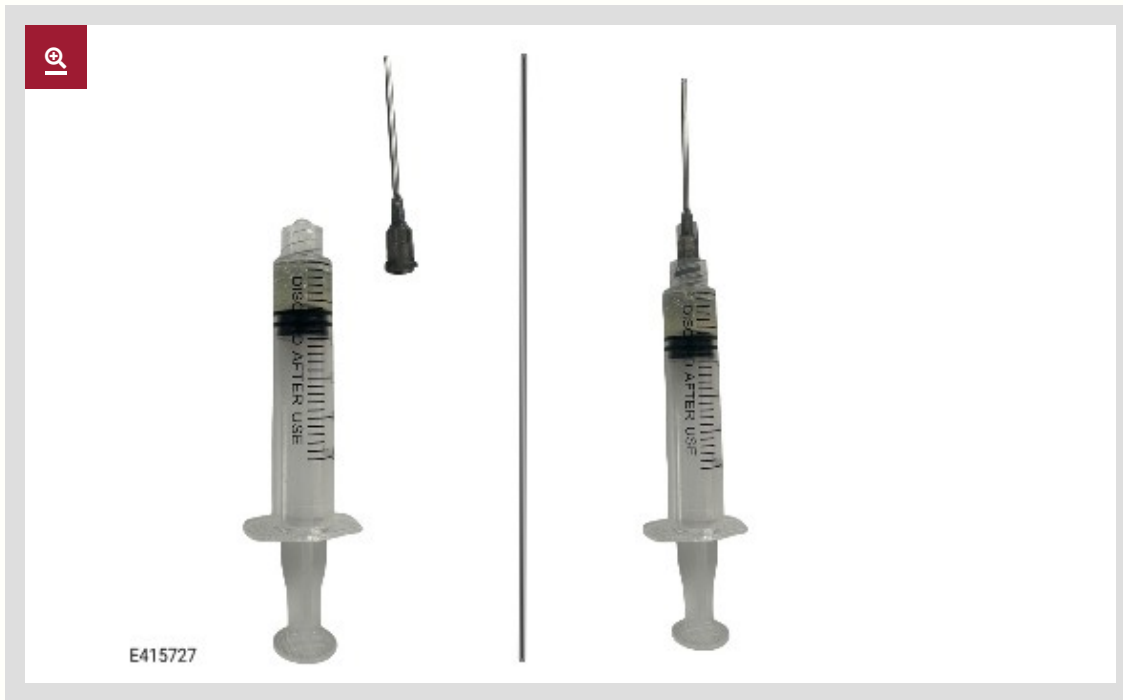
2. Install a suitable 18 gauge (Ga) blunt needle tip onto the syringe body.  
The needle tip must be secure.

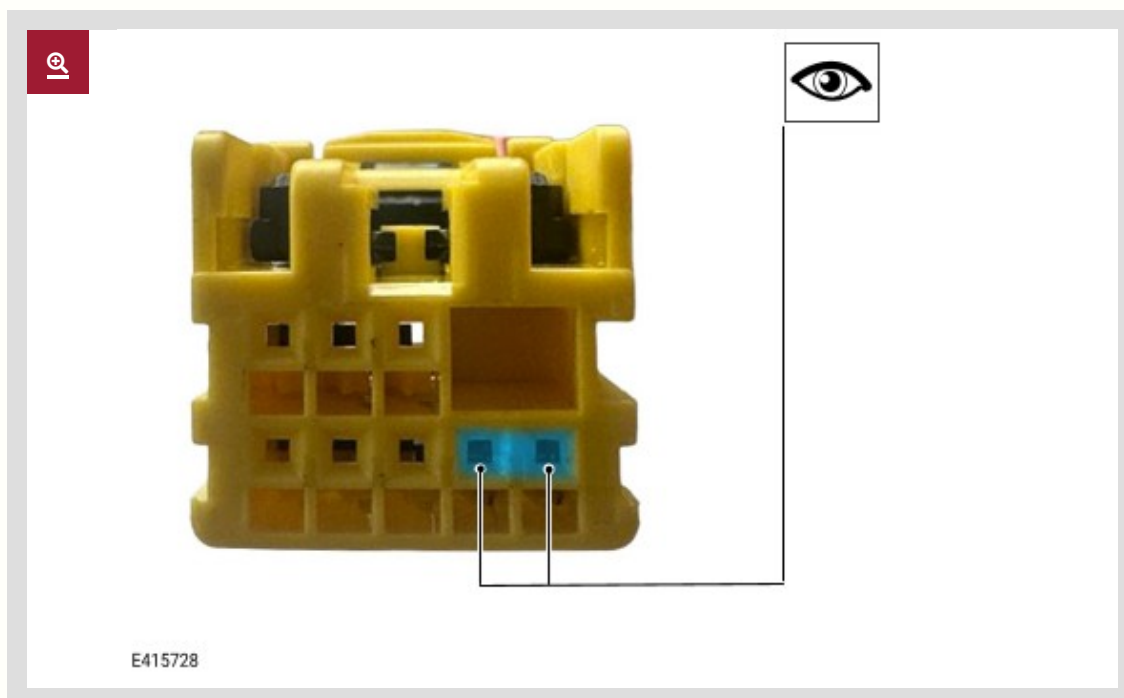
3. Inspect the electrical connector to identify which cavities contain terminals.

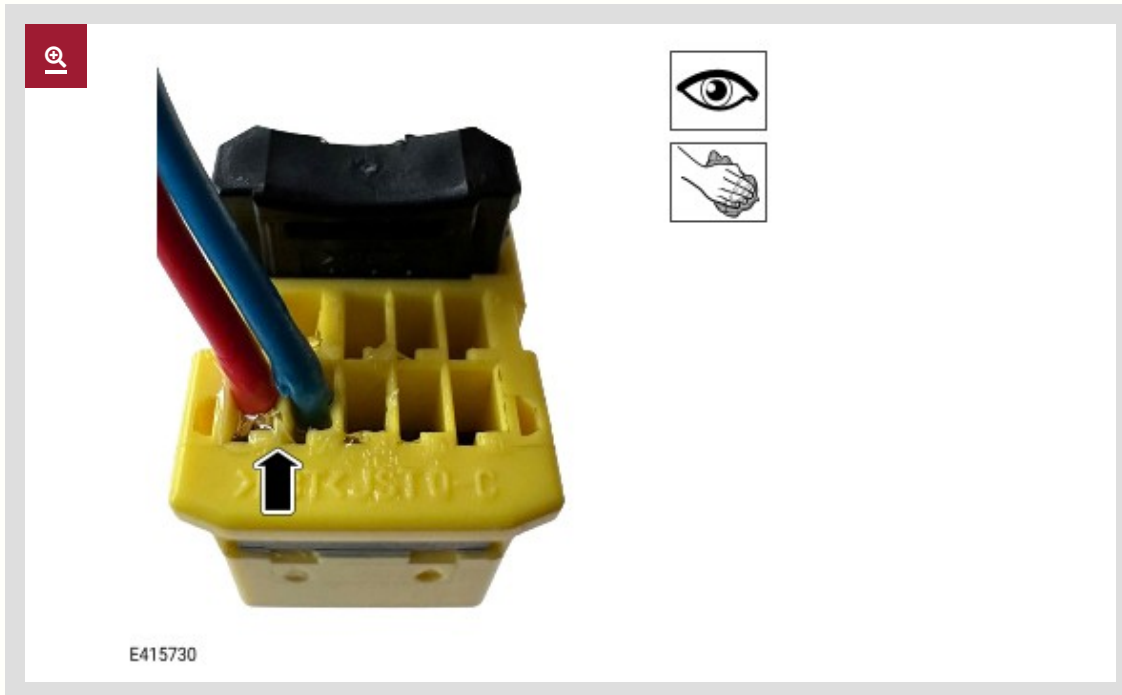
5. After applying a minimum of 0.2 grams of TECGEL 7436 EC OR Nyogel 760G gel into each cavity containing a terminal, inspect the rear of the electrical connector. Confirm that TECGEL 7436 EC OR Nyogel 760G gel is visibly present at the rear of the electrical connector, as shown in the illustration.

- If TECGEL 7436 EC OR Nyogel 760G gel **IS** visible at the rear of the electrical connector, wipe away any excess TECGEL 7436 EC OR Nyogel 760G gel from the front face and rear face of the electrical connector before continuing.
- If TECGEL 7436 EC OR Nyogel 760G gel **IS NOT** visible at the rear of the electrical connector, repeat steps 4 and 5.

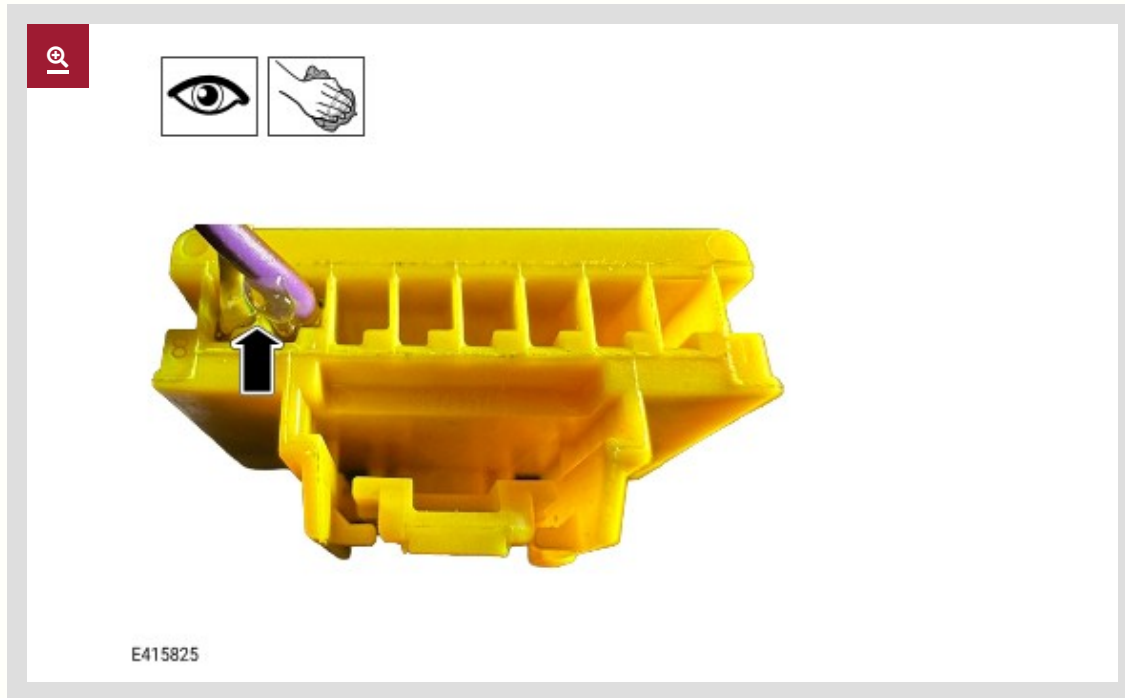
10. After applying a minimum of 0.2 grams of TECGEL 7436 EC OR Nyogel 760G into each cavity containing a terminal, inspect the rear of the electrical connector. Confirm that TECGEL 7436 EC OR Nyogel 760G is visibly present at the rear of the electrical connector, as shown in the illustration.

- If TECGEL 7436 EC OR Nyogel 760G **IS** visible at the rear of the electrical connector, wipe away any excess TECGEL 7436 EC OR Nyogel 760G from the front face and rear face of the electrical connector before continuing.
- If TECGEL 7436 EC OR Nyogel 760G **IS NOT** visible at the rear of the electrical connector, repeat steps 9 and 10.
