## **RV Products Recall 26E-036**

### **Inspection and Repair Procedure**

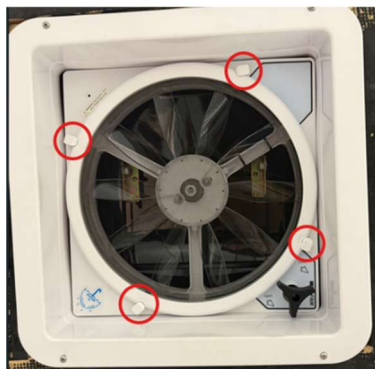
- Record the vehicle identification number (VIN).
- Remove screen on fan by twisting four lock-in tabs:

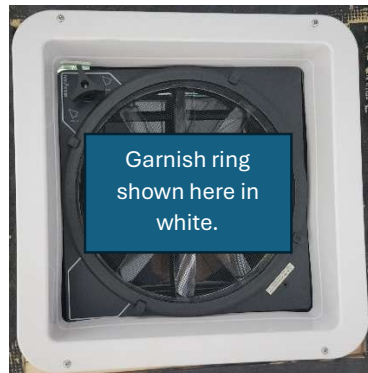
- Remove and lower the control plate. Loosening or removing the garnish ring and disconnecting the network cable from the PCB may be helpful for this step. Use care to avoid damaging the fan assembly.

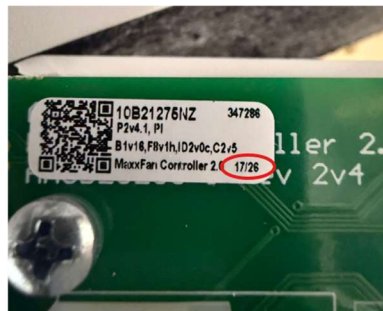
- Identify the date code on the PCB (circled in red below) and determine if the date code is in the affected range.

- All PCB's with a date code of week 51 of 2025 (51/25) through week 25 of 2026 (25/26) and do not feature a "QC Passed" sticker are affected.
  - Examples of QC stickers:

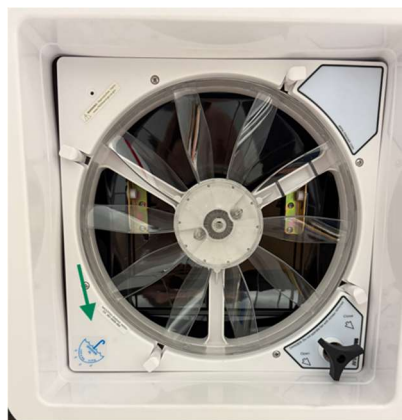
- **If the date code is outside of the identified recall range**, or the date code is in range but features a “QC Passed” sticker:  
sticker:
  - Record the date code from the PCB
  - Photograph the PCB with date code and “QC Passed” visible (if applicable).
  - Re-assemble the fan following the prior steps in reverse. Do not reattach the screen.
  - Place provided “QUAL INSP” sticker in the corner of the fan control plate. Placement shown below with green arrow.

- Photograph the reassembled fan showing the sticker in place and the fan serial number.
  - Reattach the screen.
- **If the PCB date code is within the recall range** and does not feature a “QC Passed” sticker, the PCB must be replaced. Continue to the next section.

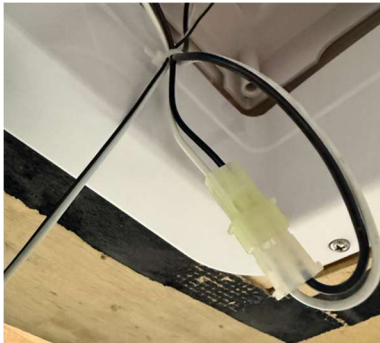
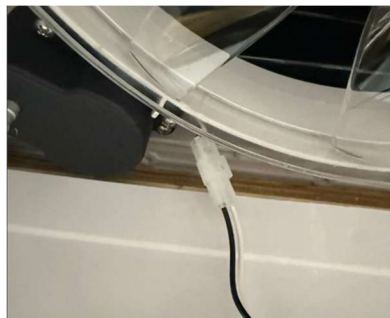
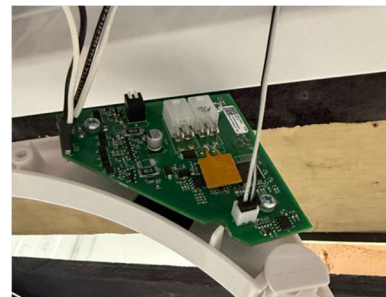
- Disconnect wiring (3) or (4) places
  - Fan motor connection
  - Lift motor connection
  - Network connection
  - Rain sensor (does not apply to some models)

- Carefully cut and remove zip tie on wiring.
- Destroy the removed PCB, then photograph the destroyed PCB.
- Install the new validated PCB to the back of the control plate using the same screws that were removed previously.
- Photograph the new PCB with date code and “QC Passed” visible (if applicable).
- Reattach wires and replace zip tie.

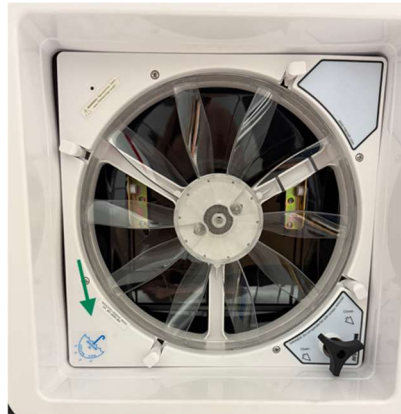
- Re-assemble the fan following the prior steps in reverse. Do not reattach the screen.
- Place provided “QUAL INSP” sticker in the corner of the fan control plate. Placement shown below with green arrow.

- Photograph reassembled fan showing the sticker in place and the fan serial number.
- Reattach the screen.
- Run a test on the fan to validate connections are made properly.
