**RAM**

2026 (DT) Ram 1500 Pickup

## SYMPTOM DESCRIPTION

Inspect, and if necessary, replace the headlamp assembly.

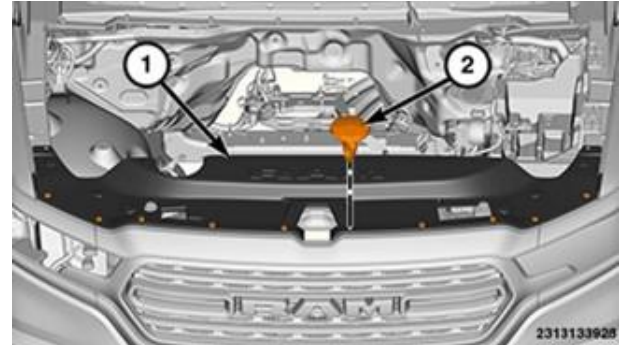
**Figure A1 – Closeout Panel**

1. Open the engine compartment hood.
2. Remove engine cover if it overlaps the closeout panel.
3. Remove the push pin fasteners and remove the closeout panel (Figure A1).
4. Using a borescope, inspect the inboard side of each headlamp to locate the manufacturer information label (Figure A2).

1 - Closeout Panel

2 - Push Pin Fastener

7. If neither lamp is suspect, install the closeout panel and push pin fasteners then close the engine compartment hood (Figure A1). Inspection is complete and vehicle may be returned to customer or inventory.
8. If one or both lamps are within the suspect range, proceed to the **Lamp Replacement Procedure**.

54. Install the anti-tamper plug in the headlamp after headlamp aiming is complete (Figure B20).
55. Install the closeout panel after headlamp aiming is complete (Figure A1).

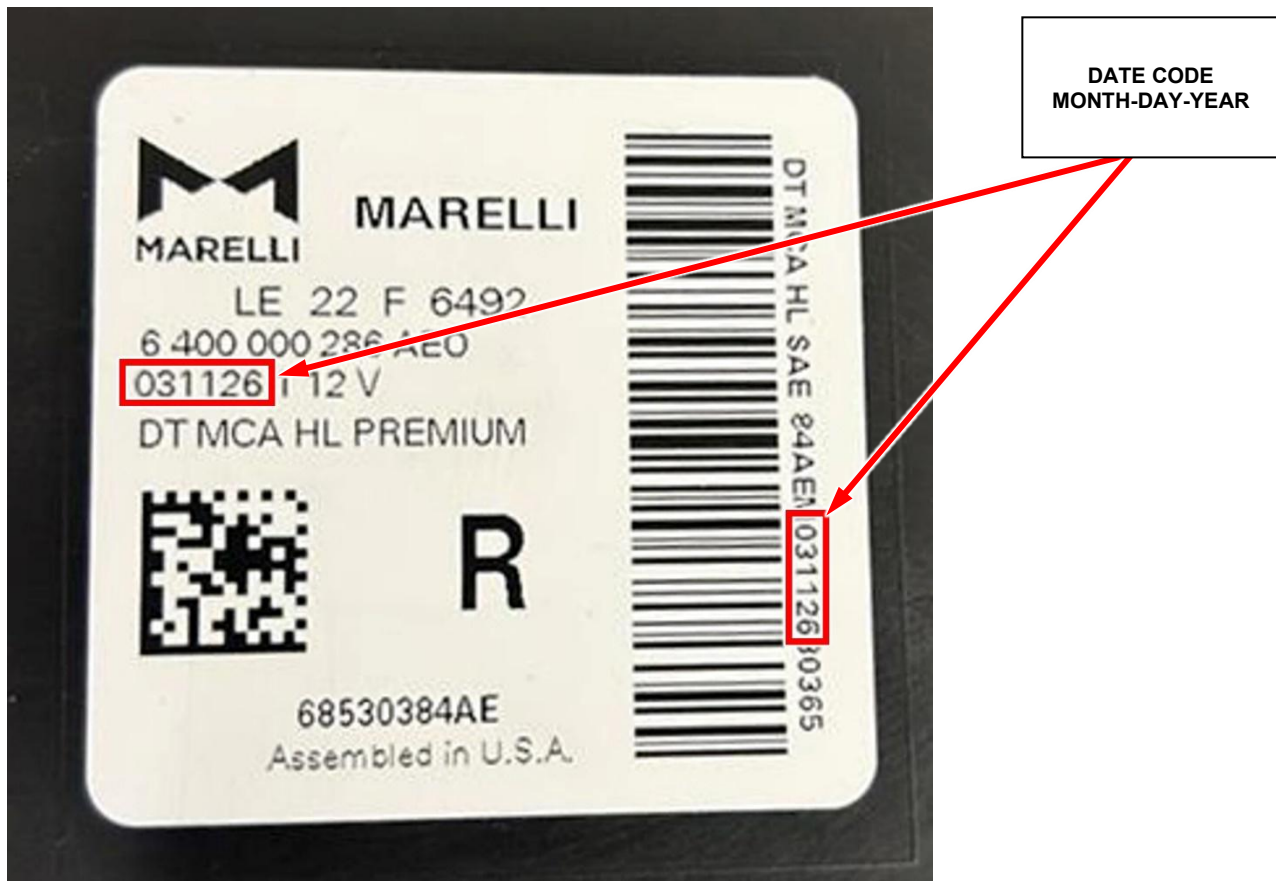
**Figure A3 – Date Code Locations on Label**

5. Read and record the date code located on the label. The date code is located in two areas on the label. One date code may be easier to read than the other depending on label orientation (Figure A3).

The Date code is **Month Day Year**.

First two digits represent **Month**, second two digits **Day**, last two digits **Year**.

**NOTE: both date codes on the label contain the same information so only one date code must be read per headlamp.**

6. If the date code identifies the lamp was manufactured between **October 29, 2025, through February 16, 2026**, the lamp is suspect and must be replaced. If the lamp was manufactured either before or after that date range, the lamp is not suspect and will NOT require replacement.

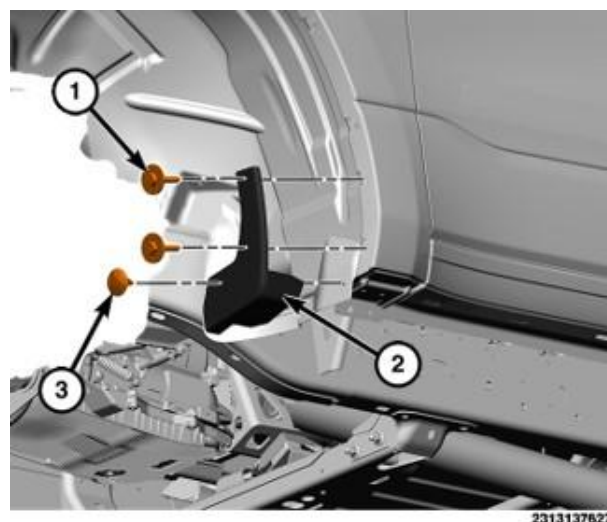
**Figure B1 – Spats**

3. Remove the screws, if equipped (Figure B1).
4. Remove the push pin fastener and remove the spat (Figure B1).

- 1 - Screw
- 2 – Spat
- 3 - Push Pin Fastener

49. Install the wheelhouse splash shields and fasteners tighten the screws securely (Figures B3 and B2).
50. Install the spat and the push pin fastener on each side of the vehicle (Figure B1).

51. Install the spat screws, if equipped on each side of the vehicle and tighten securely (Figure B1).
52. Connect the vehicle battery. Refer to the detailed service procedures available in DealerCONNECT / Service Library under: Service Info> **08 - Electrical / 8F - Engine Systems / Battery System / Standard Procedure.**

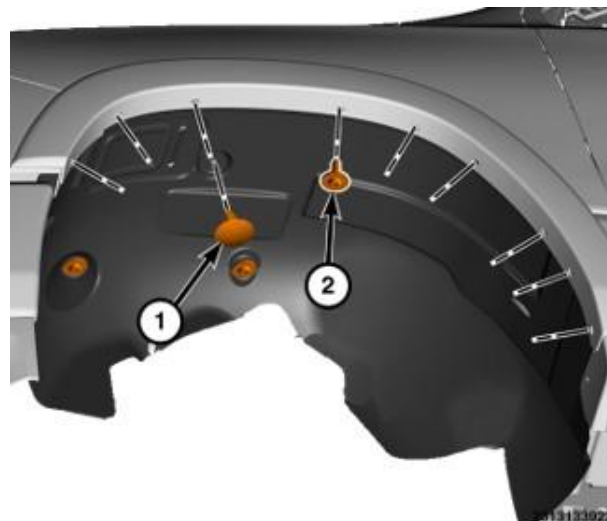
**Figure B2 – Wheelhouse Splash Shield**

5. Remove the screws and the push pin fasteners (Figure B2).

1 - Push Pin fastener

2 - Screw

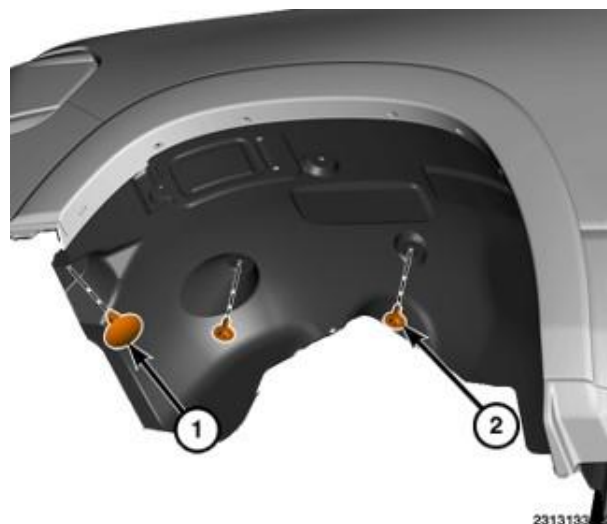
**Figure B3 – Wheelhouse Splash Shield**

6. Remove the push pin fastener and remove the screws (Figure B3).

7. Remove the wheelhouse splash shield (Figure B3).

1 - Push Pin fastener

2 - Screw

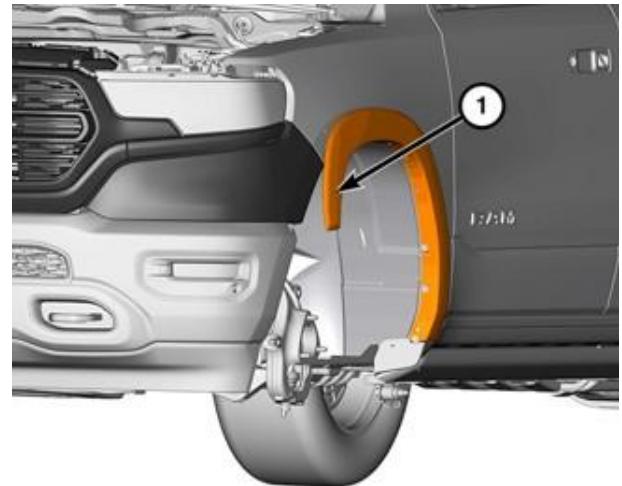
**Figure B4 – Wheel Opening Molding**

8. Release **ONLY** the front 1/2 of the wheel opening molding on each side of the vehicle (Figure B4).
9. Reach behind the backside of the fender and squeeze the wings of the w-clip together using 8 or 9 mm socket or pliers to release wheel opening molding from fender one clip at time (Figure B4).

1 - Molding

47. Install the fasteners on each side of the fascia and tighten securely (Figure B5).
48. Install the wheel opening molding on each side of the vehicle (Figure B4).

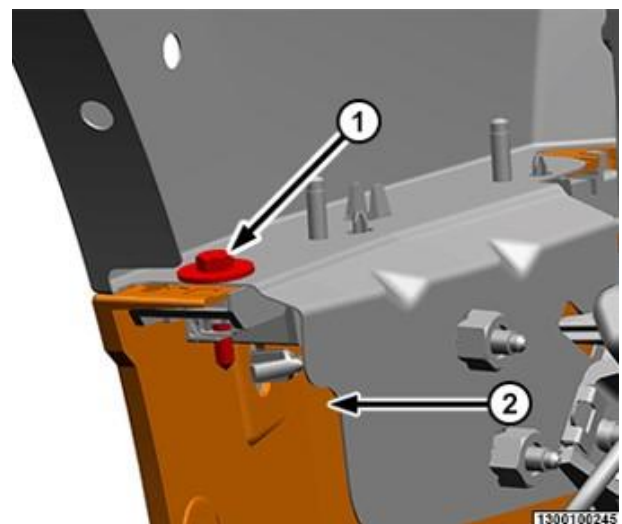
**Figure B5 – Facia Fasteners**

10. Remove the fasteners on each side of the fascia (Figure B5).

1 - Fasteners

2 - Front Fascia

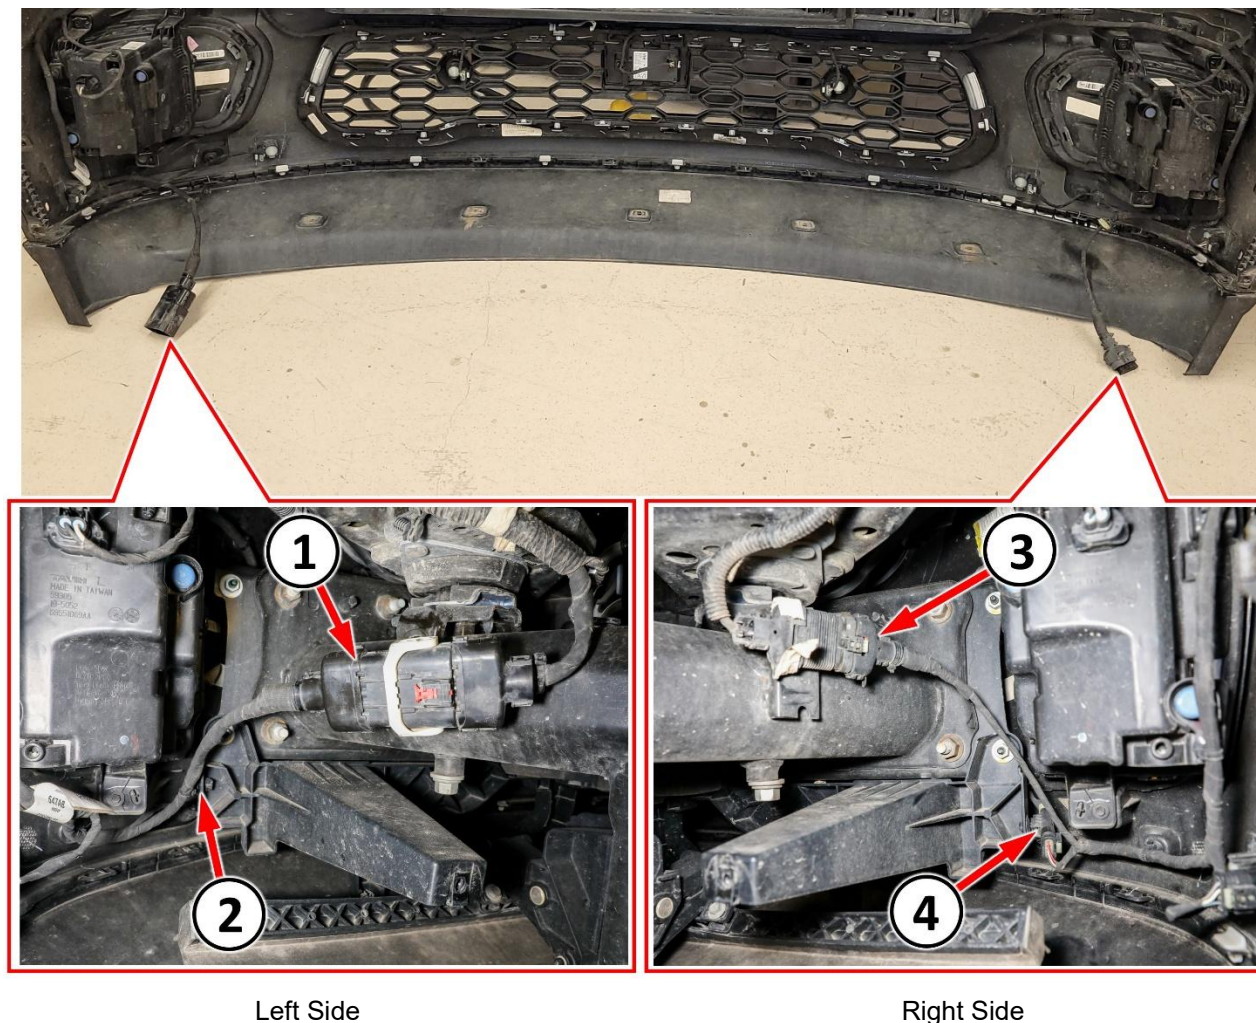
**Figure B6 – Facia Wire Harness Electrical Connectors**

11. Disconnect the wire harness electrical connectors and retainer on each side of the facia (Figure B6).

- 1 - Electrical Connector (Left Side)
- 2 - Wire Harness Retainer (Left Side)
- 3 - Electrical Connector (Right Side)
- 4 - Electrical Connector (Right Side)

45. Install the fascia air dam to lower bracket bolts and tighten to 5 N·m (44 In. Lbs.) (Figure B7).
46. Connect the wire harness connectors and retainer on each side of the fascia (Figure B6).

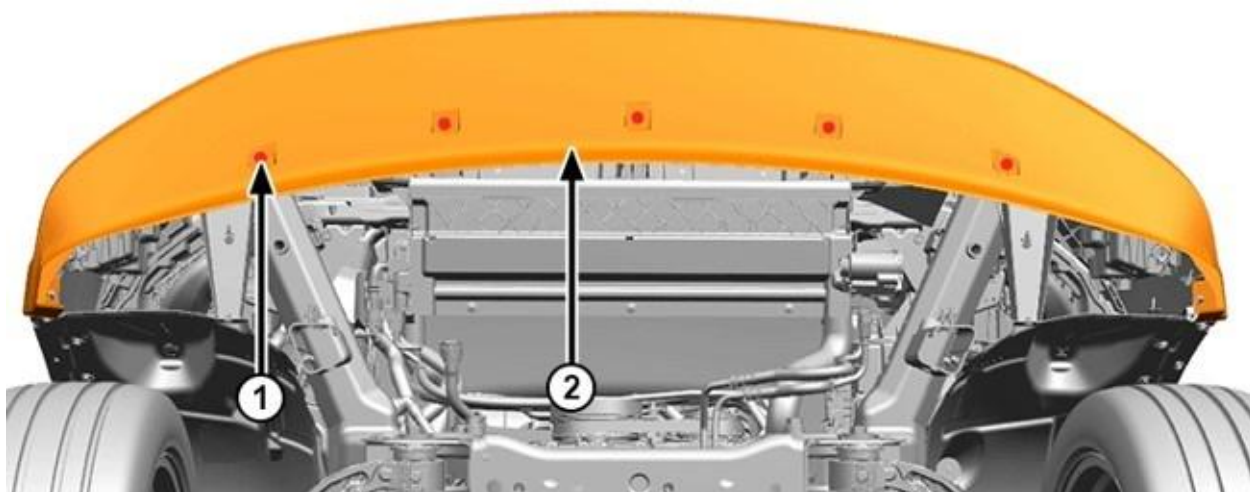
**Figure B7 – Air Dam**

12. Remove the fascia air dam to lower bracket bolts (Figure B7).

1 - Fascia Air Dam to Lower Bracket Bolts

2 - Lower Air Dam

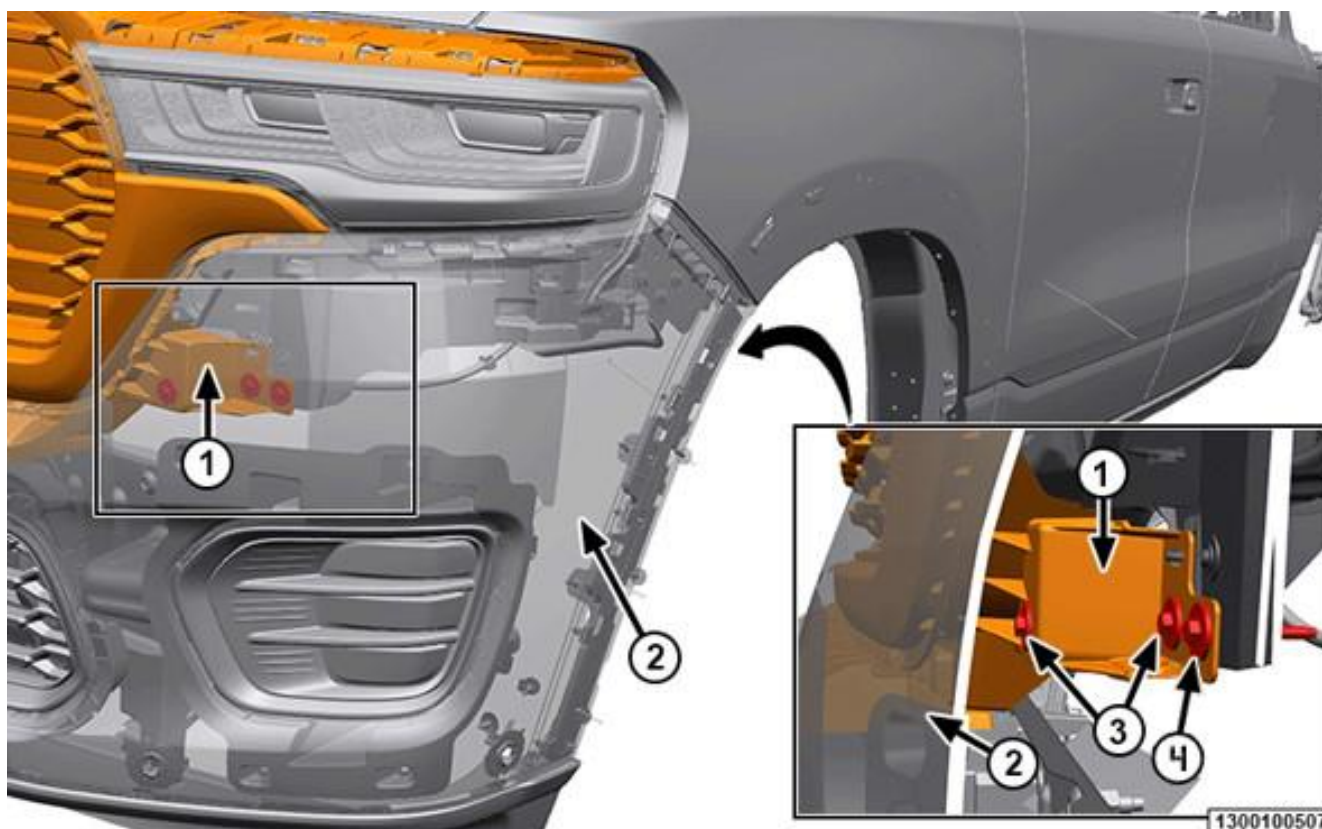
**Figure B8 – Lower Grille Carrier**

13. Reaching through the wheel well, between the fascia and the grille carrier, remove the lower grille carrier to Front End Module (FEM) bolts. Repeat for the opposite side (Figure B8).
- **DISCARD** the bolts removed from positions (3) on each side (Figure B8).
  - Retain the bolts removed from positions (4) on each side (Figure B8).

- 1 - Grille Carrier  
2 - Front Fascia  
3 - Bolts (Remove and **DISCARD**)  
4 - Bolt (Remove and retain)

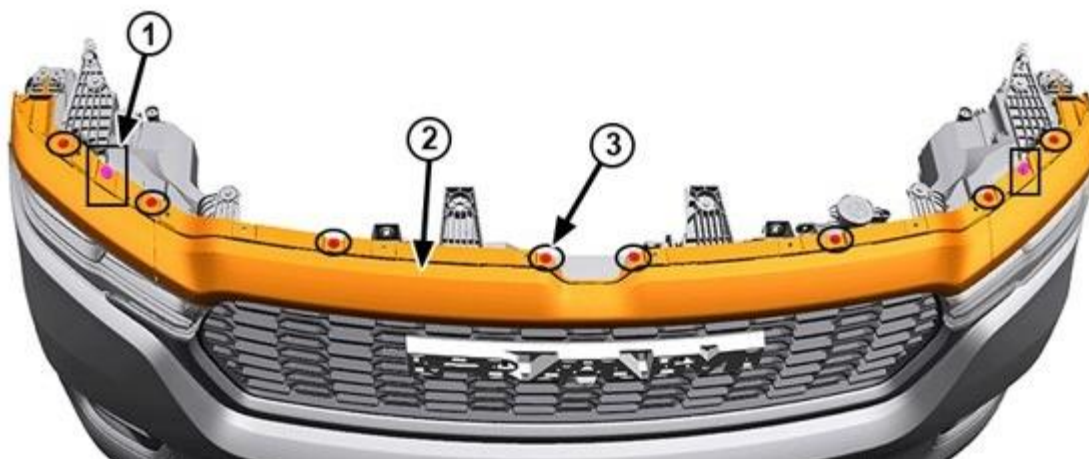
**Figure B9 – Grille Upper Trim**

14. Remove the bolts and plastic push pin fasteners that secure the grille upper trim (Figure B9).

- 1 - Push Pin Fasteners
- 2 - Grille Upper Trim
- 3 - Bolts

42. Connect the front view camera connector (Figure B11).
43. Align and engage the grille upper trim to the vehicle (Figure B10).
44. Install the bolts and plastic push pin fasteners that secure the grille upper trim then tighten the bolts securely (Figure B9).

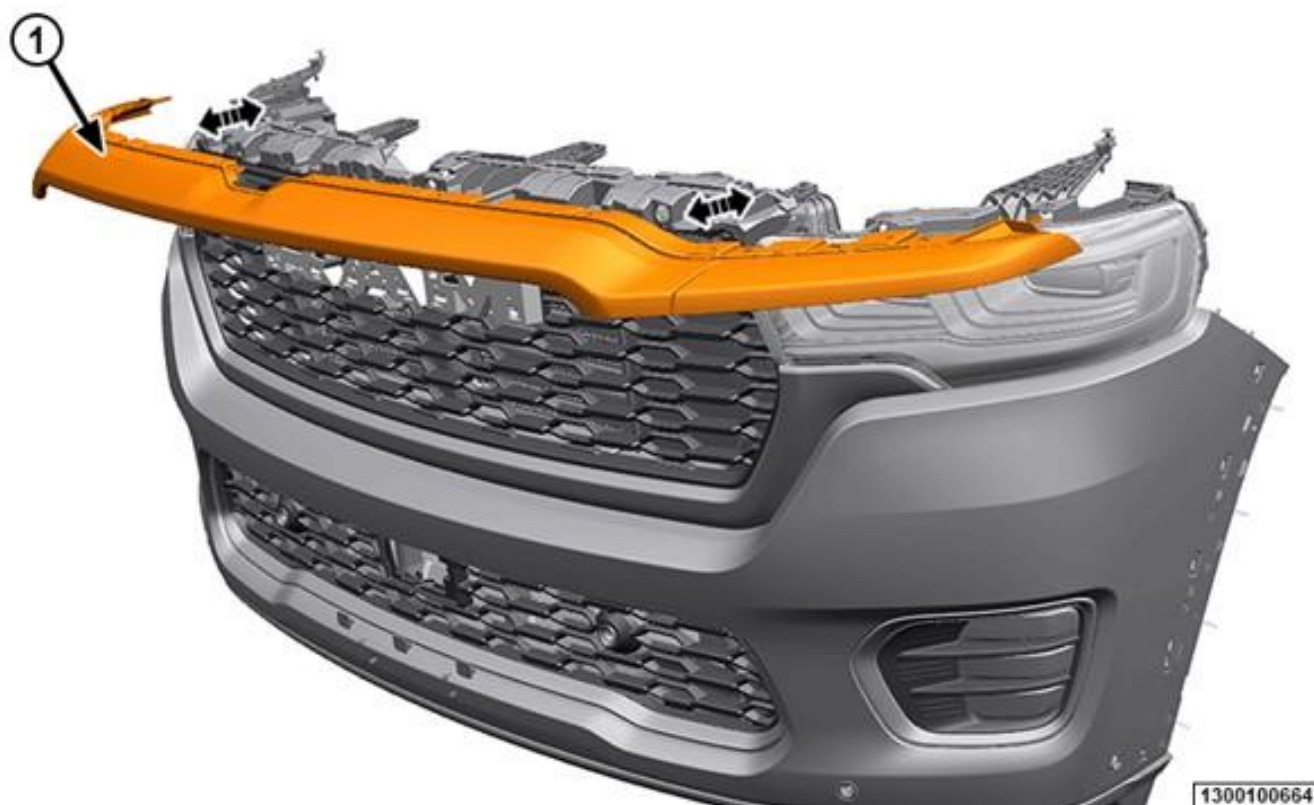
**Figure B10 – Grille Upper Trim**

15. Disengage the grille upper trim and slide it forward to remove it from the vehicle (Figure B10).

1 - Grille Upper Trim

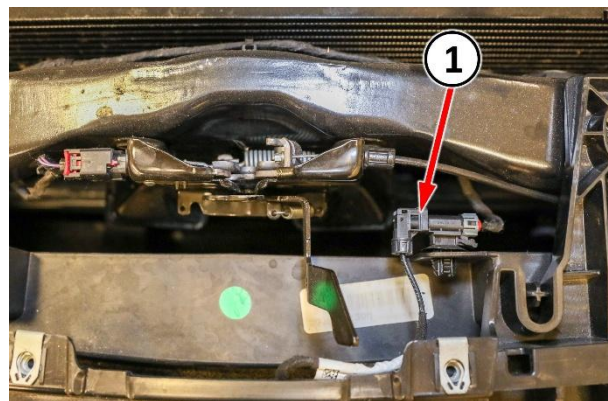
**Figure B11 – Front Camera Connector**

16. Disconnect the front camera electrical connector located near the hood latch (Figure B11).

1 – Electrical Connector

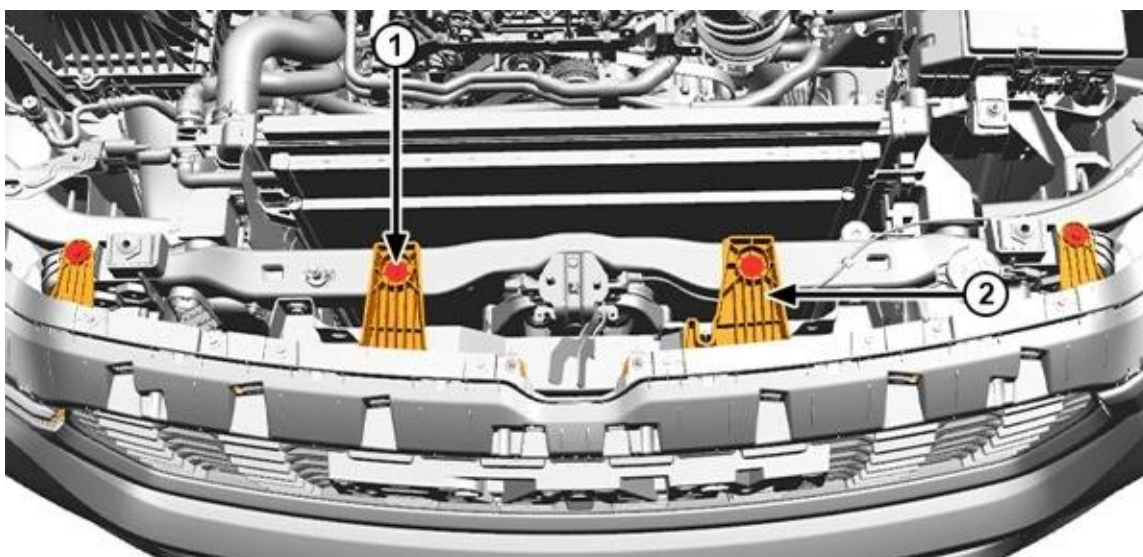
**Figure B12 – Upper Grille Carrier**

17. Remove and **DISCARD** the bolts from the upper side of the grille carrier (Figure B12).
18. Lift up on the outer tabs to release the grille carrier from the radiator support (Figure B12).

1 - Bolts

2 - Grille Carrier

40. Engage the tabs that secure the front fascia to the fenders (Figure B13).
41. Install **NEW** bolts to the upper side of the grille carrier and tighten to 5 N·m (44 In. Lbs.) (Figure B12).

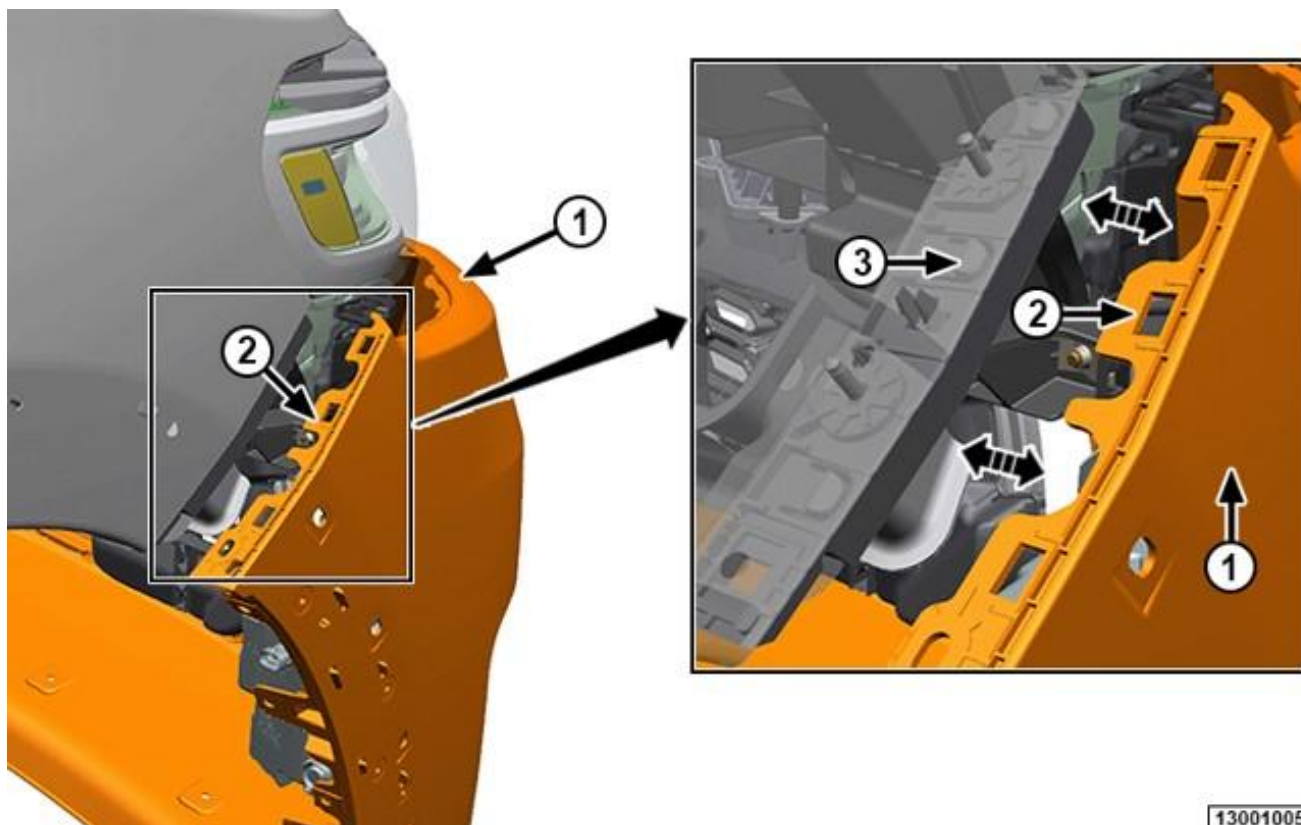
**Figure B13 – Front Fascia Retaining**

19. Disengage the tabs that secure the front fascia to the fenders (Figure B13).
20. Disconnect the front view camera connector (Figure B13).

- 1 - Front Fascia
- 2 - Front Fascia Retaining Slots
- 3 - Retaining Tabs

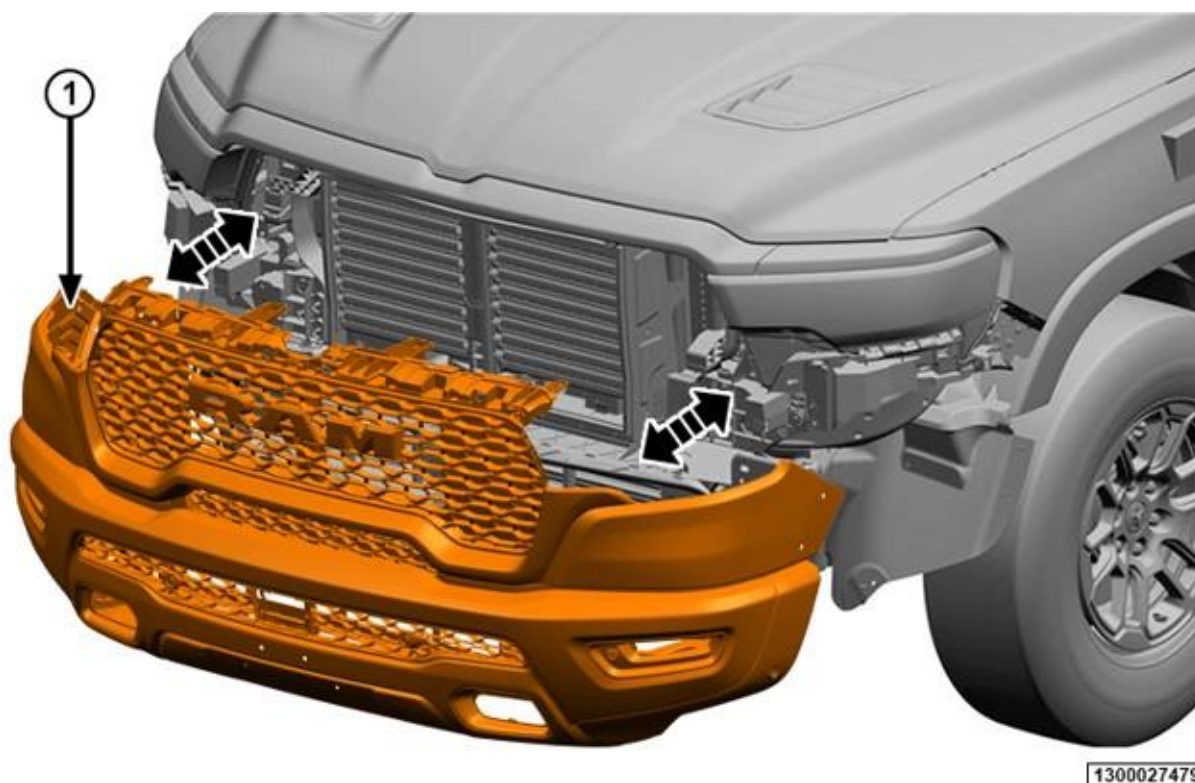
**Figure B14 – Grille and Fascia Assembly**

21. With an assistant, remove the fascia and grille assembly from the vehicle (Figure B14).

1 - Grille and Fascia Assembly

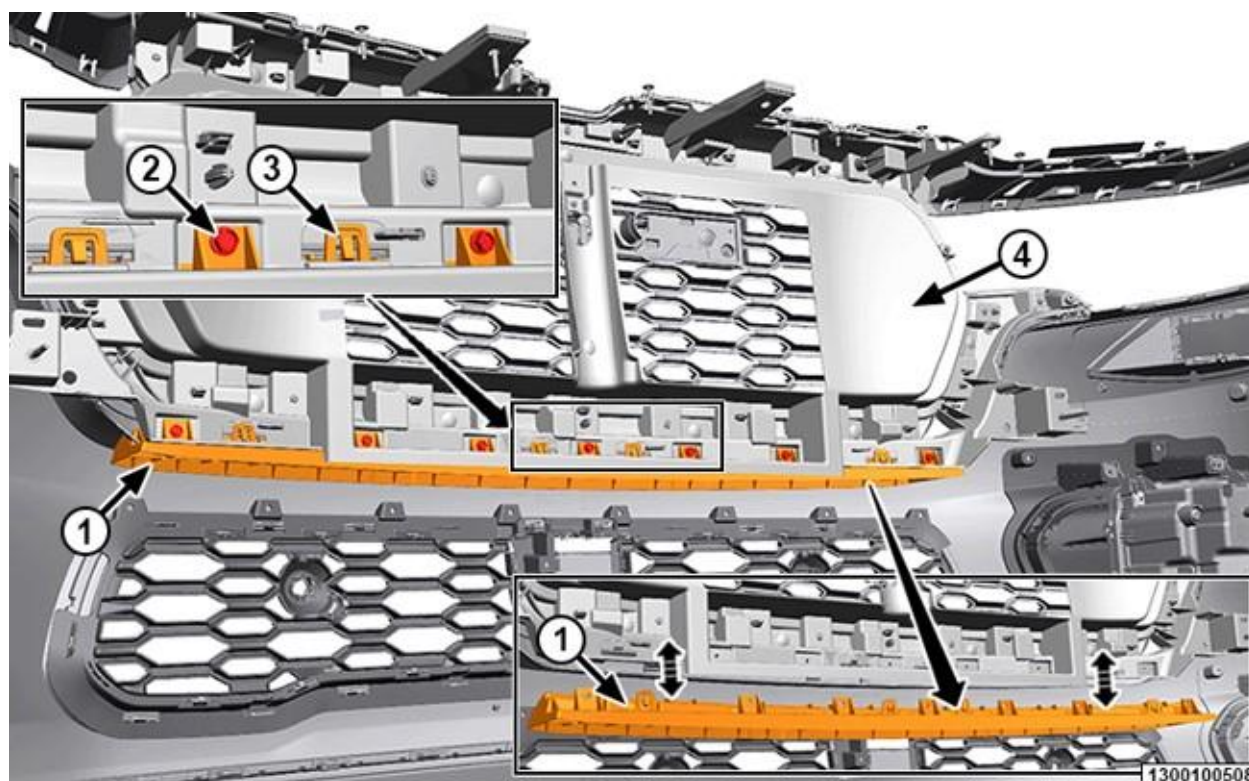
**Figure B15 – Grille to Fascia Attachment**

22. Working from the backside of the grille, remove the fasteners that secure the bracket to the lower side of the grille carrier (Figure B15).
23. Disengage the paddle clips and remove the bracket from the grille carrier (Figure B15).

- 1 - Bracket
- 2 - Fastener
- 3 - Paddle Clips
- 4 - Fascia

26. Reinstall the bracket to the grille carrier and tighten the screws securely (Figure B15).

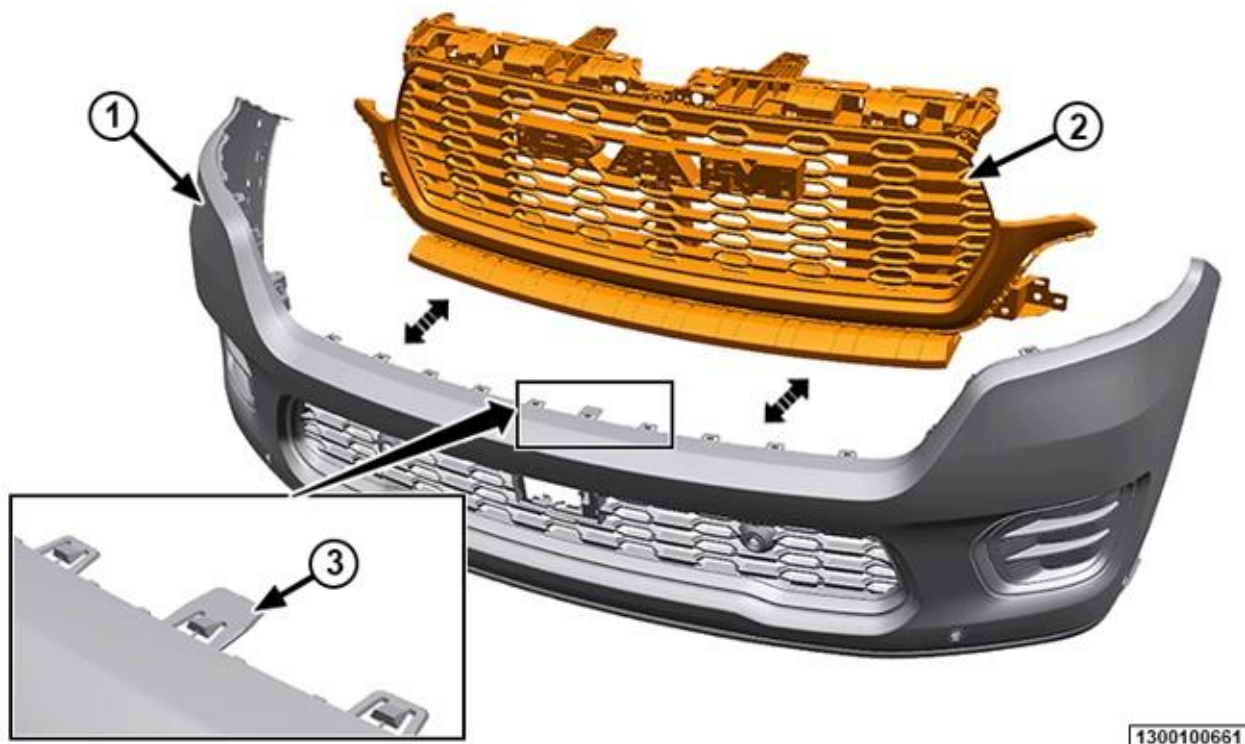
**Figure B16 – Grille to Fascia Attachment**

24. Using a trim stick, reach through the back of the grille and disengage the paddle clips to separate the grille from the fascia (Figure B16).
25. Install the bracket to the lower side of the grille carrier. Install the fasteners to secure the bracket (Figure B16).

- 1 - Front Fascia
- 2 - Grille Assembly
- 3 - Paddle Clips

36. Position the grille to the vehicle (Figure B21).
37. Install **NEW** bolts in positions (1) and reuse the bolt in position (2) on each side of the grill assembly then tighten the bolts to 5 N·m (44 In. Lbs.) (Figure B21).
38. With an assistant, position the fascia to the vehicle (Figure B16).
39. Install the fascia and verify the upper paddle clips are fully engaged to the grille (Figure B16).

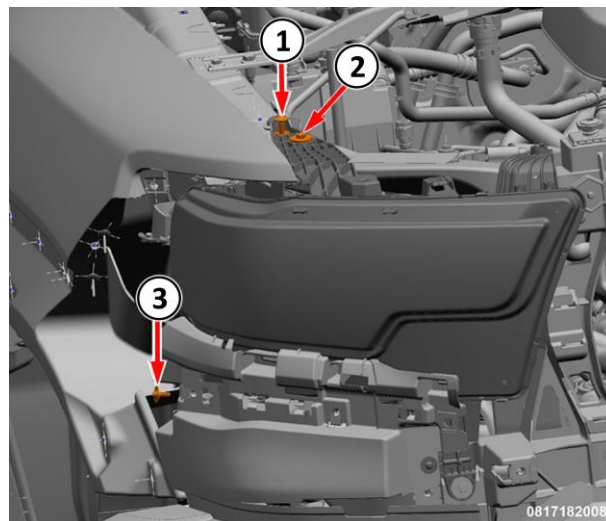
**Figure B17 – Headlamp Assembly**

27. Remove and retain the bolt from position (3) (Figure B17).
28. Remove and **DISCARD** the bolt from position (2) (Figure B17).
29. Remove the push pin fastener from position (1) (Figure B17).

- 1 - Push Pin Fastener
- 2 - Bolt
- 3 - Bolt

33. Connect the wire harness connectors to the **NEW** headlamp (Figure B18).
34. Position the **NEW** headlamp unit to the vehicle and install the push pin fastener in position (1) (Figure B17).
35. Install a **NEW** bolt in position (2) and reuse the bolt in position (3). Tighten the bolts to 6.2 N·m (54 In. Lbs.) (Figure B17).

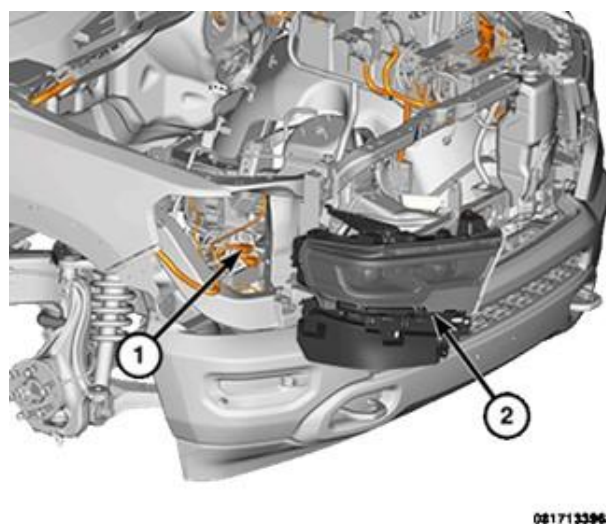
**Figure B18 – Headlamp Assembly**

30. Remove the headlamp unit and disconnect the wire harness connectors (Figure B18).

- 1 - Wire Harness Connectors
- 2 - Headlamp Unit

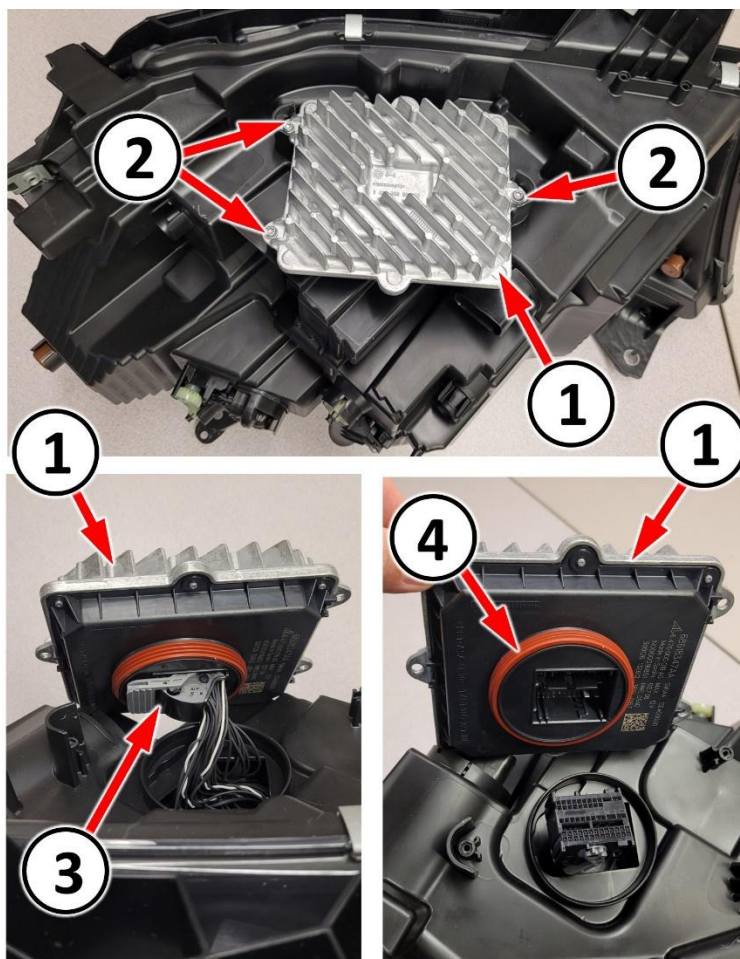
**Figure B19 – Headlamp Module**

31. Transfer the module to the **NEW** headlamp assembly (Figure B19).

- a. Remove the three screws and release the module from the lamp (Figure B19).
- b. Rotate the electrical connector lock to remove the electrical connector (Figure B19).

**CAUTION: Terminals on back side of module are fragile, avoid touching or damaging.**

- c. Transfer the module from the suspect lamp to the **NEW** lamp.
- d. Connect the electrical connector rotating the connector lock into the locked position (Figure B19).
- e. Install the module to the lamp making sure the seal is seated properly not pinched or rolled over (Figure B19).
- f. Install the three screws and tighten securely (Figure B19).

- 1 - Module  
2 - Screws  
3 - Electrical Connector  
4 - Seal

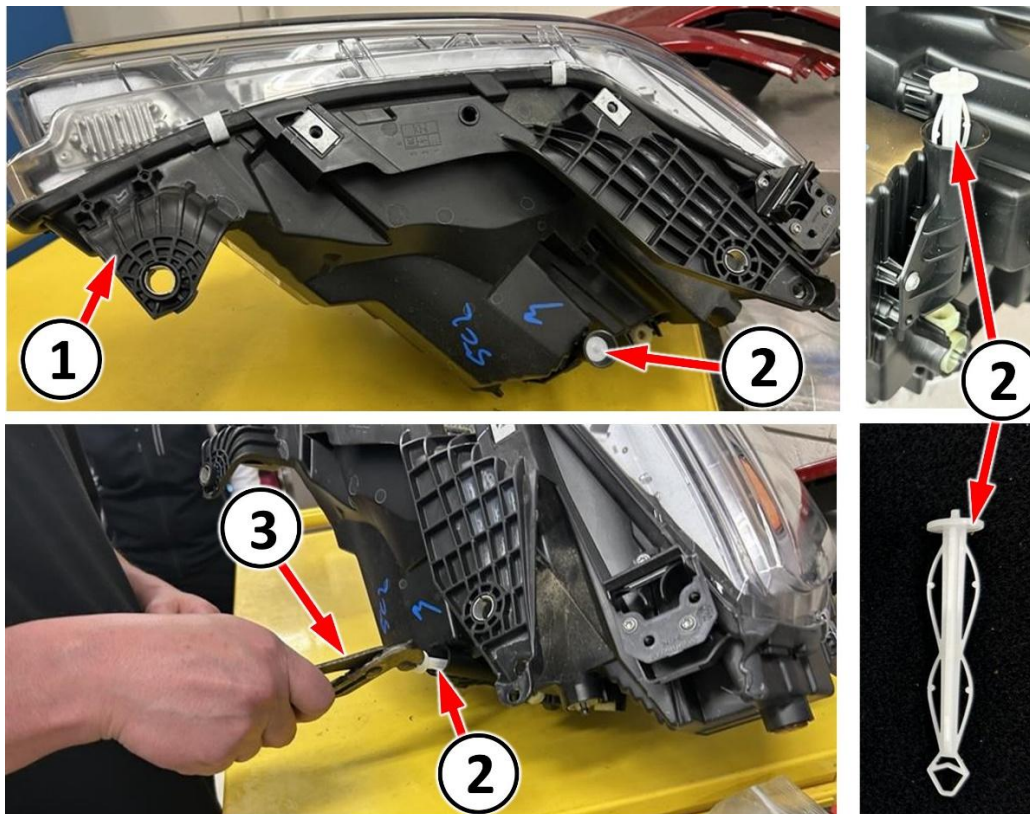
**Figure B20 – Headlamp Alignment Anti-Tamper Plug**

32. Remove the anti-tamper plug from the suspect headlamp and set aside for later installation into the **NEW** headlamp assembly (Figure B20).

- 1 - Headlamp  
2 – Anti-Tamper Plug  
3 - Pliers

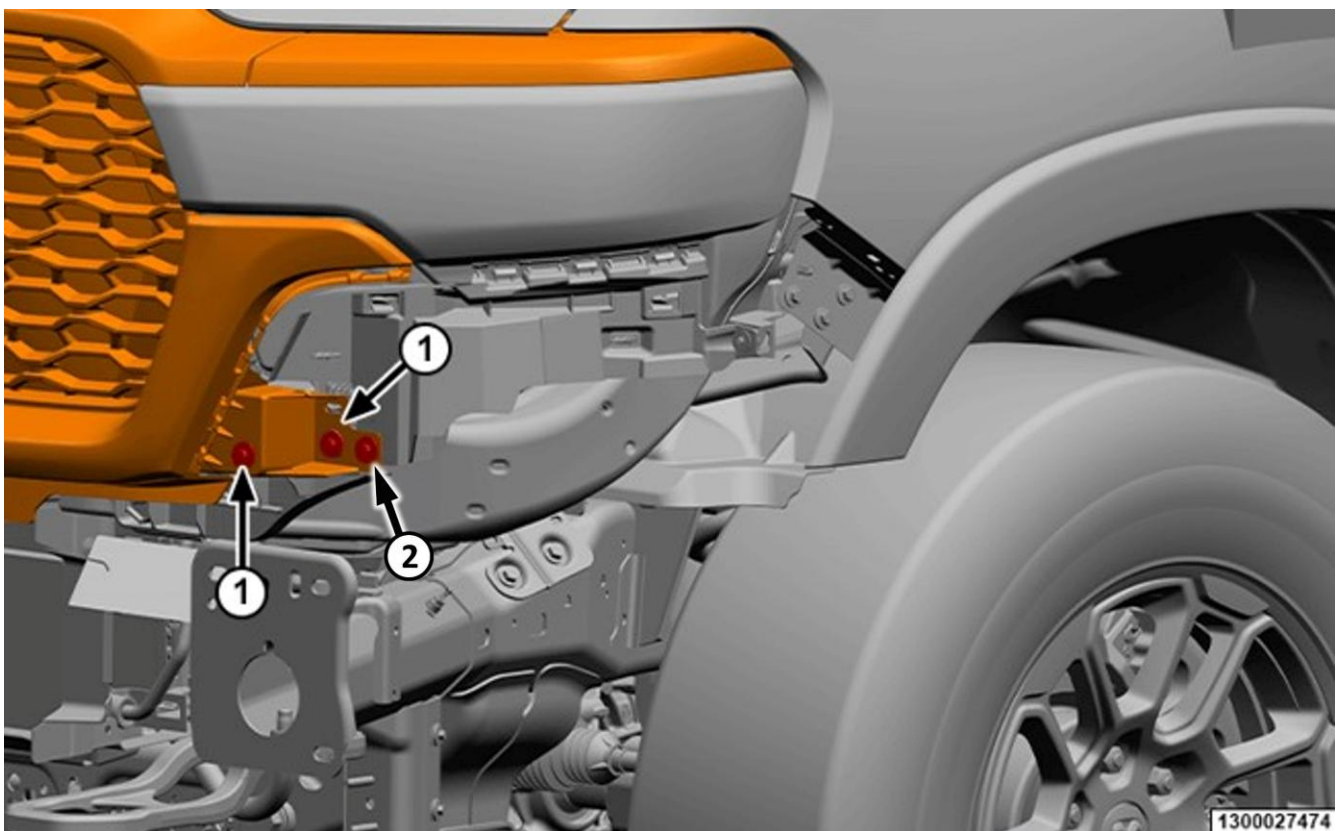
**Figure B21 – Grille Carrier**

- 1 - Bolts (**NEW**)
- 2 - Bolt (Reuse)

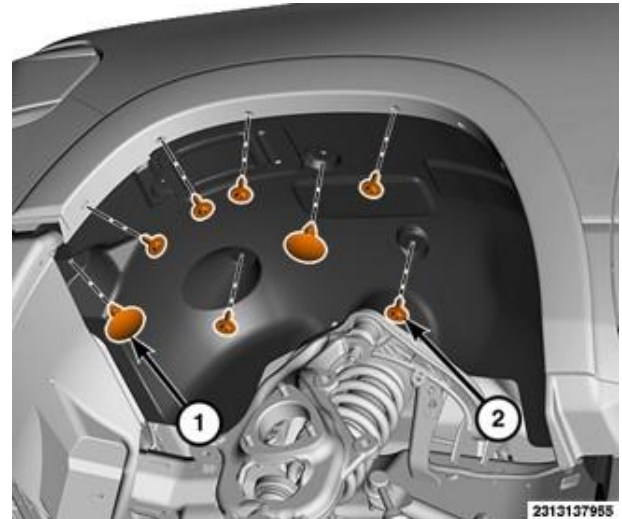
**Figure C1 – Wheelhouse Splash Shield**

3. Remove the screws and push pin fasteners and position aside the wheelhouse splash shields (Figure C1).

1 - Push Pin Fasteners

2 - Screw

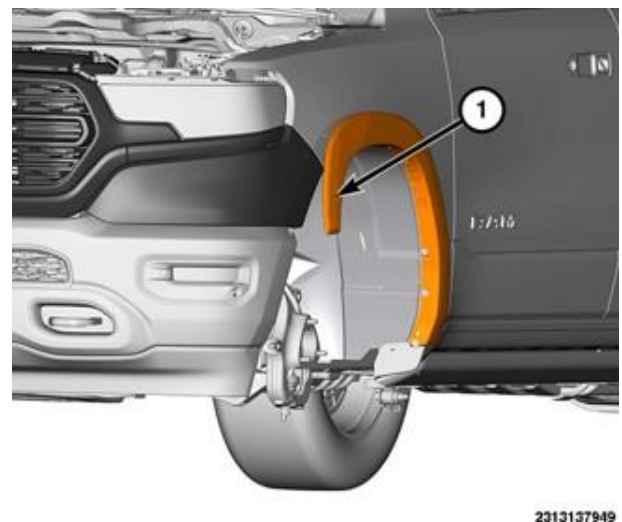
**Figure C2 – Wheel Opening Molding**

4. Release ONLY the front 1/2 of the wheel opening molding on each side of the vehicle (Figure C2).
5. Reach behind the backside of the fender and squeeze the wings of the w-clip together using 8 or 9 mm socket or pliers to release wheel opening molding from fender one clip at time (Figure C2).

1 - Molding

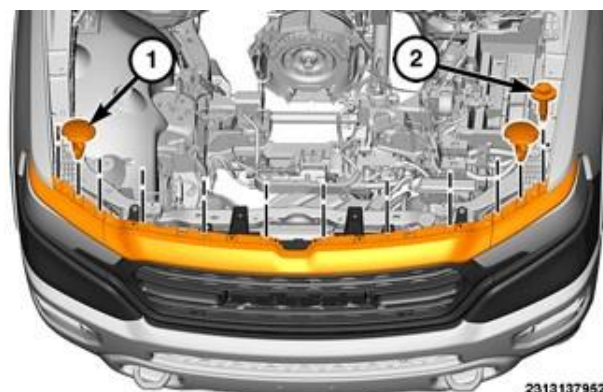
**Figure C3 – Grille Upper Trim**

6. Remove the bolts and push pin fasteners that secure the grille upper trim (Figure C3).

1 - Push Pin Fasteners

2 - Bolts

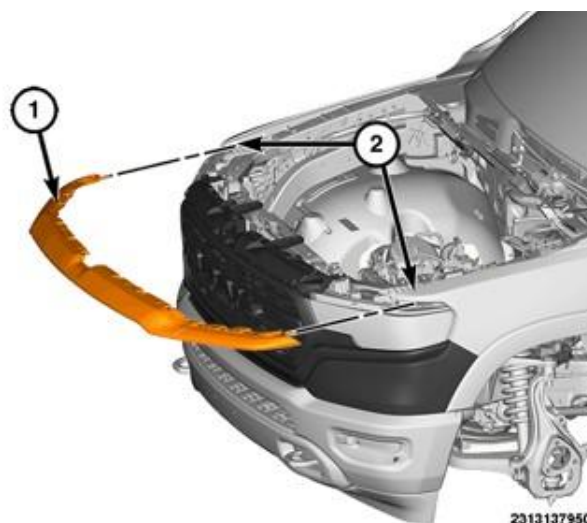
**Figure C4 – Grille Upper Trim**

7. Disengage the grille upper trim and slide it forward to remove it from the vehicle (Figure C4).

1 - Header Assembly

2 - Fenders

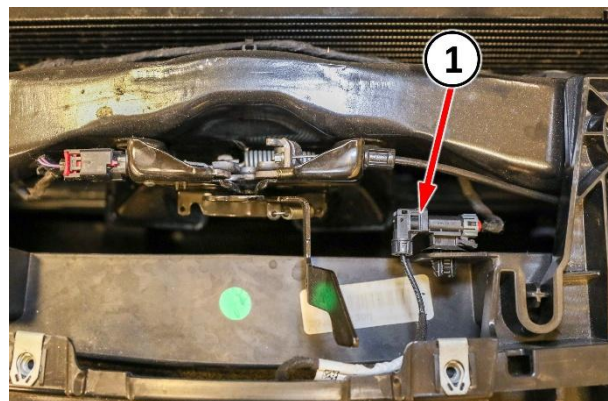
**Figure C5 – Front Camera Connector**

8. If equipped, disconnect the front camera electrical connector located near the hood latch (Figure C5).

1 – Electrical Connector

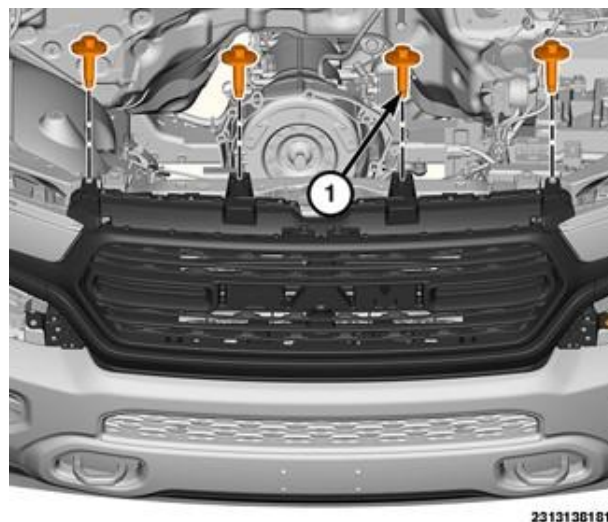
**Figure C6 – Upper Grille Carrier**

9. Remove and **DISCARD** the bolts from the upper grille carrier (Figure C6).
10. Disconnect the front camera wire harness, if equipped.

1 - Bolts

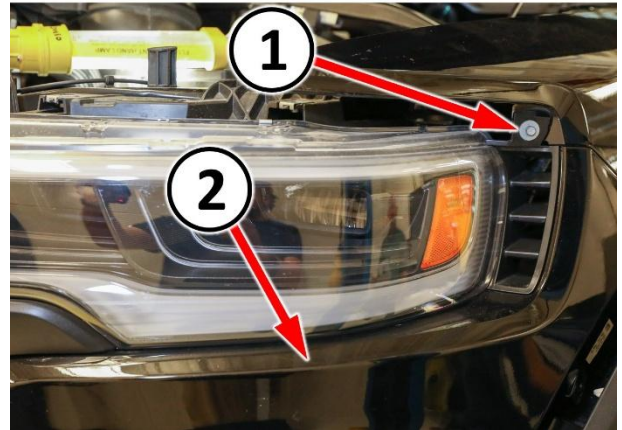
**Figure C7 – Fascia Filler Panel**

11. If applicable such as RHO model. Remove the screw above the air inlet on the fascia filler panel (Figure C7).

1 – Screw

2 - Fascia Filler Panel

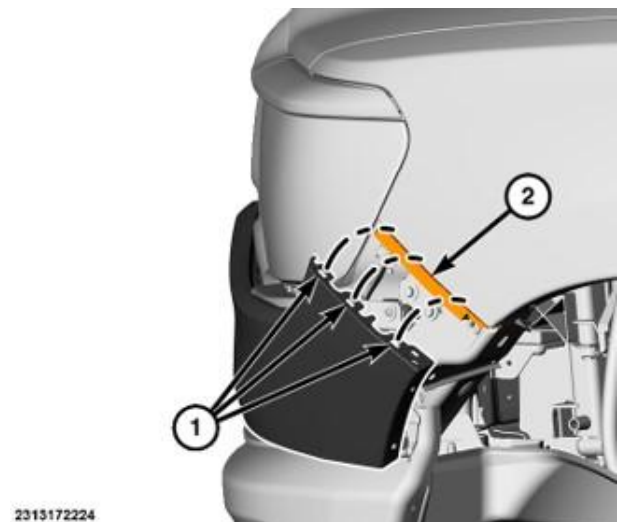
**Figure C8 – Fascia Filler Panel**

12. Using a trim stick or other suitable tool such as picks, gently release the tabs from the support clip and separate the filler panel from the fender (Figure C8).

**CAUTION: Use care when releasing the attachment clips. Damage to the components may result.**

1 - Tabs

2 - Support Clip

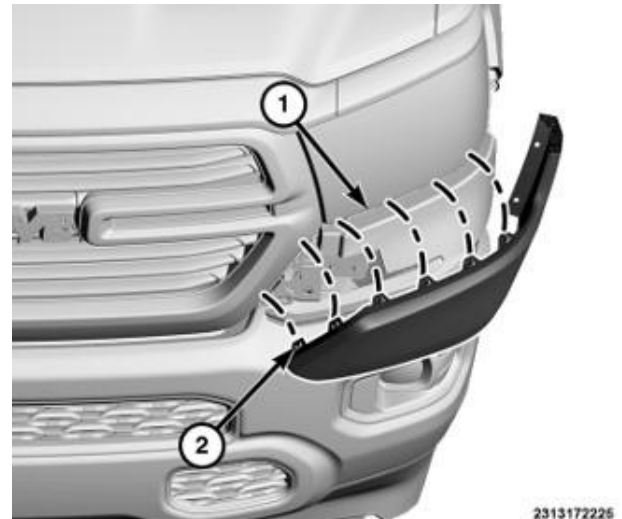
**Figure C9 – Fascia Filler Panel**

13. Starting at the top and using a wiggling motion as well as a trim stick, carefully release the clips from the headlamp support and working toward the grille (Figure C9).

1 - Headlamp Support

2 - Clip

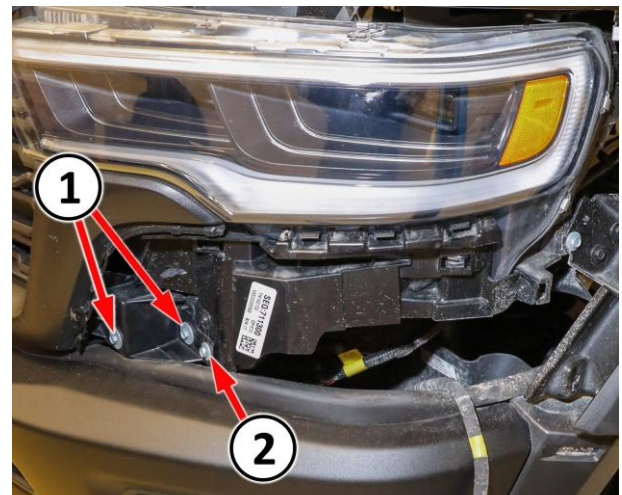
**Figure C10 – Lower Grille Carrier**

14. Remove the lower fasteners from each side of the grille assembly (Figure C10).
- **DISCARD** the bolts removed from positions (1) on each side (Figure C10).
  - Retain the bolts removed from positions (2) on each side (Figure C10).

1 - Bolts

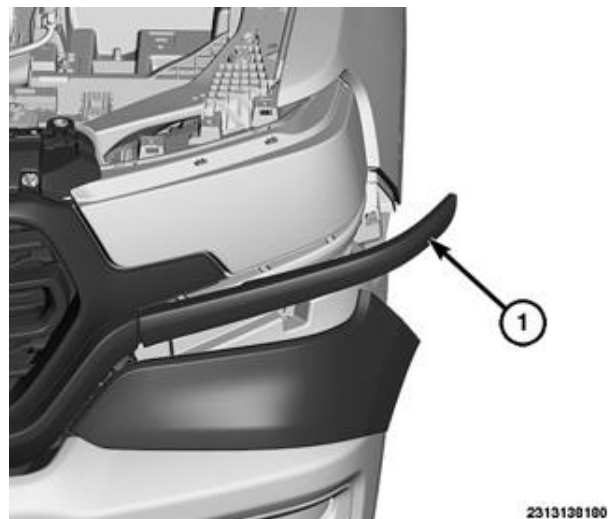
**Figure C11 – Lamp Molding**

15. Release the moldings from the front lamp units, if equipped (Figure C11).

1 - Molding

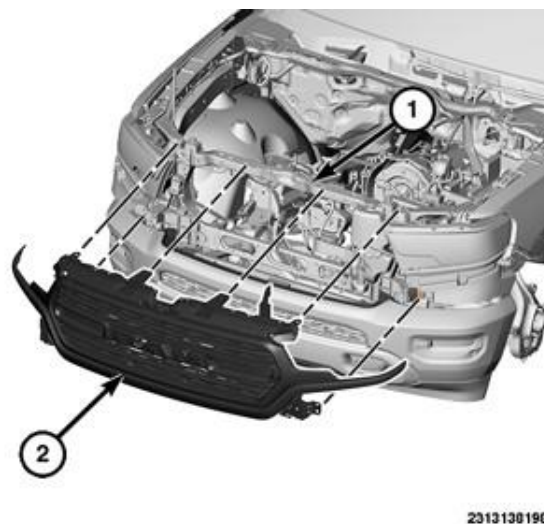
**Figure C12 – Grille Assembly**

16. Remove the grille assembly from the vehicle (Figure C12).

1 - Radiator Support Crossmember

2 - Grille Assembly

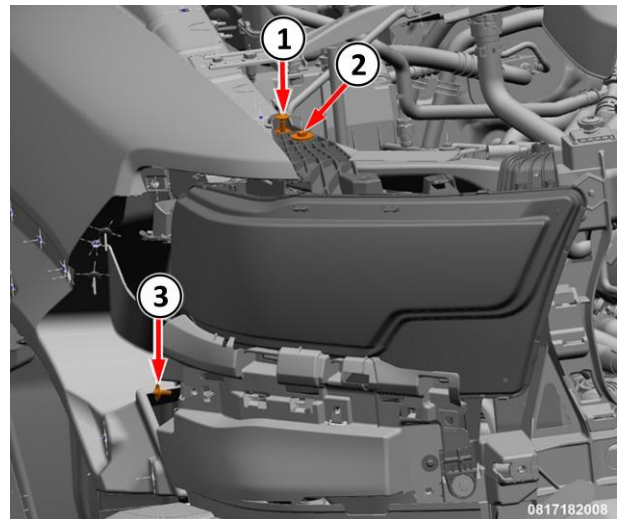
**Figure C13 – Headlamp Assembly**

17. Remove and retain the bolt from position (3) (Figure C13).
18. Remove and **DISCARD** the bolt from position (2) (Figure C13).
19. Remove the push pin fastener from position (1) (Figure C13).

- 1 - Push Pin Fastener
- 2 - Bolt
- 3 - Bolt
