**RAM**

2026 (DT) Ram 1500 Pickup

## SYMPTOM DESCRIPTION

Inspect, and if necessary, replace the headlamp assembly.

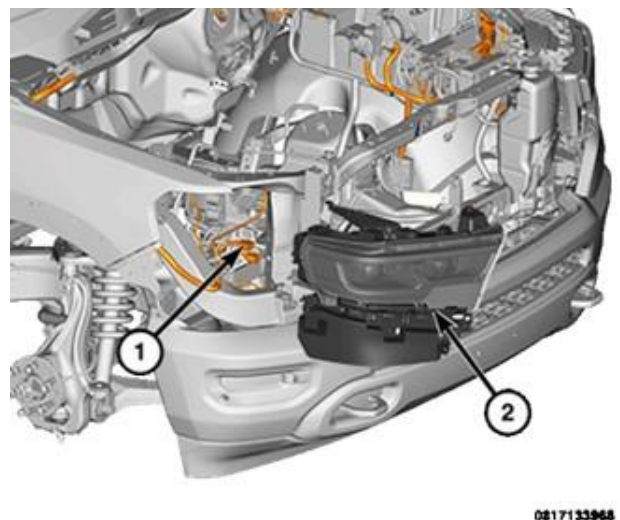
**Figure C14 – Headlamp Assembly**

20. Remove the headlamp unit and disconnect the wire harness connectors (Figure C14).

- 1 - Wire Harness Connectors
- 2 - Headlamp Unit

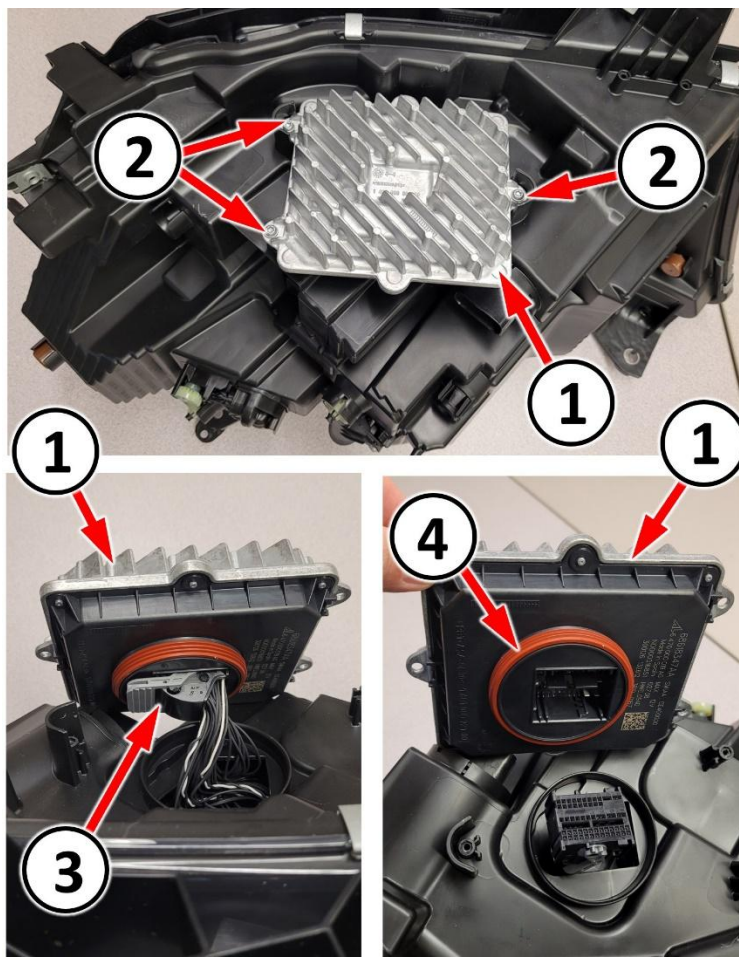
**Figure C15 – Headlamp Module**

**CAUTION: Terminals on back side of module are fragile, avoid touching or damaging.**

- c. Transfer the module from the suspect lamp to the **NEW** lamp.
- d. Connect the electrical connector rotating the connector lock into the locked position (Figure C15).
- e. Install the module to the lamp making sure the seal is seated properly not pinched or rolled over (Figure C15).
- f. Install the three screws and tighten securely (Figure C15).

- 1 - Module  
2 - Screws  
3 - Electrical Connector  
4 - Seal

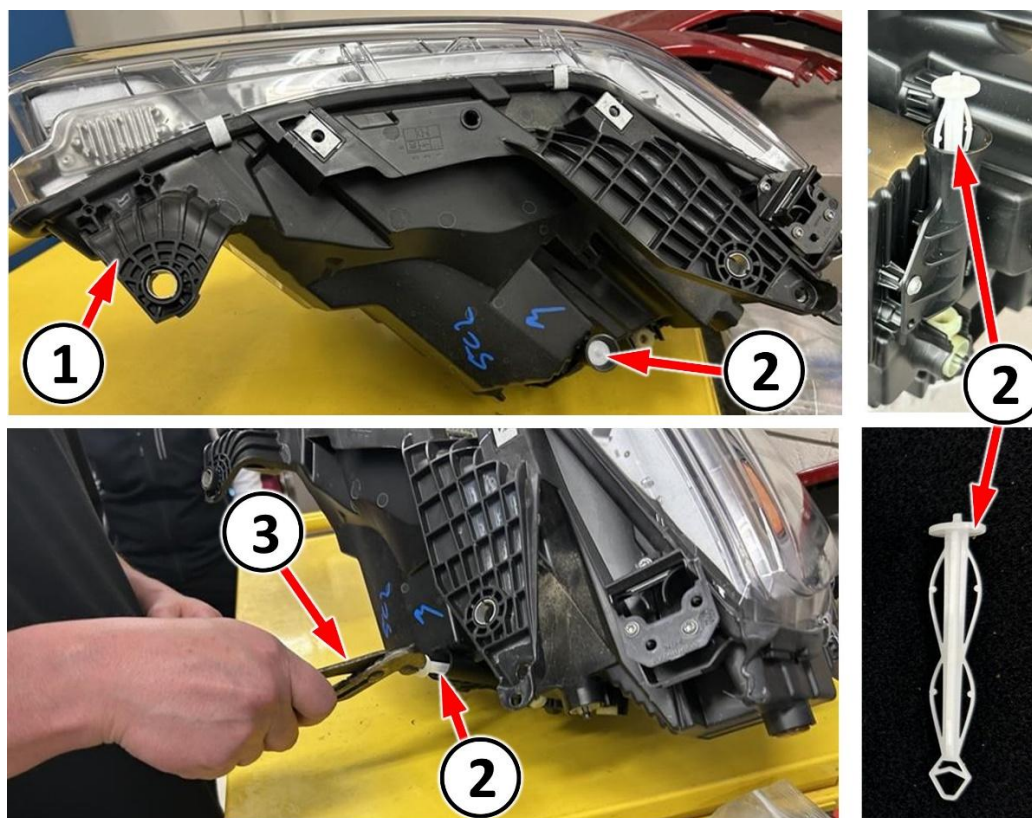
**Figure C16 – Headlamp Alignment Anti-Tamper Plug**

22. Remove the anti-tamper plug from the suspect headlamp and set aside for later installation into the **NEW** headlamp assembly (Figure C16).

- 1 - Headlamp
- 2 – Anti-Tamper Plug
- 3 - Pliers
