## Inverter Bonding Repair

| <b>Bulletin Type:</b> | Recall | <b>Publication Date:</b> | July 2026 |

| <b>Incident:</b> | Inverter was not bonded to the chassis. |

## INVERTER BONDING INSTALLATION INSTRUCTIONS

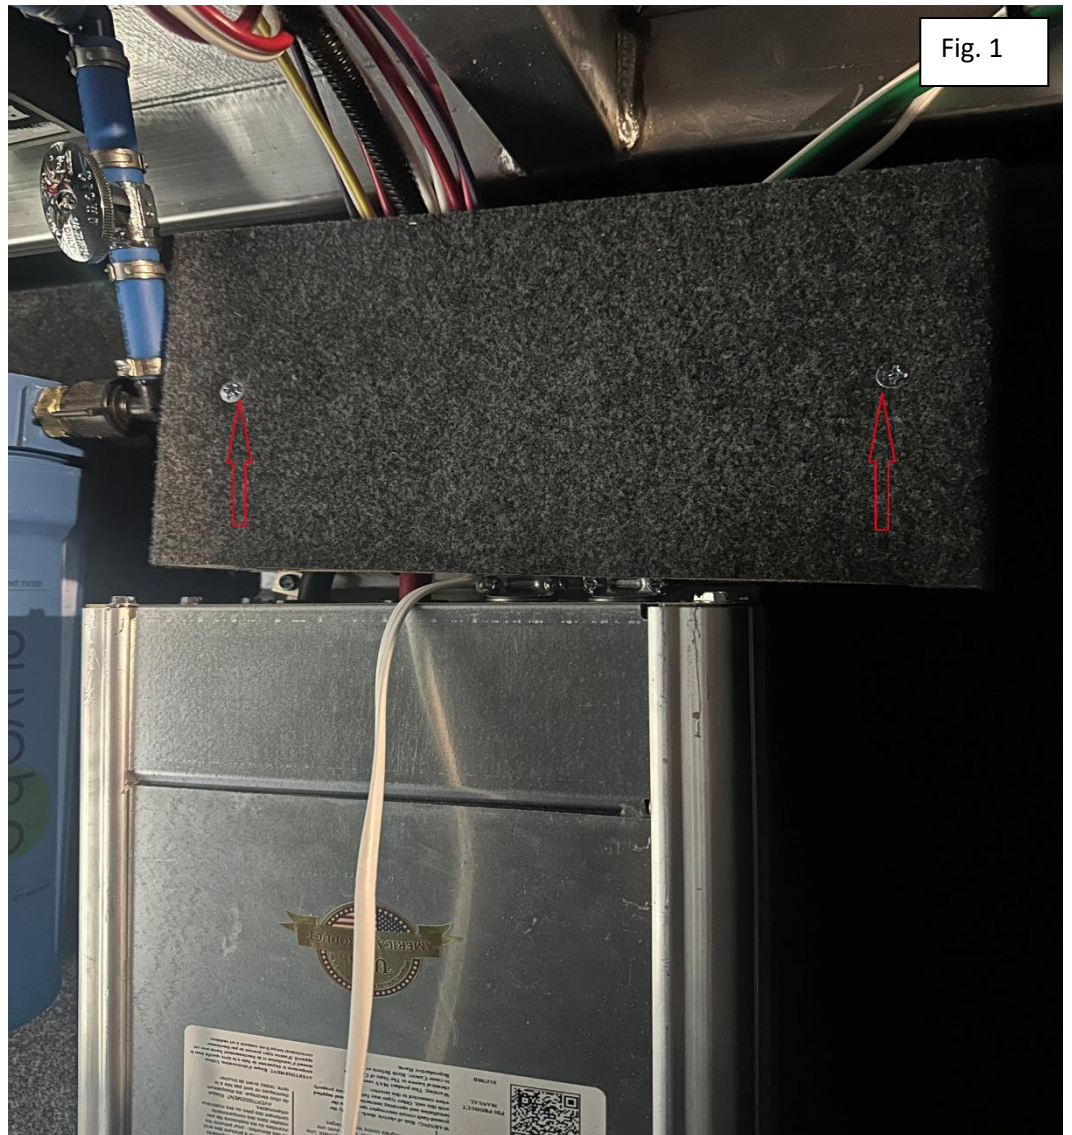
Fig. 1

1. Inverter is located inside of the Off door side of the RV in the second from the front baggage door.
2. Remove felt cover with #2 square headed bit. (Figure 1)

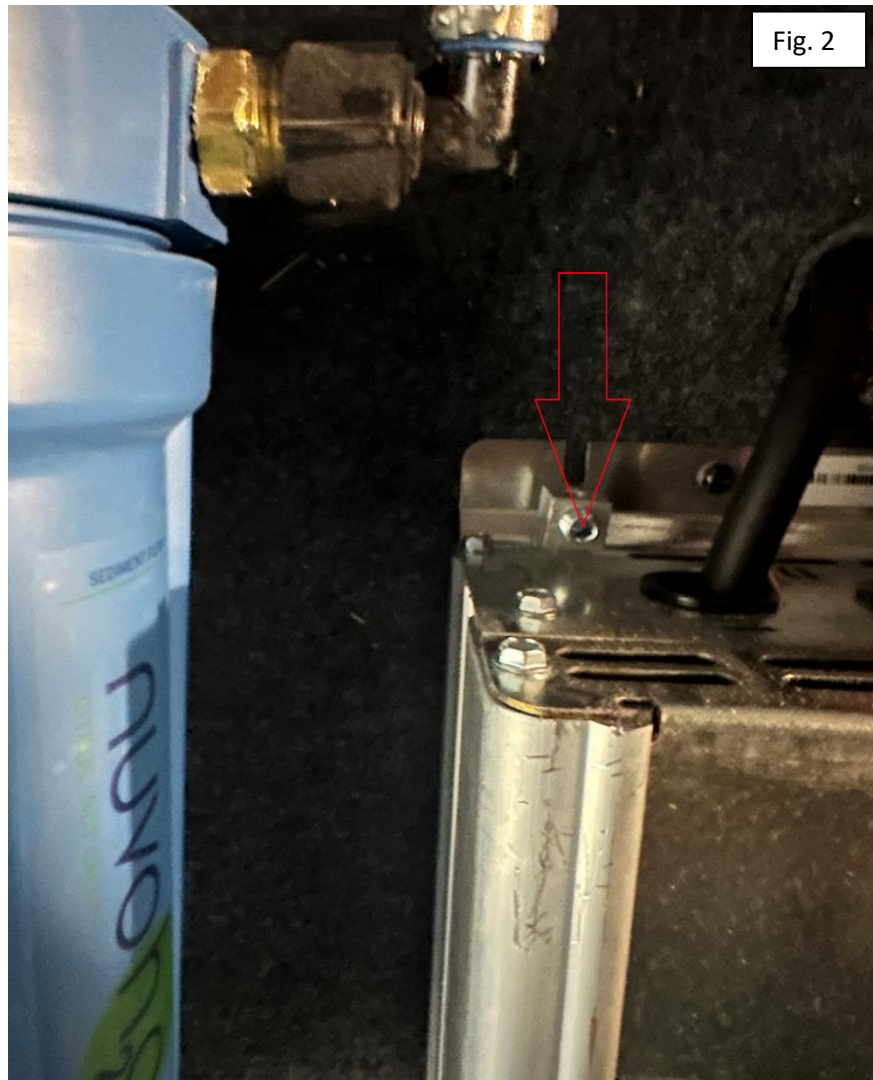
3. Attach Hex washer HD lag to steel framing directly above inverter with star washer on top then ground lug with wire attached to it. (Figure 2)

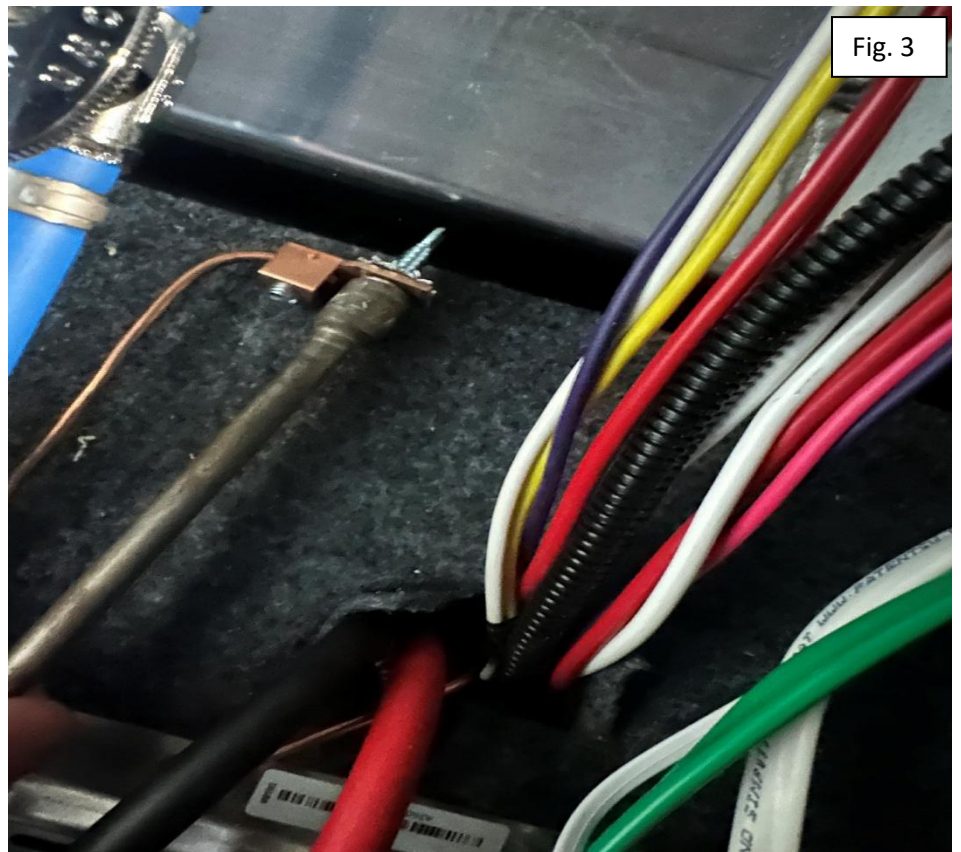
Fig. 3

4. Cut ground wire to desired length and insert into ground port on inverter. Tighten the allen bolt with 5/64 sae allen wrench. (Figures 3 – 4)

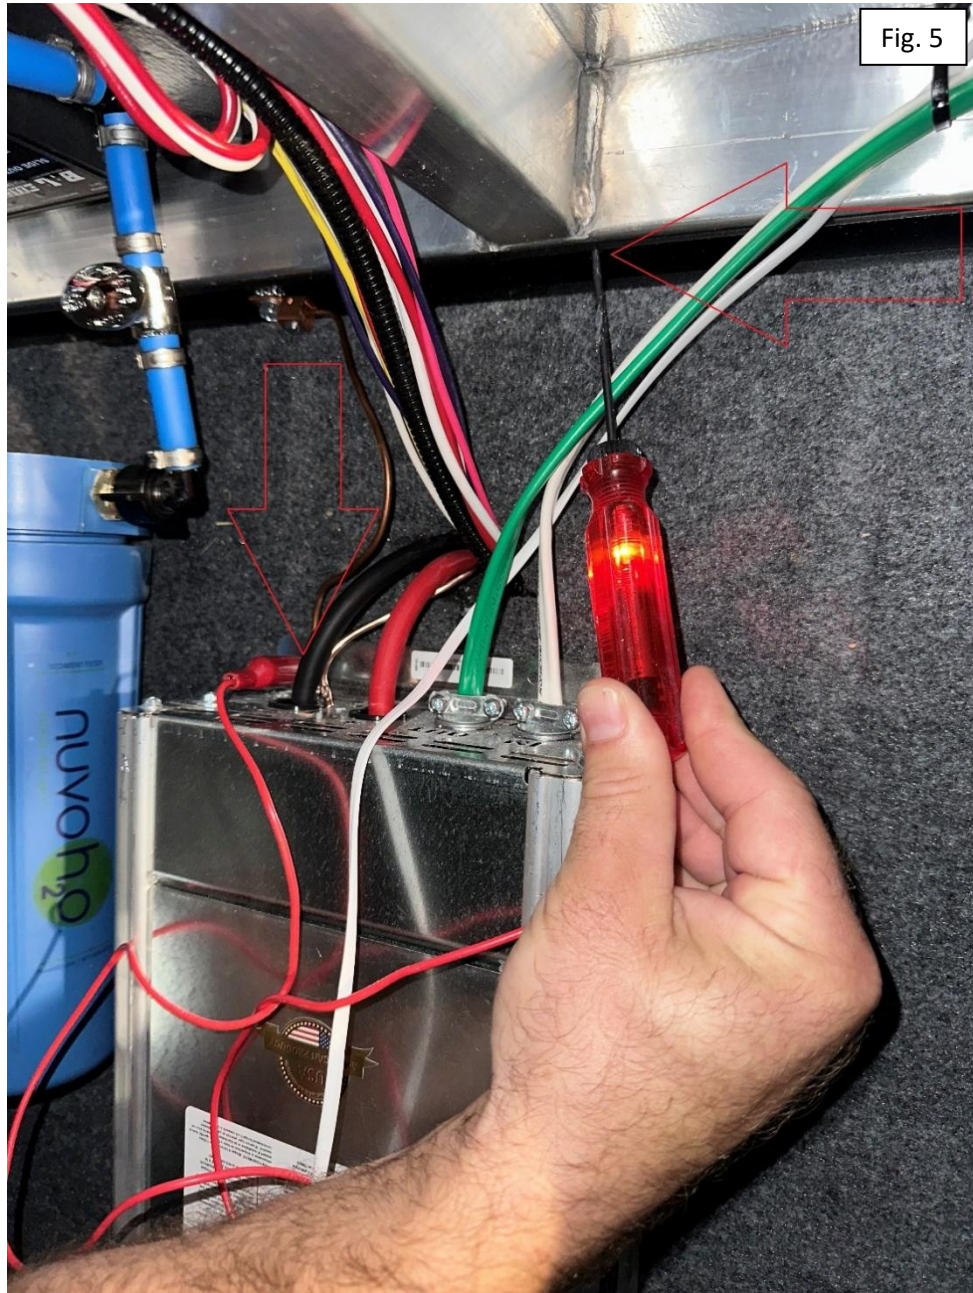
5. Do a continuity test from the ground pot on the inverter to the framing where you attached the wire and lug.
  - a. Move on to next step if test functions correctly.
  - b. Relocate lag screw to make sure lag is in steel framing, not aluminum floor framing if test does not function correctly. (Figure 5)

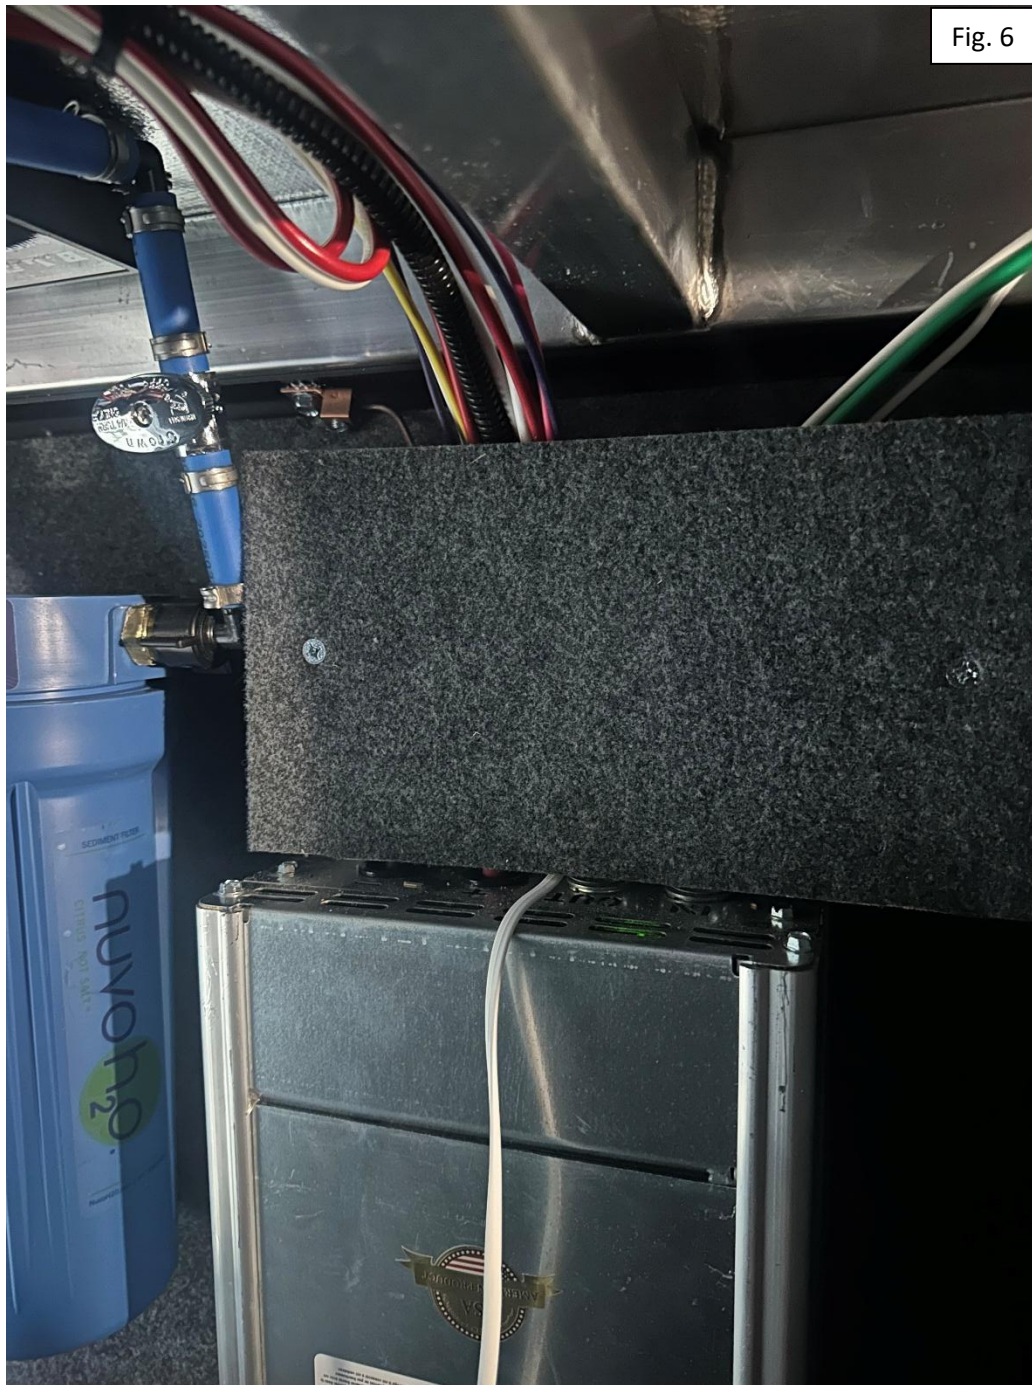
Fig. 6

6. Reinstall felt cover as shown in figure 6.
