| <b>Recall:</b> | 26V-446 NHTSA / 2026-336 TC | <b>Product:</b> | Airxcel MaxxAir Roof Ventilation Fan |

This document accompanies **NHTSA Safety Recall 26V-446/TC safety recall 2026-336**, a companion to Airxcel (RV Products) Equipment Recall 26E-036. The repair procedure for this recall is the attached Airxcel document, “RV Products Recall 26E-036 Inspection and Repair Procedure.” Perform the repair exactly as described in that document. This claim preparation document provides the GDRV-specific claim coding, pre-authorization requirements, and supplementary references for the repair.

## **RV Products Recall 26E-036**

### **Inspection and Repair Procedure**

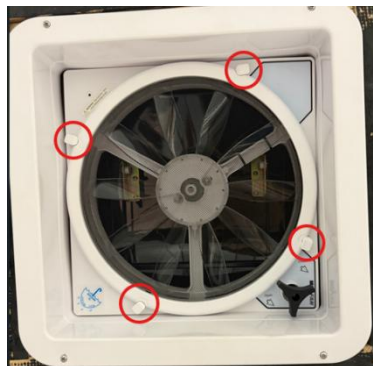
- Record vehicle identification number (VIN)
- Prior to working on any installed fan, make sure that all power is disconnected or the associated breaker is turned off to avoid potential electric shock.
- Additionally, ensure that proper PPE is worn at all times during the process.
- Remove screen on fan by twisting four lock-in tabs:

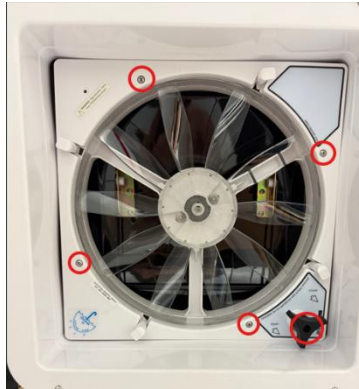
- Remove 4 screws in fan face and 1 in handle:

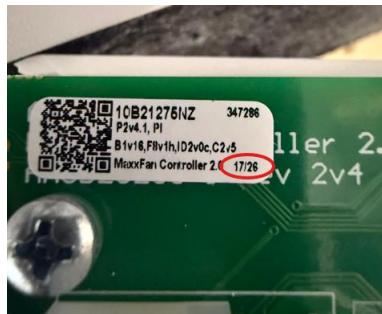
- Remove fan face
- Photograph PC board with date code visible:

- Record the date code from the PCB which is in the location circled in the above image.
- If the date code is outside of the identified recall range or the date code is in range but contains a “QC Pass” sticker:
  - Re-assemble fan following the prior steps in reverse.
  - Place provided “QUAL INSP” sticker in the corner of the fan control plate (placement shown below with green arrow)

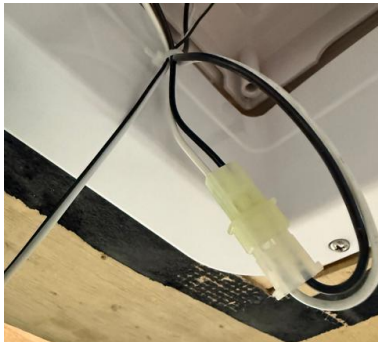
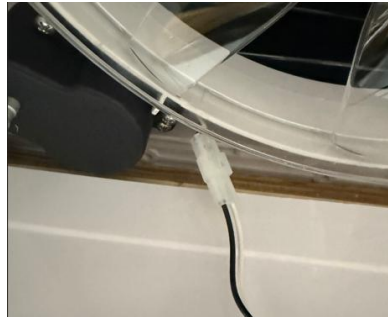
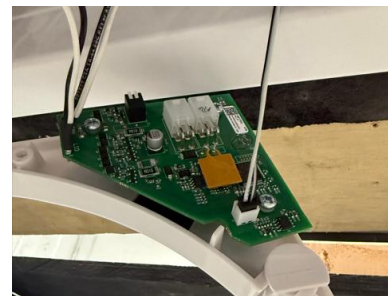
- Disconnect wiring, (3) places

- Carefully cut and remove zip tie on wiring
- Destroy then photograph the destroyed PCB.
- Replace the PCB by securing the new validated PCB to the control panel using the same screws that were removed before.
  - Reattach wires and replace zip tie

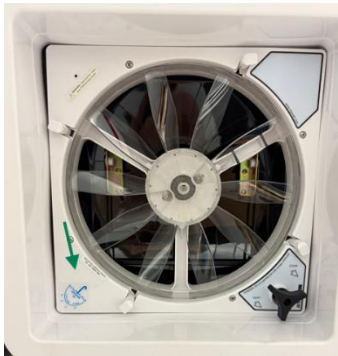
- Re-assemble the fan
  - Place provided “QUAL INSP” sticker to the right of rain the sensor sticker (placement shown below with green arrow)

- Photograph reassembled fan with sticker in place and the serial number label visible and clear enough to read.
- Run a test on the fan to validate connections are made properly.
