| <b>Recall:</b> | 26V-446 NHTSA / 2026-336 TC | <b>Product:</b> | Airxcel MaxxAir Roof Ventilation Fan |

This document accompanies **NHTSA Safety Recall 26V-446/TC safety recall 2026-336**, a companion to Airxcel (RV Products) Equipment Recall 26E-036. The repair procedure for this recall is the attached Airxcel document, “RV Products Recall 26E-036 Inspection and Repair Procedure.” Perform the repair exactly as described in that document. This claim preparation document provides the GDRV-specific claim coding, pre-authorization requirements, and supplementary references for the repair.

## **RV Products Recall 26E-036**

### **Inspection and Repair Procedure**

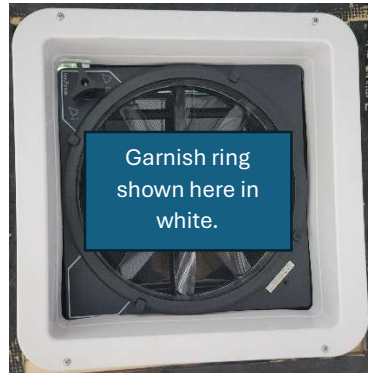
- Remove and lower the control plate. Loosening or removing the garnish ring and disconnecting the network cable from the PCB may be helpful for this step. Use care to avoid damaging the fan assembly.

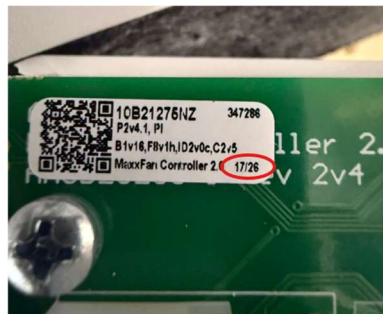
- Identify the date code on the PCB (circled in red below) and determine if the date code is in the affected range.

- All PCB's with a date code of week 51 of 2025 (51/25) through week 25 of 2026 (25/26) and do not feature a "QC Passed" sticker are affected.
  - Examples of QC stickers:

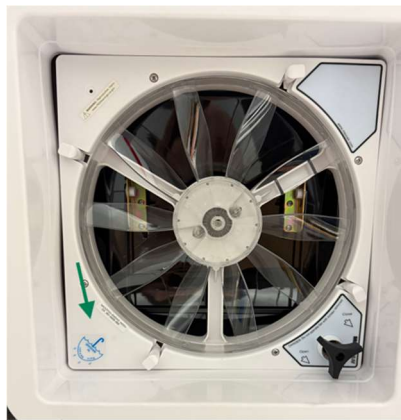
- **If the date code is outside of the identified recall range**, or the date code is in range but features a “QC Passed” sticker:  
sticker:
  - Record the date code from the PCB
  - Photograph the PCB with date code and “QC Passed” visible (if applicable).
  - Re-assemble the fan following the prior steps in reverse. Do not reattach the screen.
  - Place provided “QUAL INSP” sticker in the corner of the fan control plate. Placement shown below with green arrow.

- Photograph the reassembled fan showing the sticker in place and the fan serial number.
  - Reattach the screen.
- **If the PCB date code is within the recall range** and does not feature a “QC Passed” sticker, the PCB must be replaced. Continue to the next section.
