## VOLUNTARY RECALL CAMPAIGN

### VOLUNTARY RECALL CAMPAIGN 2025-2026 QX80; CERTIFICATION LABEL

CAMPAIGN ID #: P6A14  
APPLIED VEHICLES: 2025-2026 QX80 (Z63)

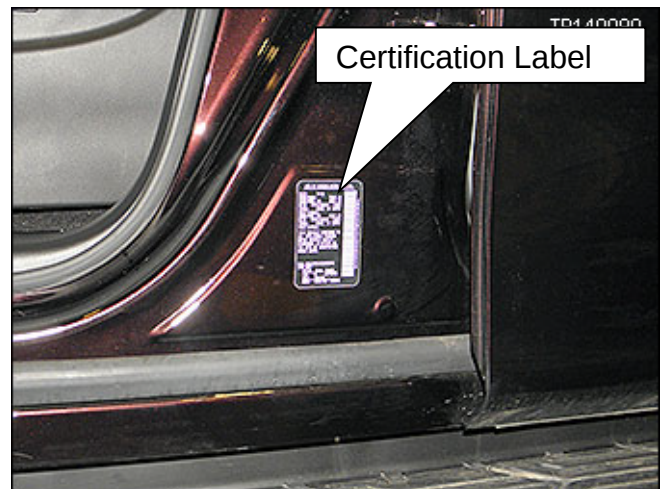
Figure 1

2. Open the driver's door.
  3. Locate the existing certification label (Figure 1).  
**HINT: The certification label has the VIN on it.**
  4. Make sure the VIN on the new certification label matches the VIN on the old certification label (Figure 2 and Figure 3).

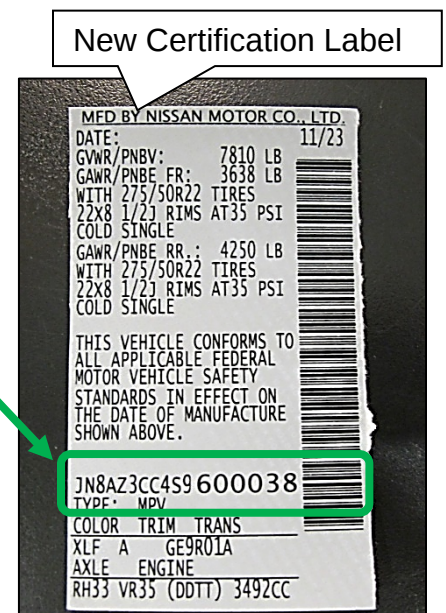
Figure 2

- The VINs MUST MATCH.

**VIN Must Match**

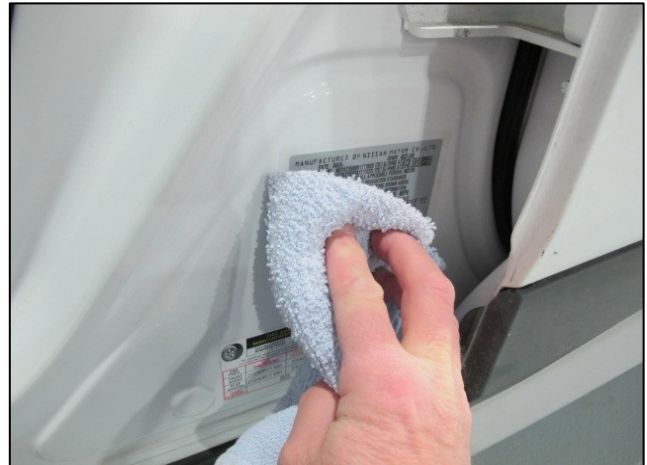
Figure 4

5. Clean the old Certification label and the area around it with a mild detergent and water.

- Care should be taken not to use harsh chemicals that may damage the existing label.
- It is important that the surface be free of dirt and oil to ensure proper adhesion of the new label.

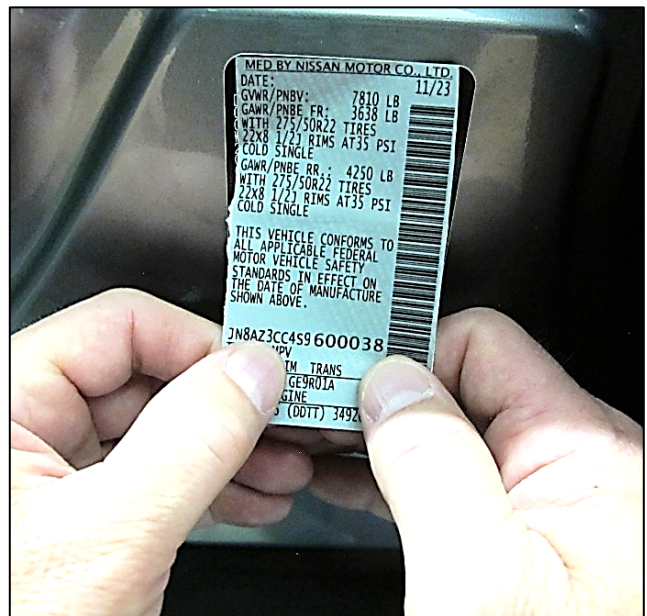
Figure 5

7. Peel the new label from the backing sheet, center it and affix it directly over the top of the existing label.

- The replacement certification label is a different color (Gray) and will be installed over the existing black Certification label. The edges of the black label may be visible.
- The adhesive on the label is permanent. Extra care should be taken when applying the new label since it cannot be moved once it is attached.
