# VOLUNTARY RECALL CAMPAIGN

| BT26-010 | NTB26-042 | July 21, 2026 |

## VOLUNTARY RECALL CAMPAIGN 2025-2026 ARMADA; CERTIFICATION LABEL

CAMPAIGN ID #: P6A13  
APPLIED VEHICLES: 2025-2026 Armada (Y63)

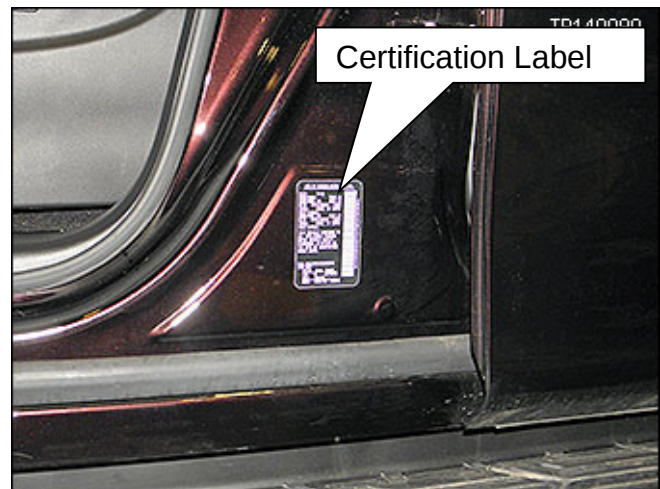
Figure 1

2. Open the driver's door.
  3. Locate the existing certification label (Figure 1).  
**HINT: The certification label has the VIN on it.**
  4. Make sure the VIN on the new certification label matches the VIN on the old certification label (Figure 2 and Figure 3).

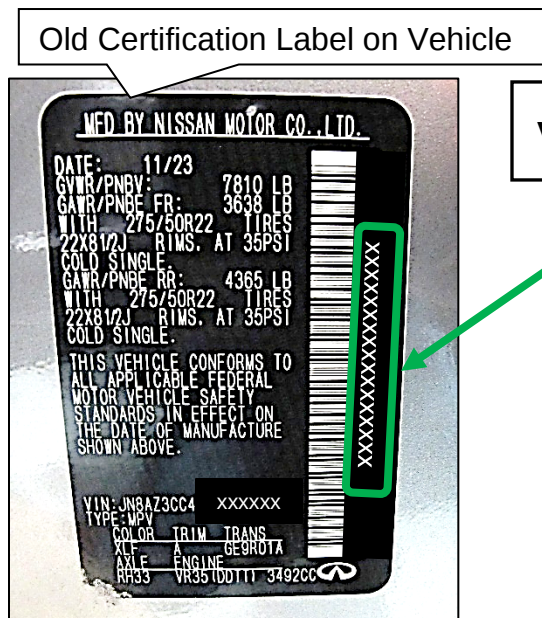
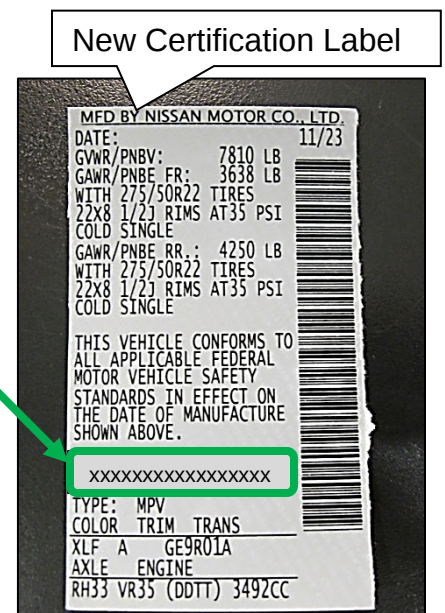
Figure 2

- All Dealer inventory vehicles affected by this campaign will have a NEW Certification Label supplied to the dealer.
  - Each replacement certification label is vehicle specific. Make sure the VIN on the new certification label matches the VIN on the vehicle/old certification label.

**VIN Must Match**

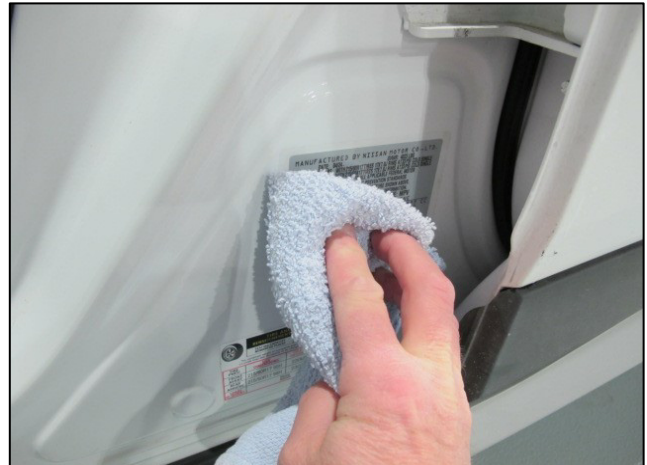
Figure 4

5. Clean the old Certification label and the area around it with a mild detergent and water.

- Care should be taken not to use harsh chemicals that may damage the existing label.
- It is important that the surface be free of dirt and oil to ensure proper adhesion of the new label.
