## RECALL 26V477 / 2026-360 REMEDY INSTRUCTIONS

## **RV Products Recall 26E-036**

### **Inspection and Repair Procedure**

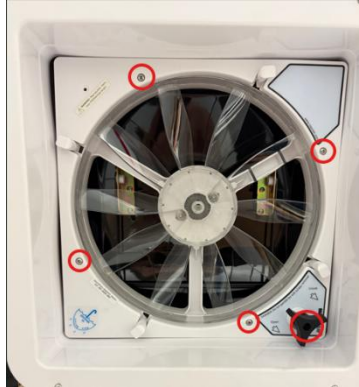
- Remove 4 screws in fan face and 1 in handle:

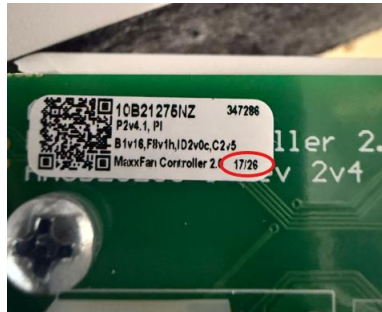
- Remove fan face
- Photograph PC board with date code visible:

- Record the date code from the PCB which is in the location circled in the above image.
- If the date code is outside of the identified recall range or the date code is in range but contains a “QC Pass” sticker:
  - Re-assemble fan following the prior steps in reverse.
  - Place provided “QUAL INSP” sticker in the corner of the fan control plate (placement shown below with green arrow)

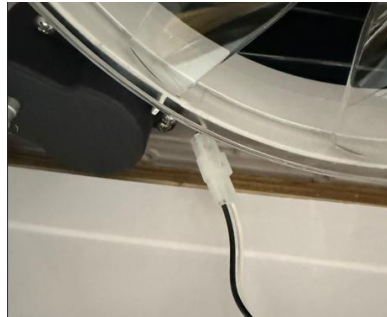
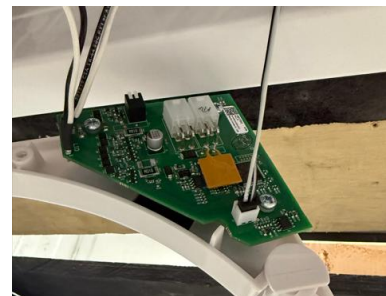
- Disconnect wiring, (3) places

- Carefully cut and remove zip tie on wiring
- Destroy then photograph the destroyed PCB.
- Replace the PCB by securing the new validated PCB to the control panel using the same screws that were removed before.
  - Reattach wires and replace zip tie
