## Work Instructions – HVAC Relay & Fuse Block Revision

NHTSA Recall 26V-652  
Author: E-ONE Engineering  
Date: October 12, 2026

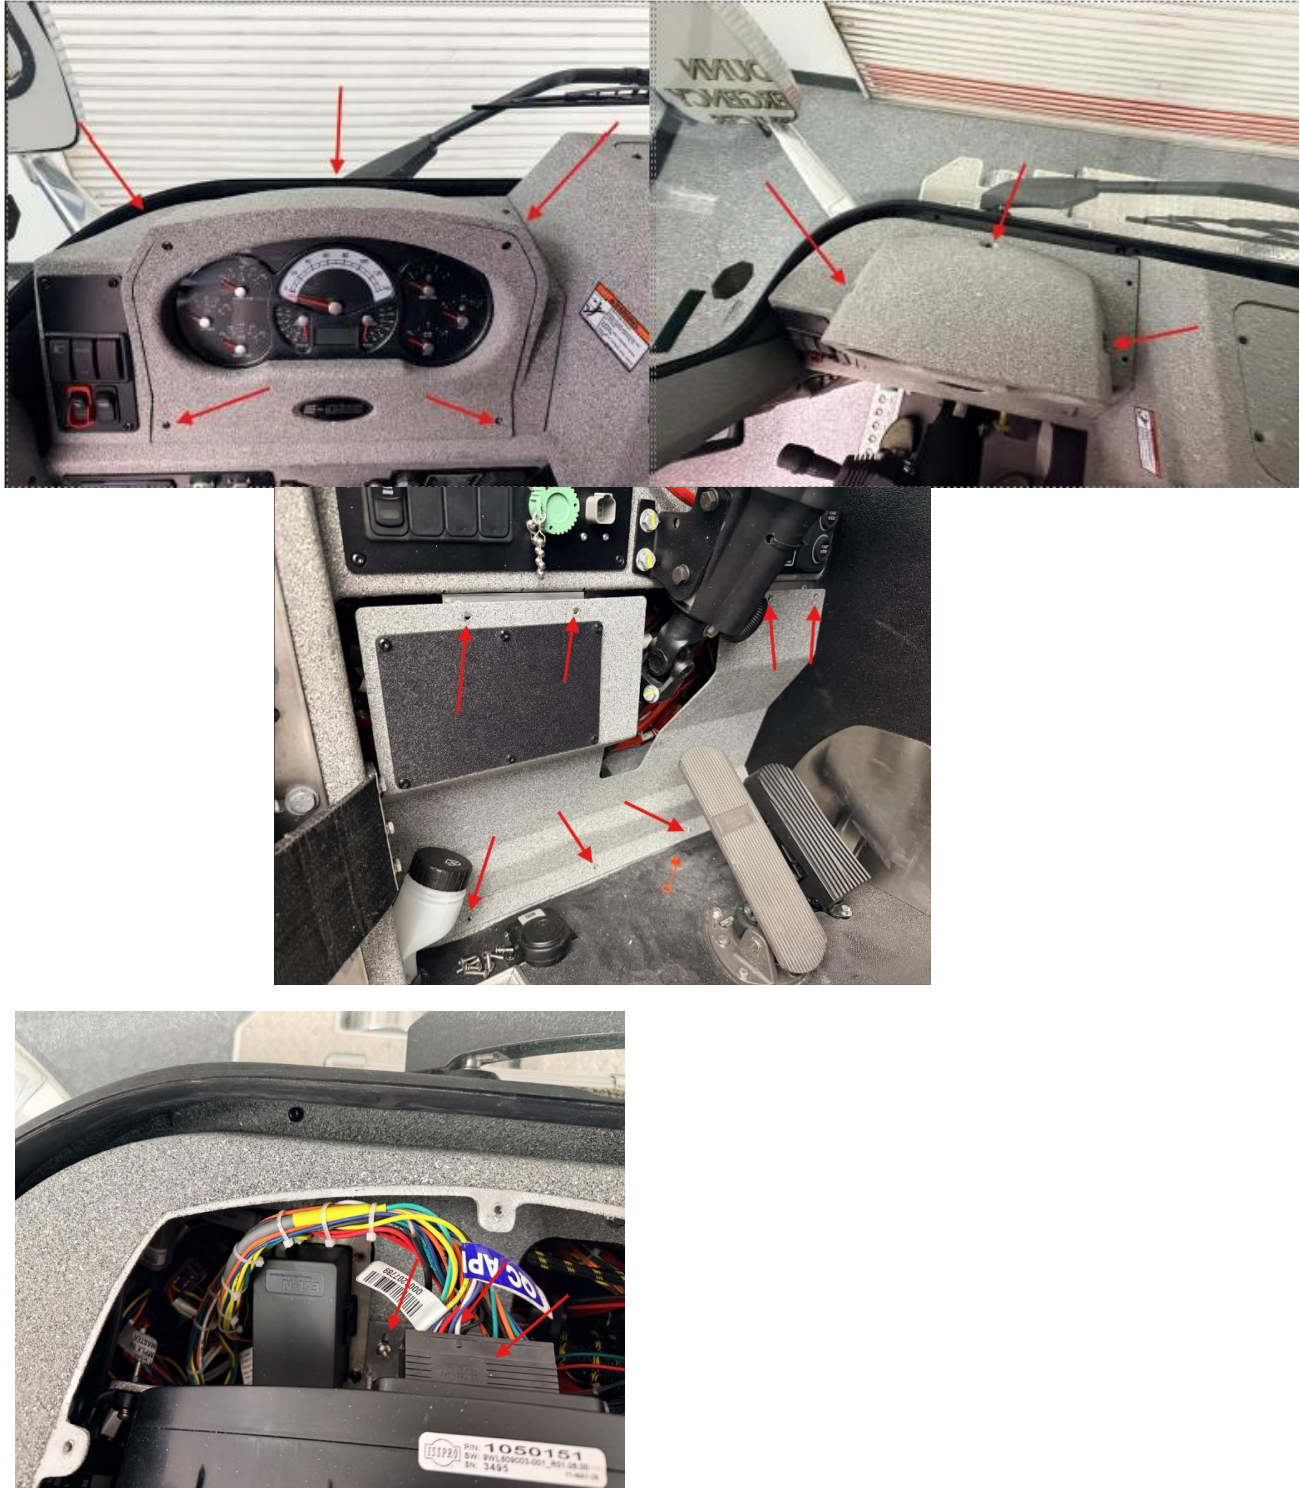
Remove the gauge cluster as shown to gain access to the existing Bussmann fuse block.

- Support and protect the gauge cluster and associated wiring throughout the repair process.
- **Do not allow the gauge cluster to hang unsupported by its wiring harnesses or connectors.**

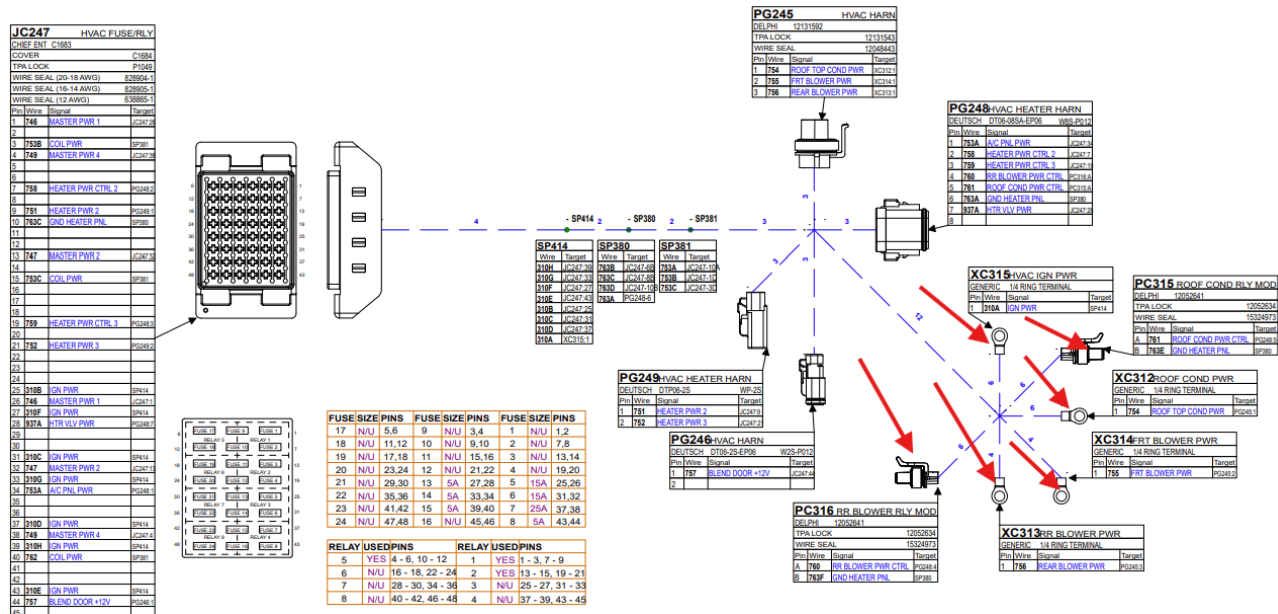
### Step 4 - Remove Existing Bussmann Fuse Block

Disconnect and remove the existing Bussmann fuse block and the cable connecting the fuse block to the ignition solenoid.

Install the replacement HVAC harness in accordance with the applicable harness print and connector identification documentation. The replacement harness incorporates six new connections associated with the updated relay configuration.

Before making each connection:

1. Identify the connector and terminal designation.
2. Locate the corresponding connection on the applicable harness print.
3. Verify the physical connection location against the engineering documentation.
4. Complete the connection only after all identification and location requirements have been verified

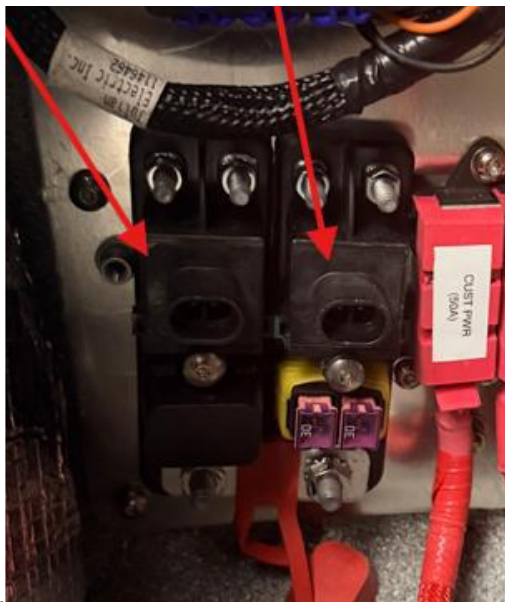
### Step 5 - Install Power Relay Fuse Modules

Install two Power Relay Fuse Modules (P/N 1121588) in the driver-side kick plate area as shown in the applicable engineering documentation.

Prior to installation, verify that four 30-amp fuses (P/N 1110116) are installed in the specified fuse positions.

- Two P/N 1121588 fuse modules were installed.
- Four required fuses installed.
- Fuse ratings verified at 30 amps.
- Modules securely mounted.
- Wiring properly routed and supported.
- No pinching, chafing, rubbing, or interference present.

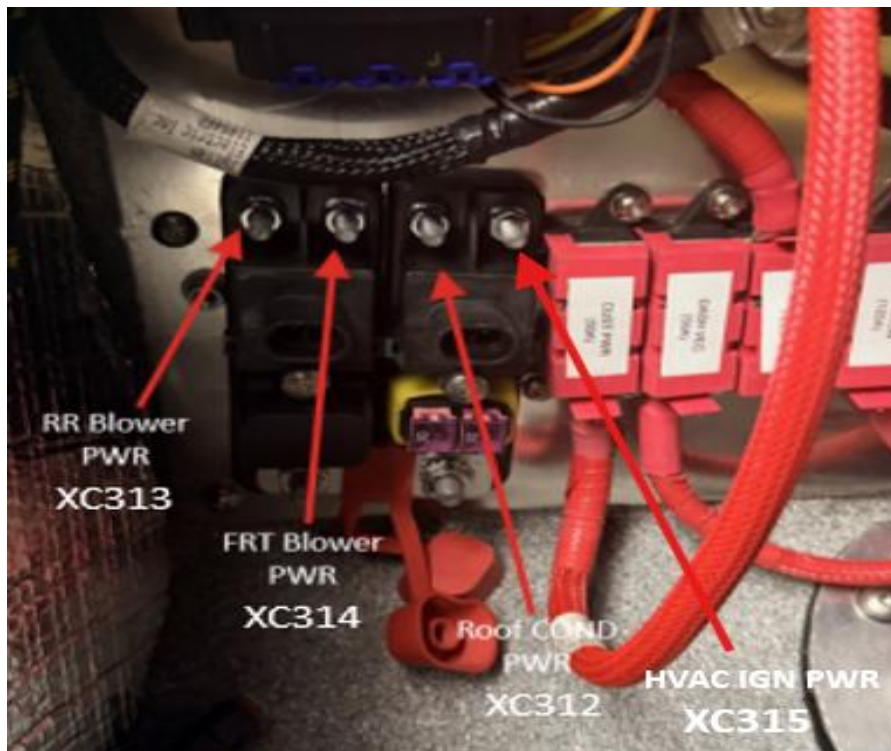
### Step 6 - Connect XC312, XC313, XC314, and XC315

Install eyelet terminals:

- XC312
- XC313
- XC314
- XC315

onto the studs specified in the applicable harness print.

1. Verify connector identification.
2. Verify the designated stud location on the harness print.
3. Confirm both references match.
4. Install the eyelet terminal. Verify the eyelet is fully seated and securely fastened.

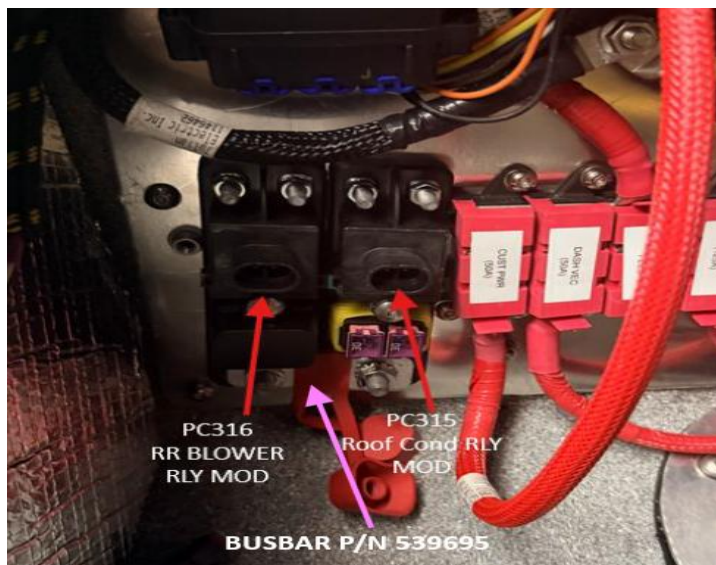
### Step 7 - Connect PC315 and PC316

Connect PC315 and PC316 to the locations identified in the connector documentation and applicable harness print.

- Installed in the correct location.
- Fully engaged.
- Positively retained.
- Properly routed without interference.

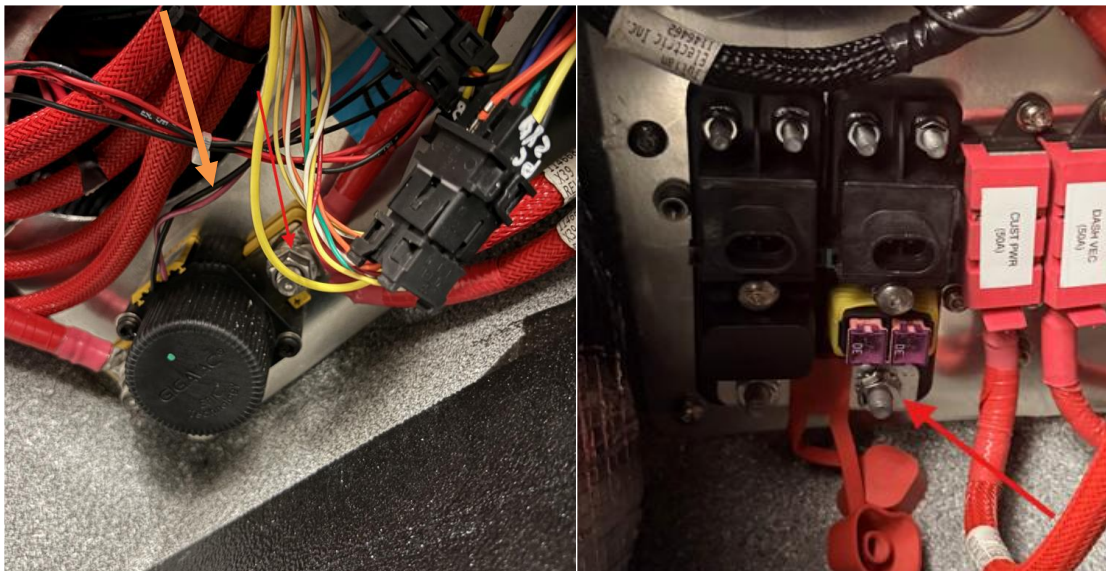
### Step 9 - Install Power Cable

Install the supplied red power cable (P/N 1166364) between the ignition solenoid and the Power Relay Fuse Module in accordance with the applicable engineering documentation.

Connections installed on the M6 output studs of the Power Relay Module (P/N 1121588) shall be torqued to a maximum of **48 in-lb (5.4 N·m)** and M8 input studs of the Power Relay Module (P/N 1121588) shall be torqued to a maximum of **144 in-lb (16.3 N·m)**.

- Correct connection points.
- Proper cable routing.
- Adequate clearance from surrounding components.
- No pinching, chafing, rubbing, or interference.
- Cable is properly secured.
