NHTSA Recall Number: 26V-032 School Bus  
NHTSA Recall Number: 26V-033 Non-School Bus

**SUBJECT:** R26AA: Improper Window Markings on Lippert Windows

This document refers to the procedure for adding etched identification to a glass window.

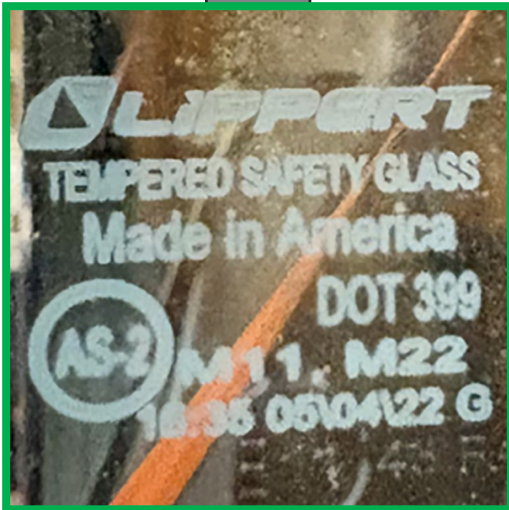
Fig. 1

- Visually inspect the upper and lower glass of each bus window. Look for the DOT logo.
  - Sash Window - Correct (Fig. 1)
  - Sash Window - Incorrect (Fig. 2)
- Note each window where the DOT logo is not compliant (Fig. 2).
  - Driver's Window - Correct (Fig. 3)
  - Driver's Window - Incorrect (Fig. 4)

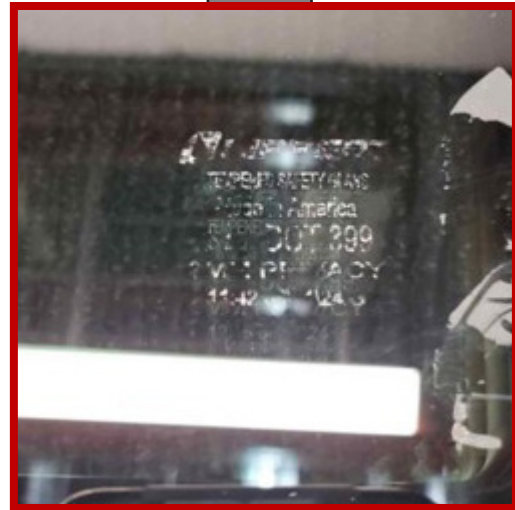
Fig. 2

It has been determined certain Blue Bird Vision and All American School and Non-School Buses with Lippert windows may not have a DOT marking on the window. The DOT marking on the window may be partially illegible or not legible at all. This is a FMVSS 205, Glazing Materials Non-compliance. Under certain conditions if the designator is illegible, safety personnel may not know the type of glass leading to an increased risk of personal injury, reduced visibility, and increase the risk of a crash.

2. Apply stencil (Fig. 6) directly above the DOT marking on the glass.
3. Remove the backing of the stencil and affix to the window using the bottom corner and right side of the frame as reference points (Fig. 6).
