## Safety Recall: 2024 Integra Driver's Seat Lift Link Bolt Loose

Year	Model	Trim Level	VIN Range
2024	Integra	A-Spec	Check iN VIN status for eligibility.

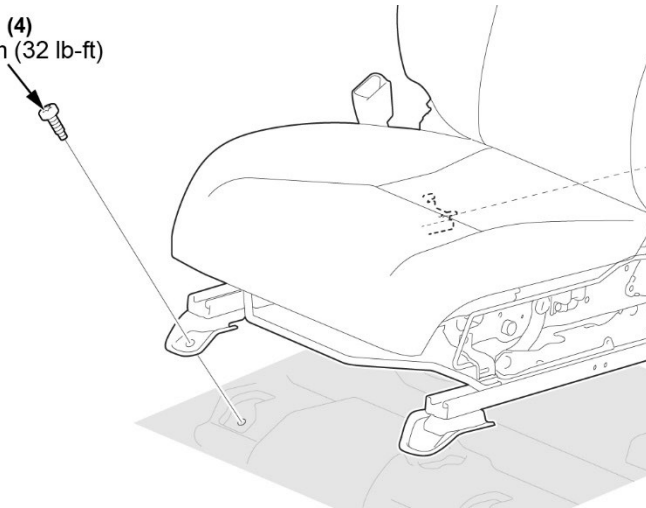
1. Remove the seat bolts using a 50 IP TORX Plus socket.

**BOLTS (4)**  
43 N·m (32 lb-ft)

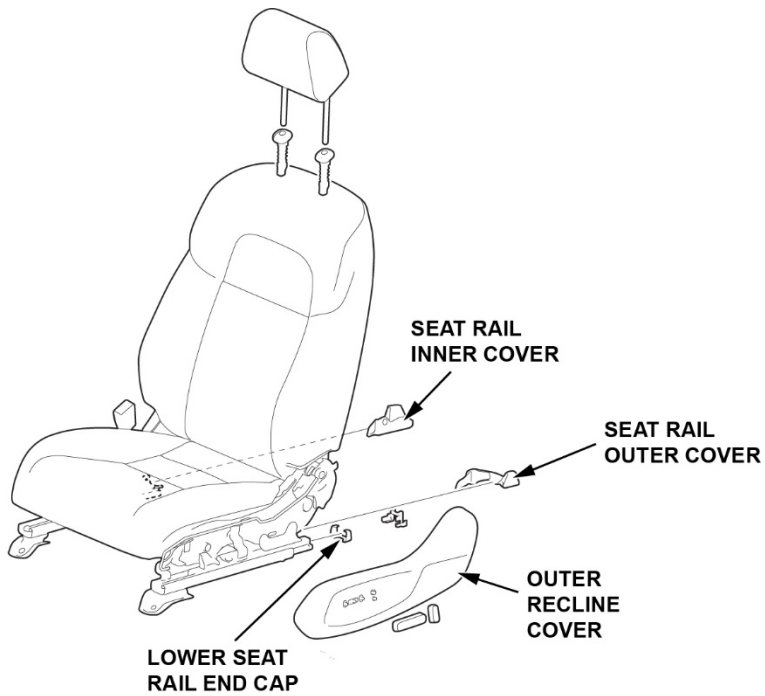
5. Remove the following:

1. [Outer recline cover](#)
2. [Seat rail inner and outer covers](#)
3. [Seat rail end caps](#)

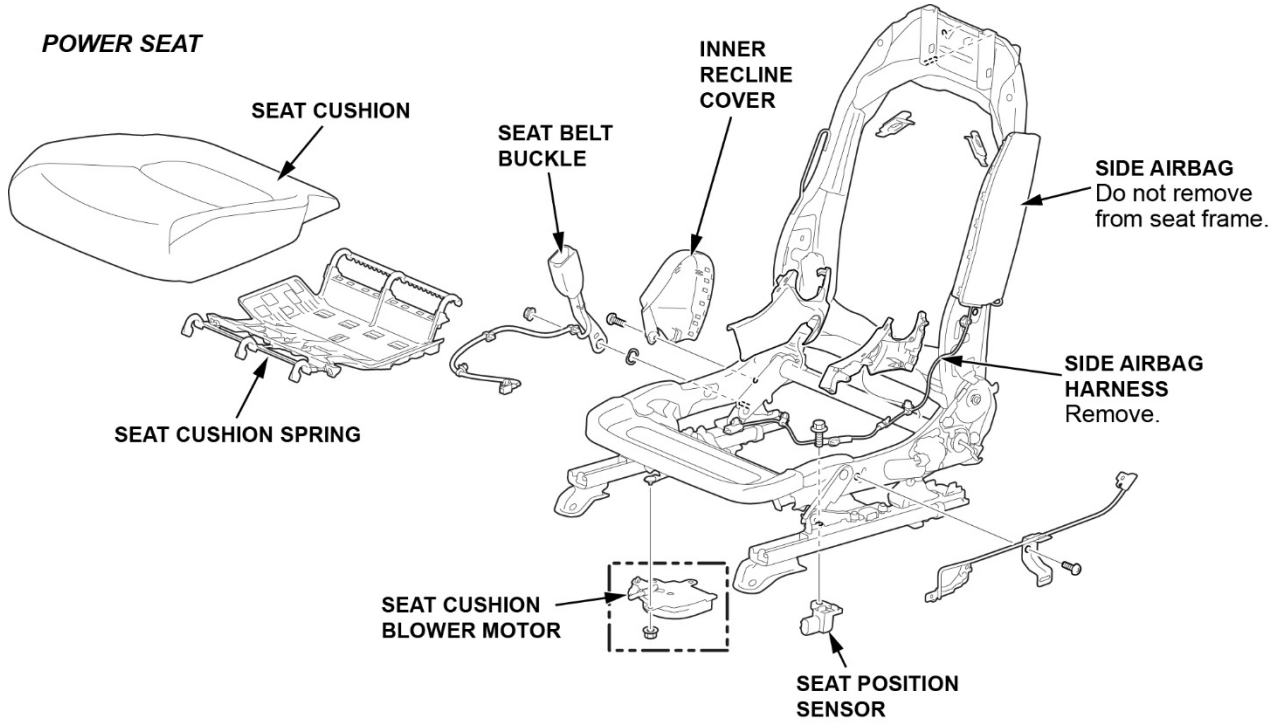
**POWER SEAT**

7. Remove the following:
  1. [Inner recline cover](#)
  2. Harness for [driver's side airbag](#) (do not remove airbag)
  3. [Seat cushion](#)
  4. Seat harness
  5. [Seat cushion spring](#)
  6. Disconnect the seat position sensor
  7. Disconnect the [seat belt buckle](#)

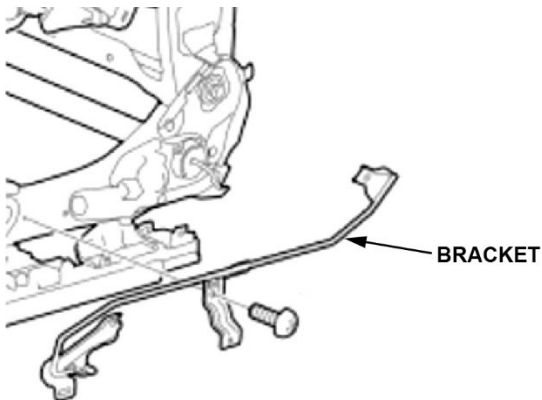
8. Remove the 3 mounting bolts, then remove the bracket.

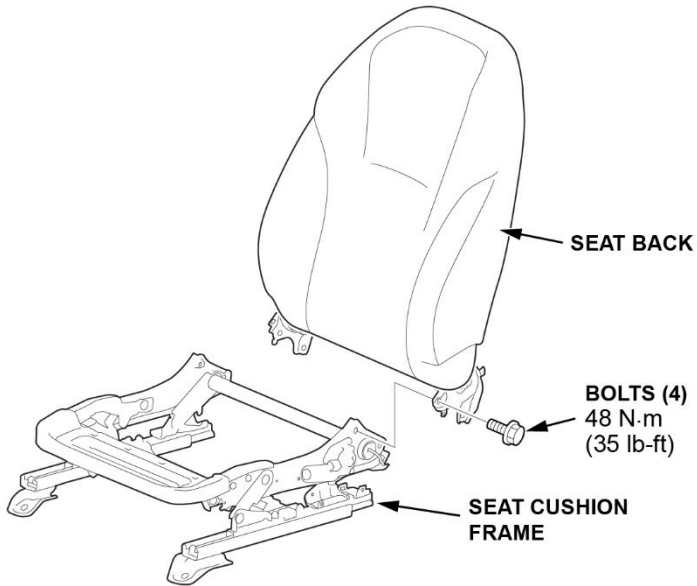
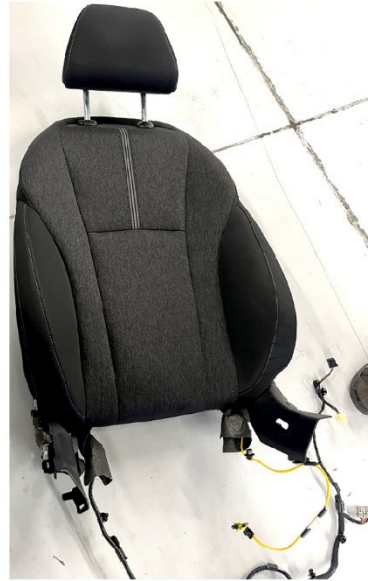
9. Remove the four bolts holding the seat back to the seat cushion frame, then remove the seat back assembly.

NOTE: **Do not** disassemble the seat back assembly.

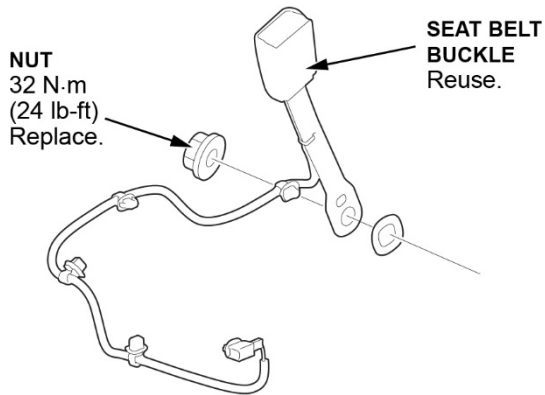
10. Transfer the [seat belt buckle](#) to the new seat cushion frame.

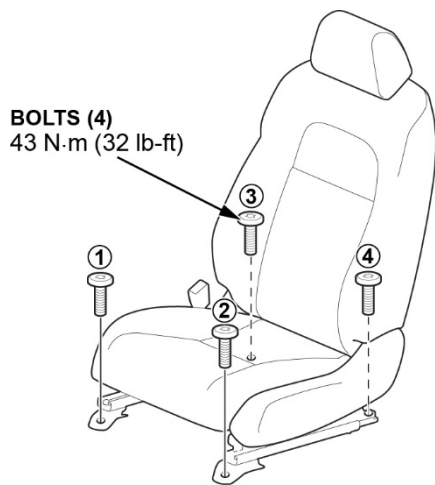
13. Install the driver's seat into the vehicle. Hand tighten the bolts, then torque to specification, in sequence, using the 50 IP TORX Plus socket Driver.
