January 30, 2026

Version 1

Safety Recall: 2023 Accord and Accord Hybrid Driver's Seat Lift Link Bolt Loose

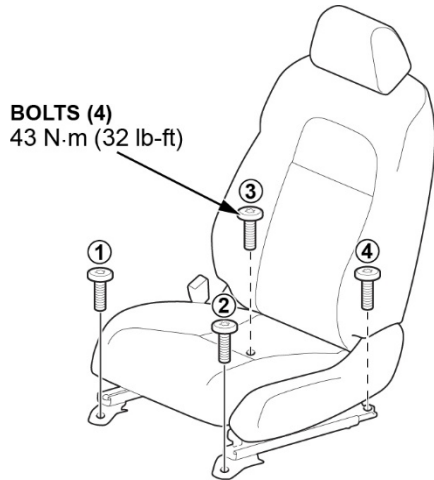
1. Remove the seat bolts using a 50 IP TORX Plus socket driver.

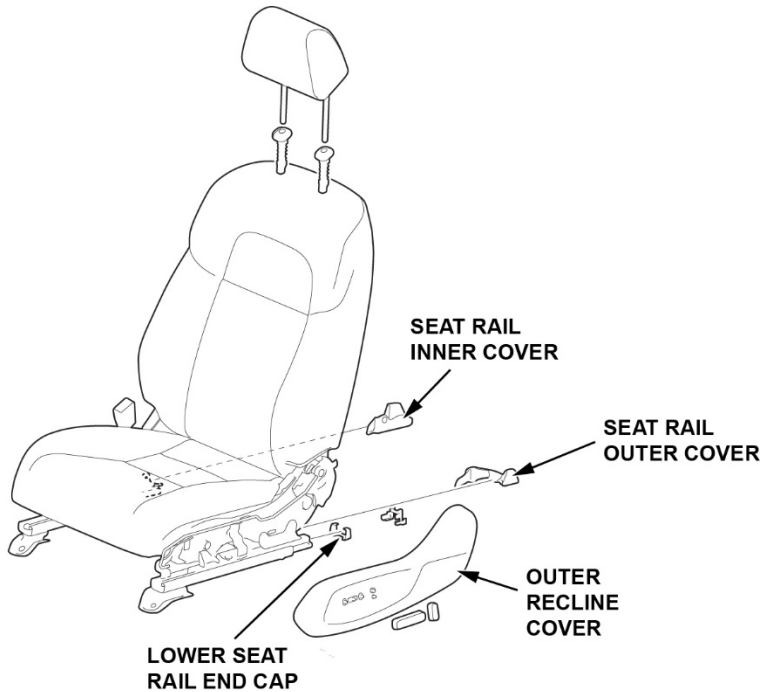
5. Remove the following:

1. [Outer recline cover](#)
2. [Seat rail inner and outer covers](#)
3. [Lower seat rail end cap](#)

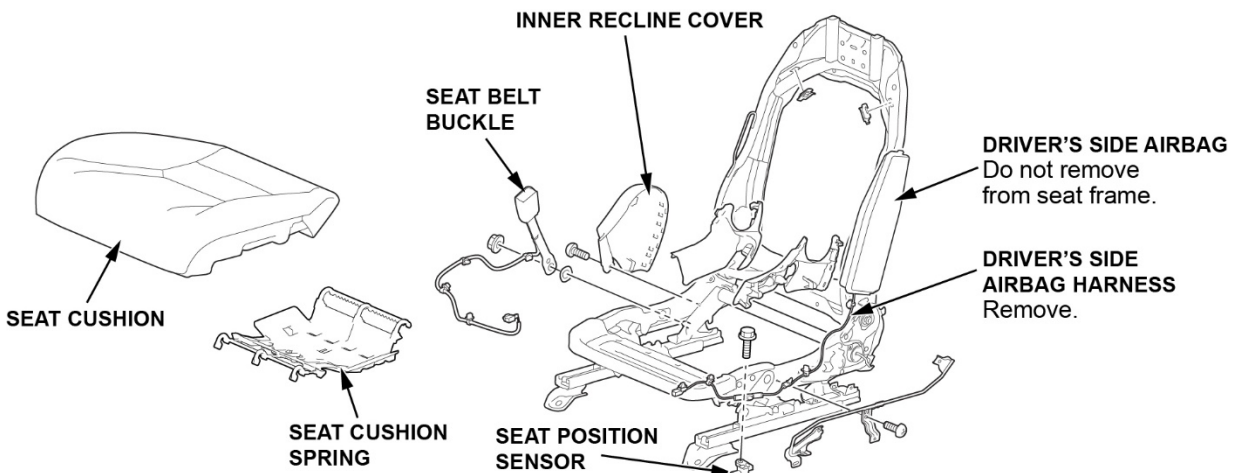
7. Remove the following:

1. [Inner recline cover](#)
2. Harness for [driver's side airbag](#) (do not remove airbag)
3. [Seat cushion](#)
4. Seat harness
5. [Seat cushion spring](#)
6. Disconnect the seat position sensor
7. Disconnect the [seat belt buckle](#)

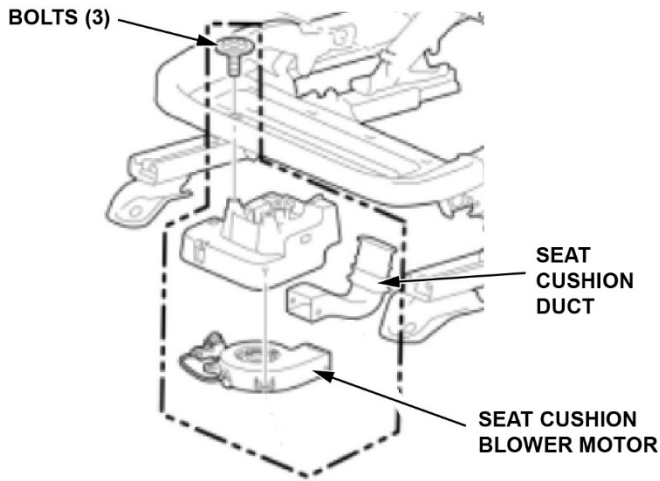
8. If equipped with seat ventilation, remove the [seat cushion blower motor](#) and [seat cushion duct](#).

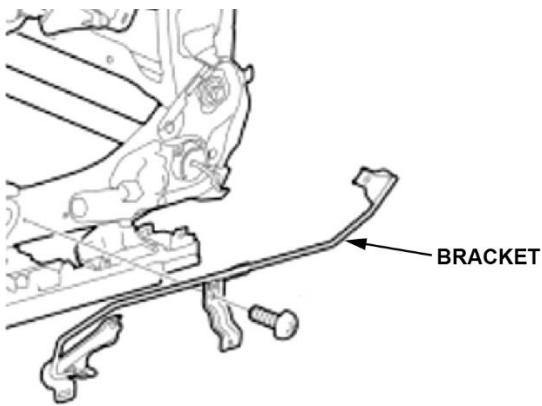
9. Remove the 3 mounting screws, then remove the bracket.

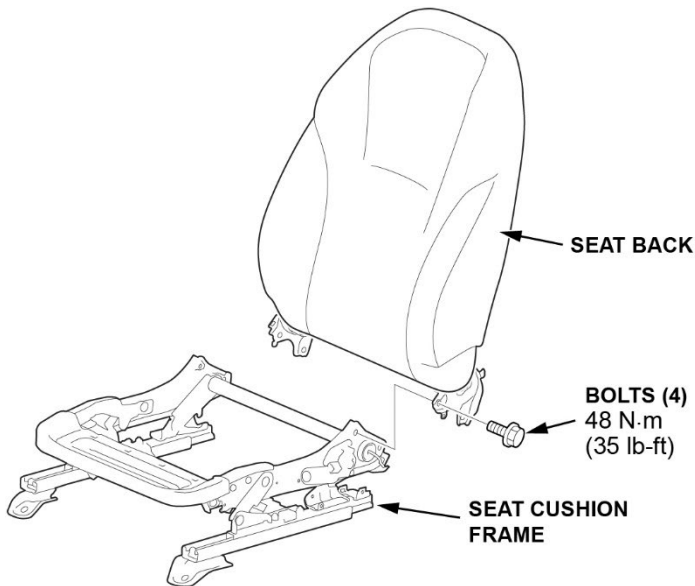
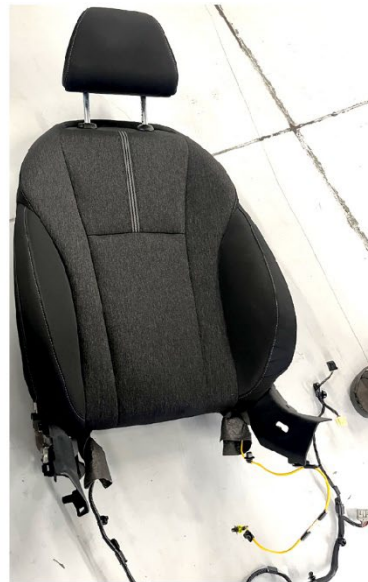
10. Remove the four bolts holding the seat back to the seat cushion frame, then remove the seat back assembly.

NOTE: **Do not** disassemble the seat back assembly.

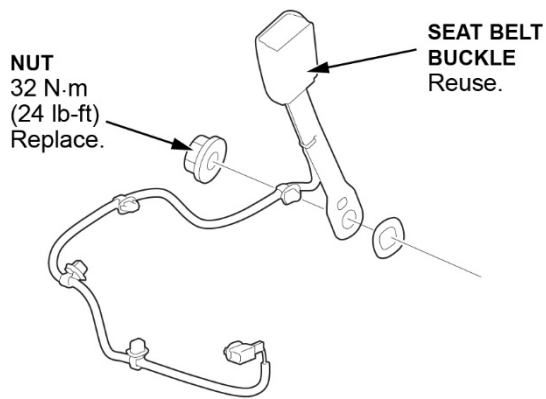
11. Transfer the [seat belt buckle](#) to the new seat cushion frame.

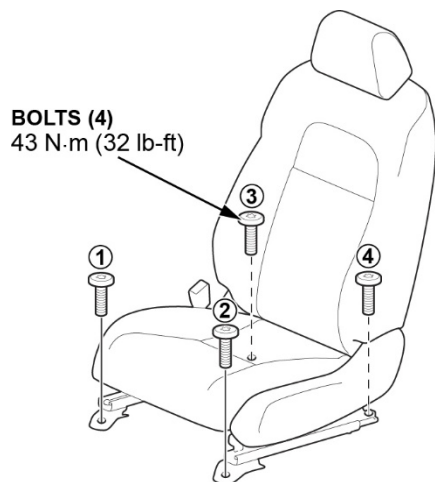
14. Install the driver's seat into the vehicle. Hand tighten the bolts, then torque the bolts, in sequence, using a 50 IP TORX Plus socket driver.
