**May 22, 2026**

Version 1

## Safety Recall: 2016–17 Accord Seat Weight Sensor/Seat Frame Rail Replacement

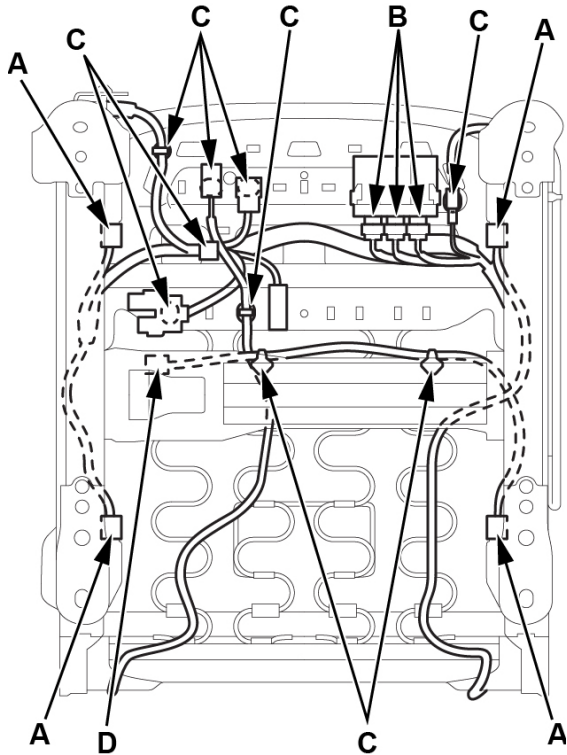
1. [Remove Front Seat-Back Cover/Pad.](#)
2. [Remove Front Seat Cushion Cover/Pad.](#)
3. Disconnecting front passenger's weight sensors:
  1. Disconnect the front passenger's weight sensor connectors (A).
  2. The front passenger's weight sensor unit connectors (B).
  3. Remove the clips (C).
  4. Disconnect the slide motor connector (D).

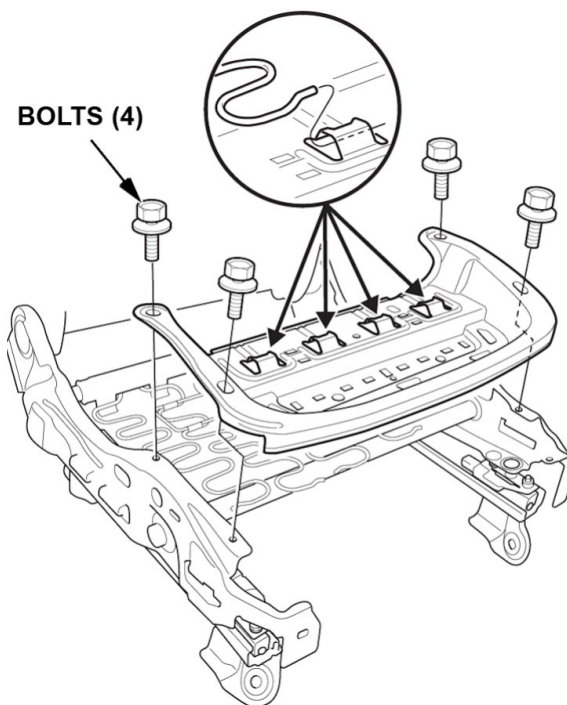
5. Remove the seat cushion frame.

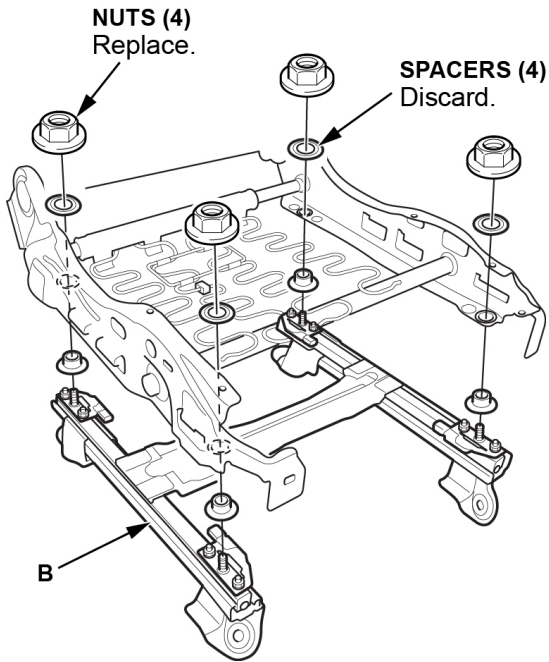
4. Remove the nuts, then remove the Front Passenger Seat Rail/Front Passenger Weight Sensors as an assembly (B).

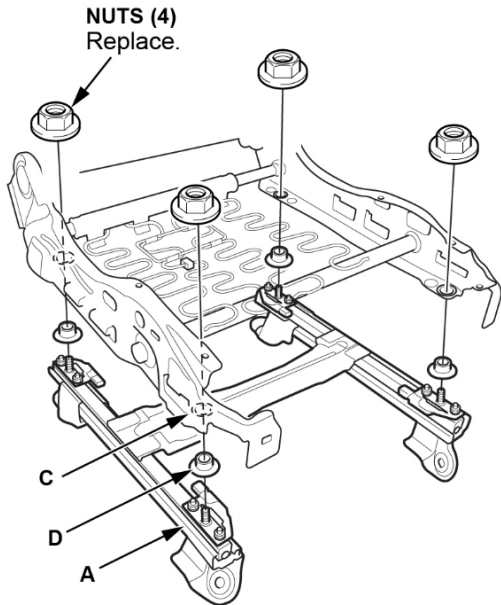
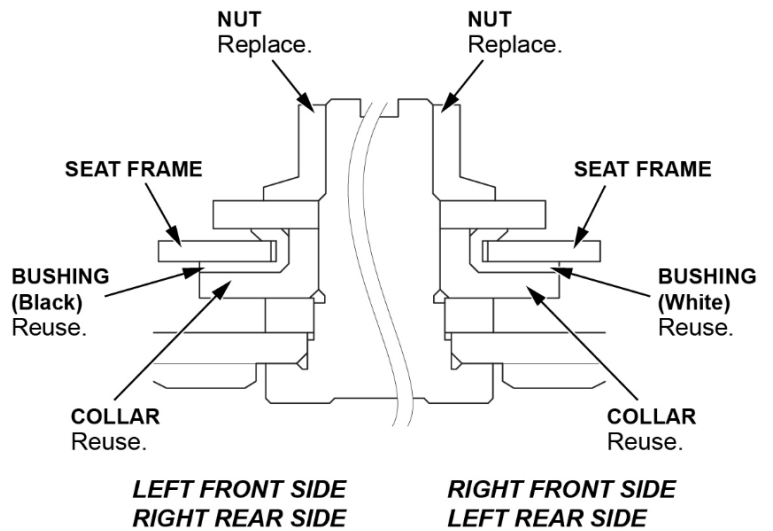
5. Install the new Front Passenger Seat Rail/Front Passenger Weight Sensors as an assembly (A) to the seat frame as shown, and loosely tighten the new nuts.

NOTE: The bushings (C) and the collars (D) can be identified by their color.

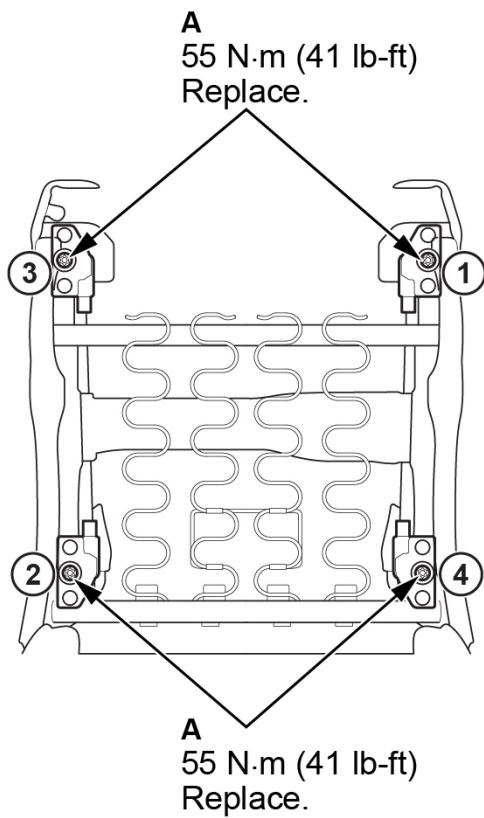
6. Tighten the nuts (A) to the specified torque.

NOTE: Tighten the nuts in the numbered sequence shown.

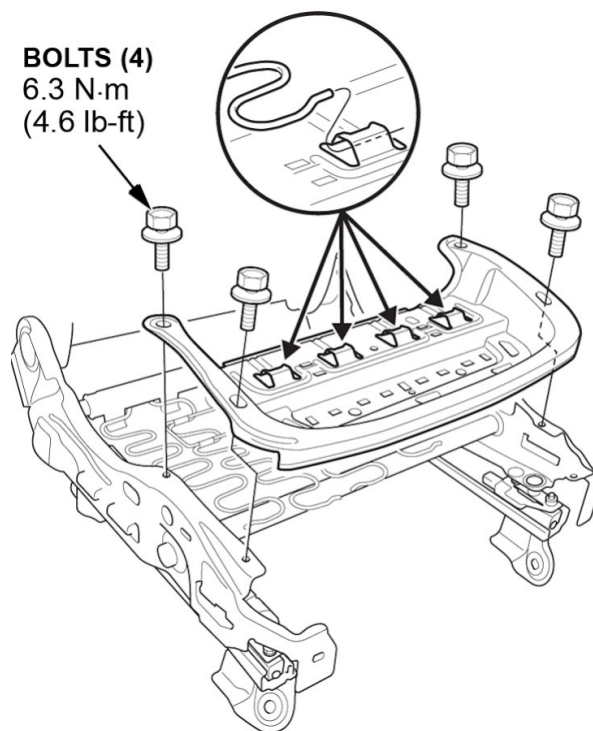
7. Install the seat cushion frame.

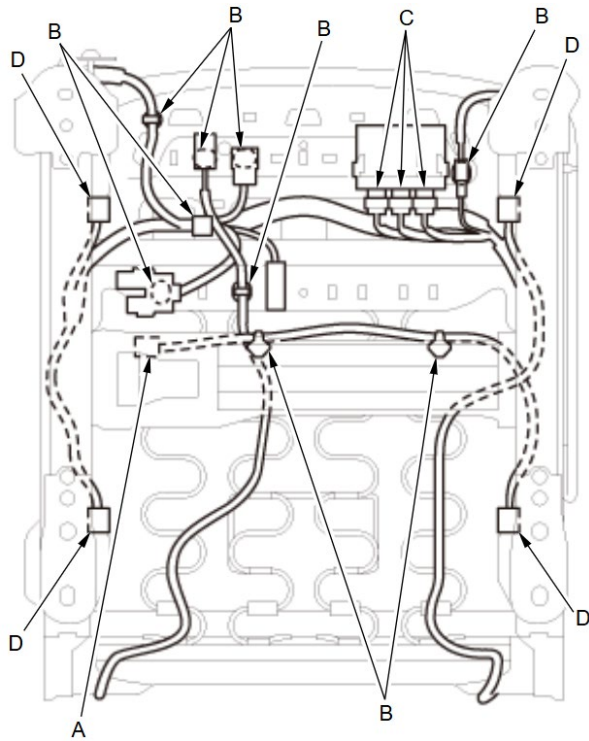
8. Connecting Front Passenger Weight Sensors:

1. Connect the slide motor connector (A).
2. Install the clips (B).
3. Connect the Front Passenger Weight Sensor Unit connectors (C).
4. Connect the Front Passenger Weight Sensor connectors (D).
