Safety Recall: 2014–20 MDX Rear Subframe Reinforcement

Vehicles operated in regions where de-icing agents are heavily used may experience premature corrosion at the rear subframe suspension mounting points. If the mounting points for the rear control arm or lower arm fail, the rear wheel(s) can become misaligned or inadequately retained, which could adversely affect vehicle handling, stability, and braking performance, increasing the risk of a crash or injury.

Install a rear subframe reinforcement kit.

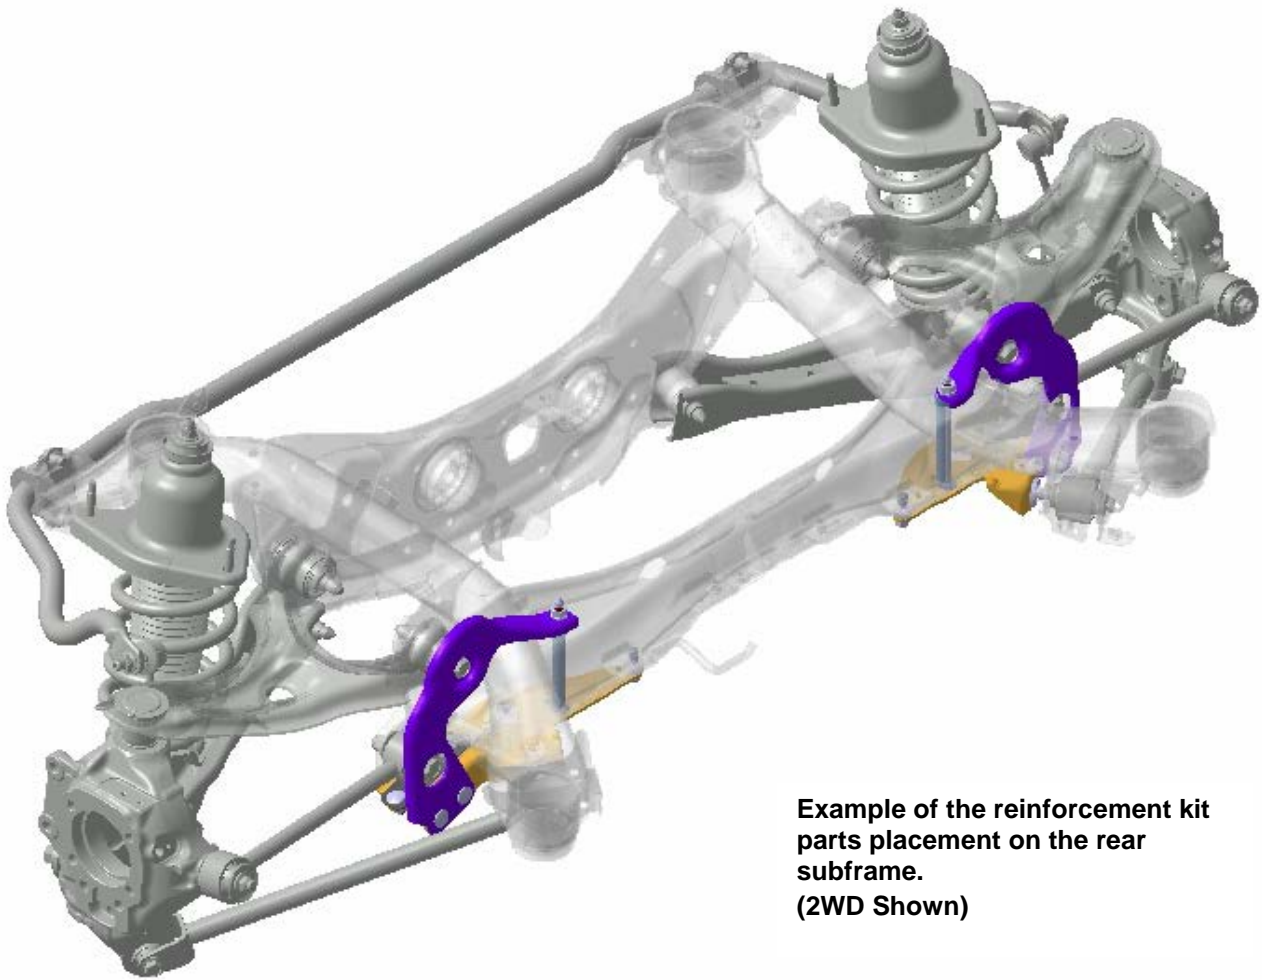
Example of the reinforcement kit parts placement on the rear subframe.
(2WD Shown)

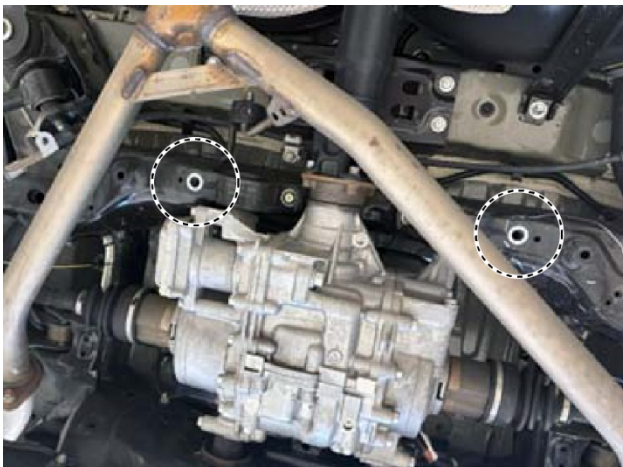
Remove and discard the rear differential outboard mounting bolts on both sides of the front crossmember, then proceed to step 5.

NOTE: If these bolts do not come out, or the weld nuts or threads are damaged, refer to [Procedures A1-A2](#) in the REAR FRAME REINFORCEMENT KIT – SUPPLEMENTAL REPAIRS section at the end of this bulletin.

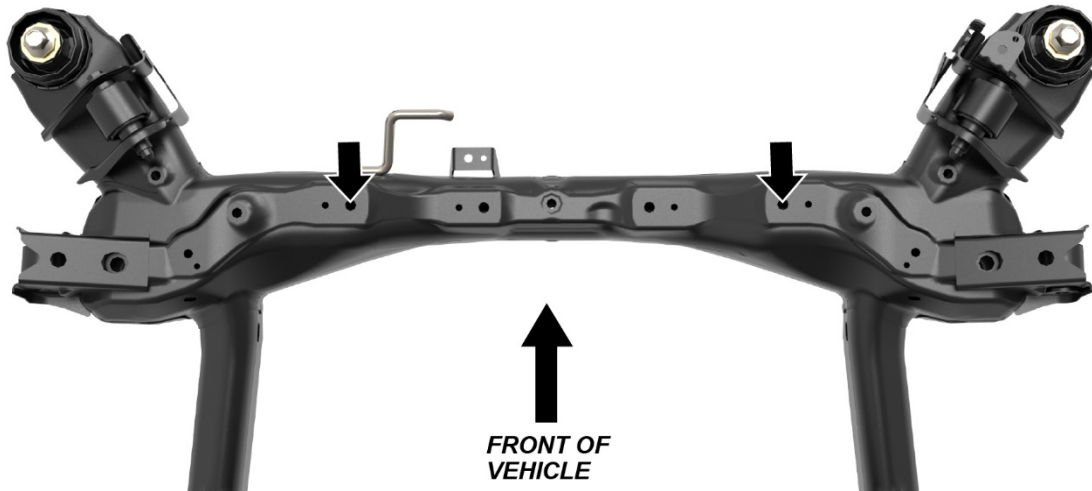
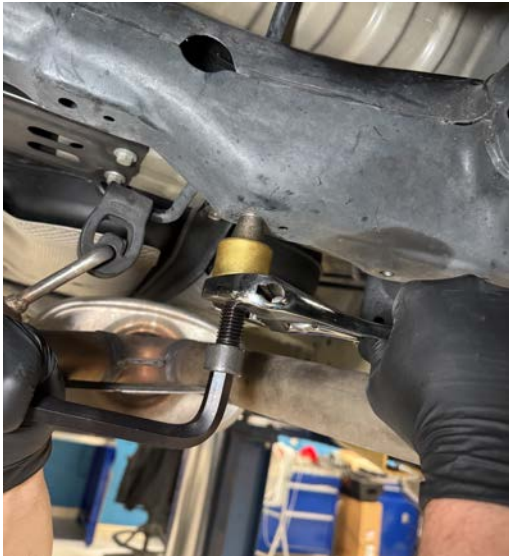
Install **M8** rivet nuts (see the [Using the Rivet Nut Installation Tool](#) Job Aid) into the locations shown in the underside of the front crossmember portion of the rear subframe, then proceed to step 5.

NOTE: If the mounting holes in the subframe are too corroded to hold the Rivet nuts, refer to [Procedure A3](#) in the REAR FRAME REINFORCEMENT KIT – SUPPLEMENTAL REPAIRS section at the end of this bulletin.

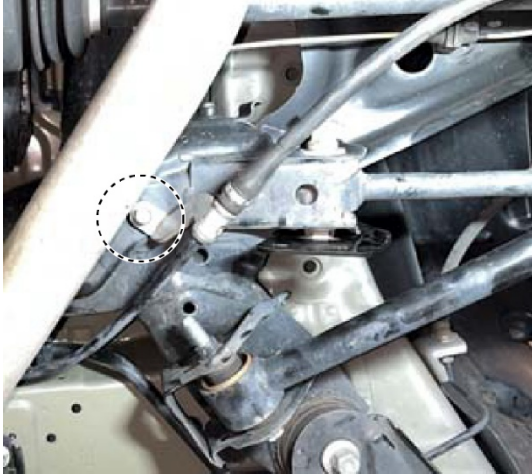
Remove the bolts that secure the parking brake wires to the subframe, then move the cables to the side.

NOTE: If these bolts do not come out, or the weld nuts or threads are damaged, refer to [Procedure B](#) in the REAR FRAME REINFORCEMENT KIT – SUPPLEMENTAL REPAIRS section of this bulletin.

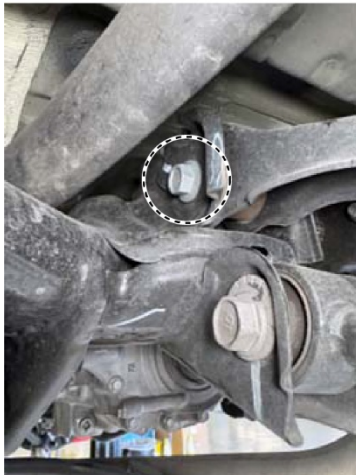
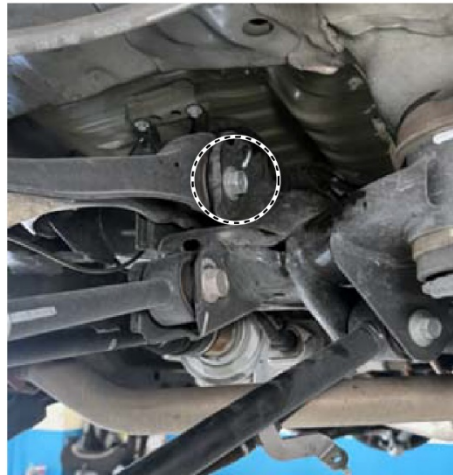
- 6.1 Clean the upper arm front bracket mounting area and front cross member upper area.

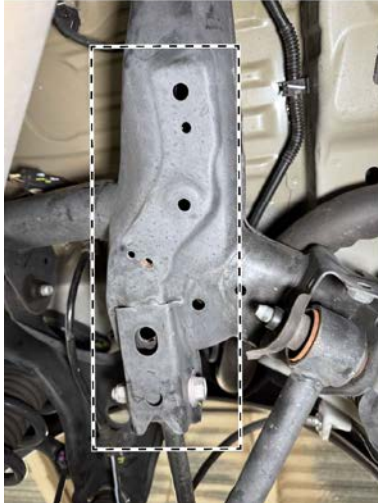
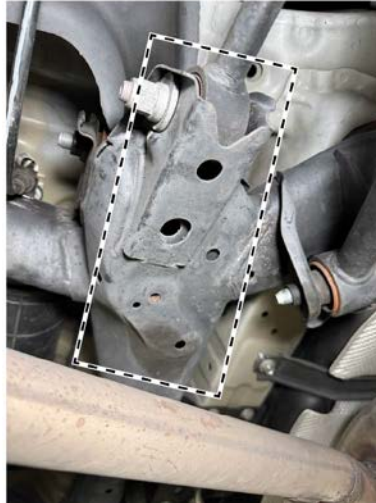
6.2 Clean the control arm bracket area, lower arm rear bracket face, and the cross member lower differential mount area (2WD only).

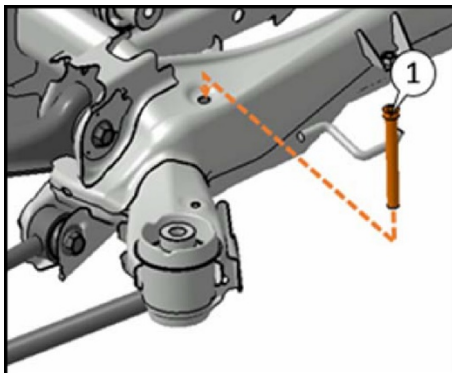
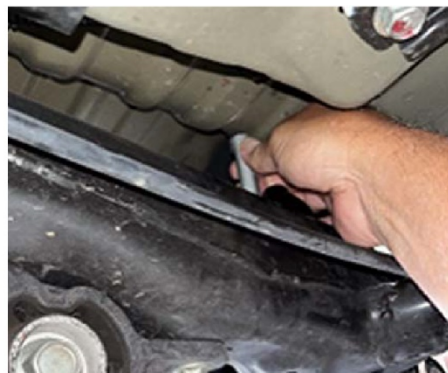
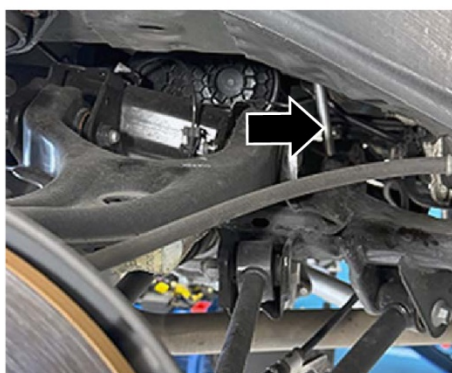
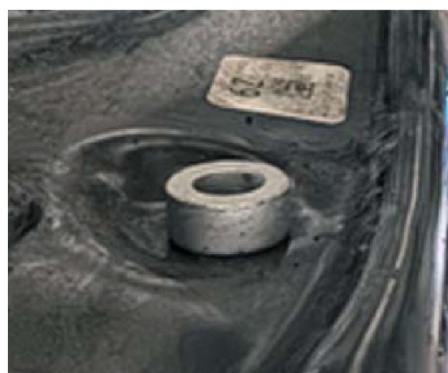
7.1 Insert the collar (1) into the top of the crossmember and ensure the head sits flush with the top of the crossmember.

NOTE: If there is not enough clearance to insert the collar into the subframe hole, see step 7.2 for additional information.

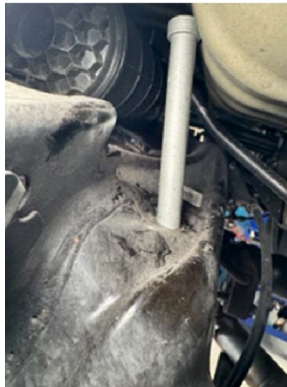
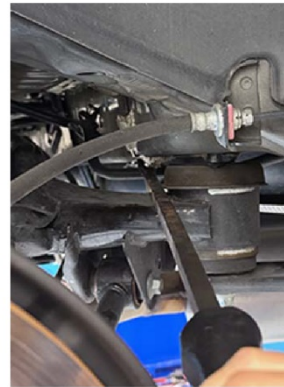
7.2 If there is not enough clearance to slide the collar into the hole, loosen the forward mounting bolt for the rear crossmember and use a pry bar to force the subframe down for more clearance. Once the collar is installed, install a new subframe mounting bolt and torque it to **132 N-m (97 lb-ft)**.

**REAR CROSSMEMBER
MOUNTING BOLT -
FORWARD LOCATION**
132 N-m (97 lb-ft)
Replace.

NOTE: **Do not** remove both forward subframe mounting bolts at the same time or an alignment will be required.

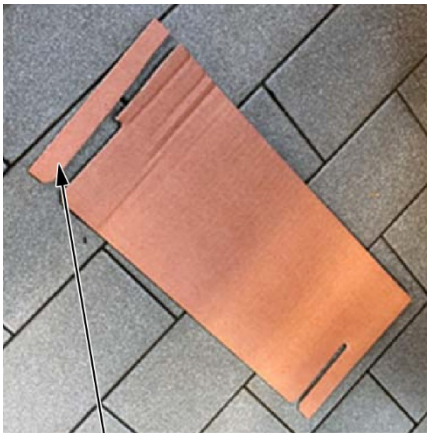
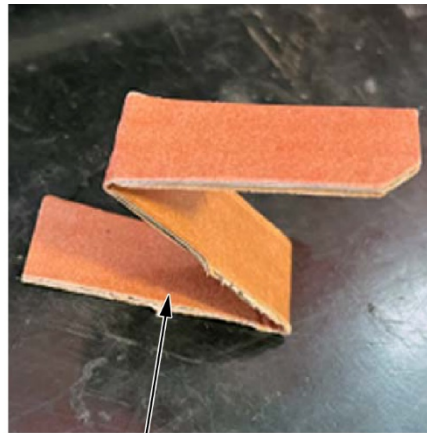
8. Make 4 cardboard masking pieces by cutting off the tabs of the cardboard parts box inserts and then fold the pieces into thirds in a "Z" shape as shown.

CARDBOARD PARTS BOX
Cut off tabs.

Fold pieces into thirds in a "Z" shape.

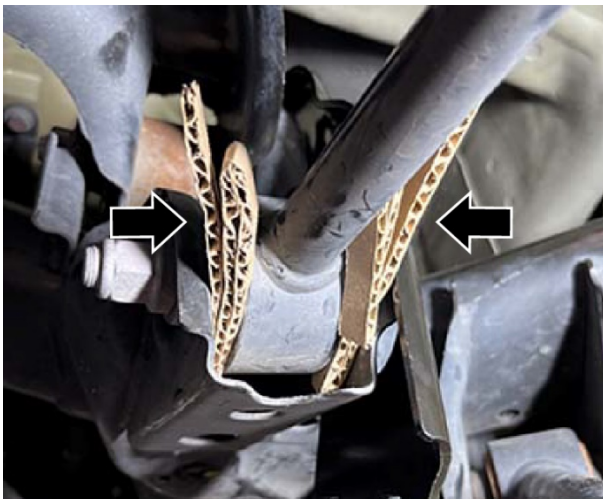
9. Insert the cardboard pieces around the control arm bushing to protect the rubber area of the bushing.

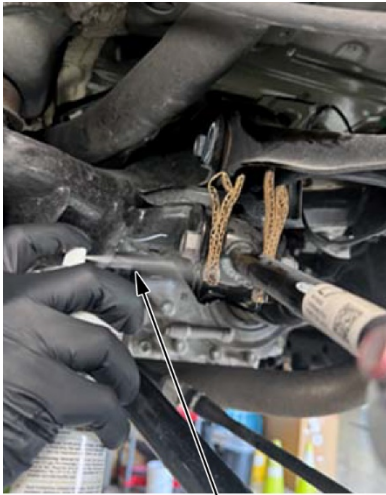
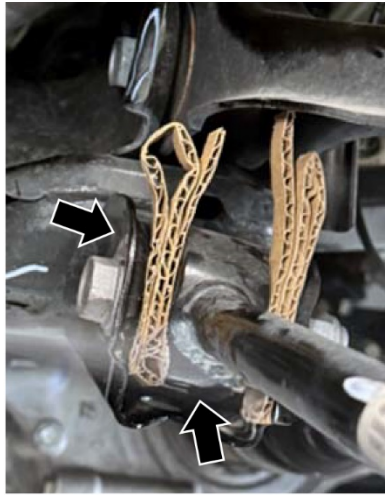
10. Apply spray wax on the inner and outer surfaces of the control arm bracket area. If overspray occurs on the stiffener bracket, wipe the surface with brake cleaner.

SPRAY WAX

NOTE: Leave the cardboard in place until the final spray wax step is completed.

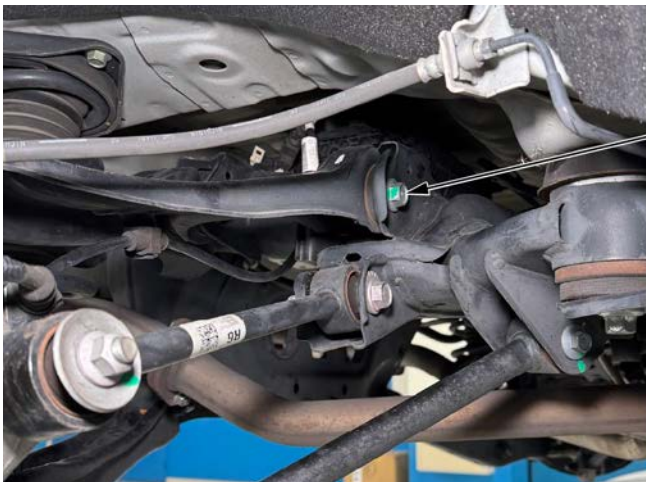
11. Remove and discard the upper arm front bolt.

UPPER ARM FRONT BOLT
Replace.

NOTE: If the weld nut is damaged or becomes separated from the subframe, refer to [Procedure C](#) in the REAR FRAME REINFORCEMENT KIT – SUPPLEMENTAL REPAIRS section at the end of this bulletin.

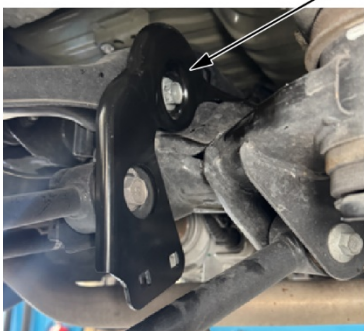
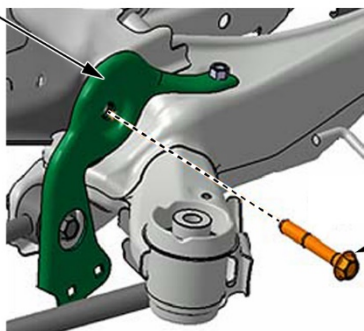
12. Install the upper stiffener bracket to the subframe using a new 14x90 mm flange bolt. Snug the bolt but **do not** tighten to final torque.

14 x 90 FLANGE BOLT
Snug bolt, do not
tighten to final torque.
Replace.

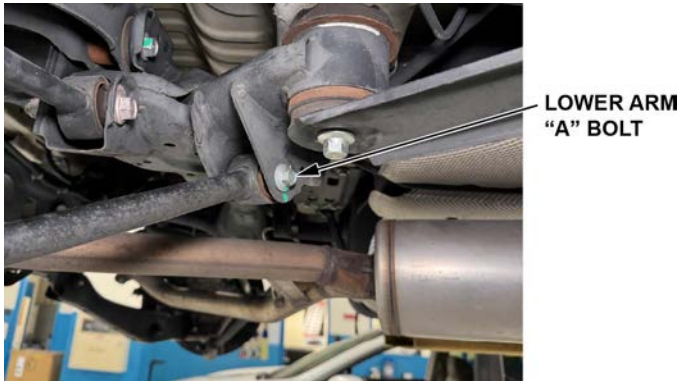
13. Remove and discard the lower arm A bolt.

NOTE: If the weld nut is damaged or becomes separated from the subframe, refer to [Procedure D](#) in the REAR FRAME REINFORCEMENT KIT – SUPPLEMENTAL REPAIRS section at the end of this bulletin.

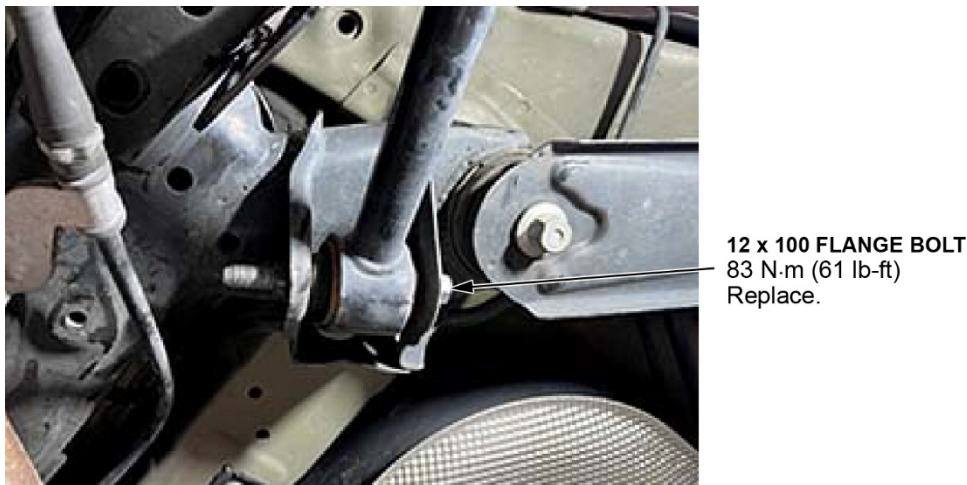
14. Install a new **12x100 mm** flange bolt from the kit into the lower arm mount. Load the suspension with the vehicle's weight and tighten the bolt to the specified torque **83 N·m (61 lb-ft)**.

NOTE: The new bolt tip will protrude beyond the weld nut.

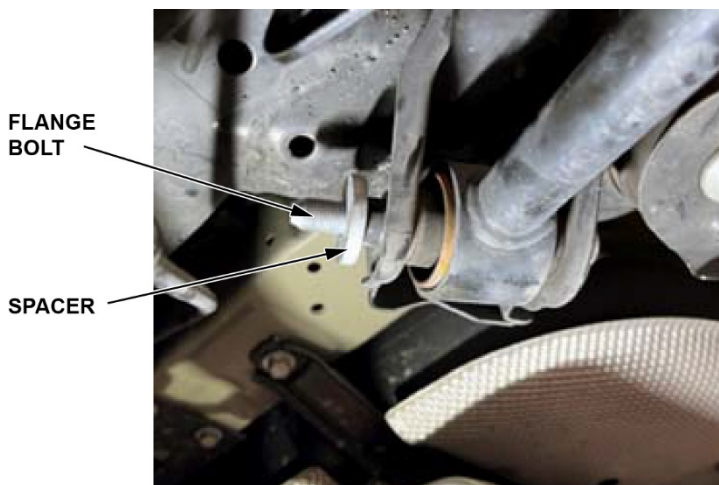
15. Install a spacer on the lower arm A **12x100 mm** flange bolt.

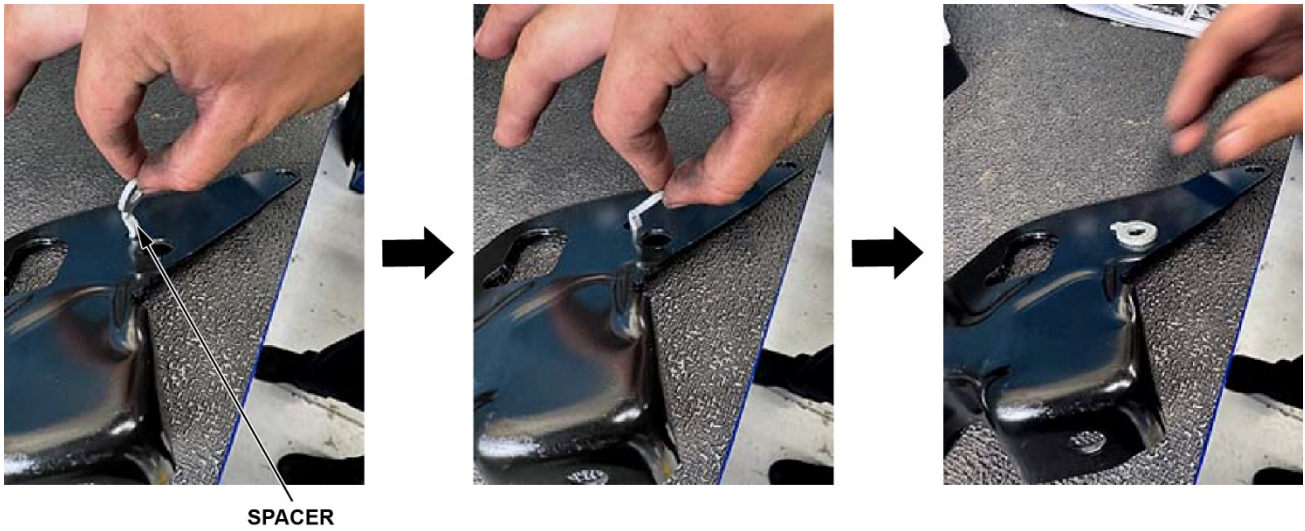
16. Insert the spacer into the lower stiffener bracket.

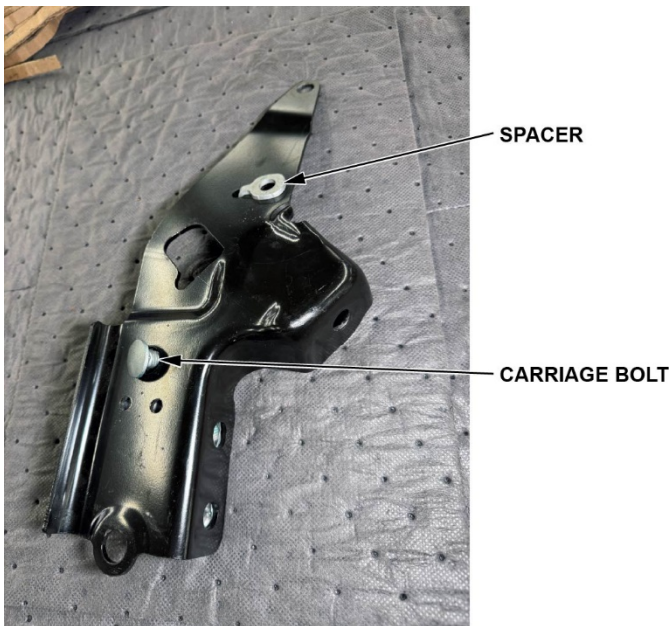
17. Place a carriage bolt in the lower stiffener in the location shown, then loosely put a flange nut on the underside to keep it in place during installation.

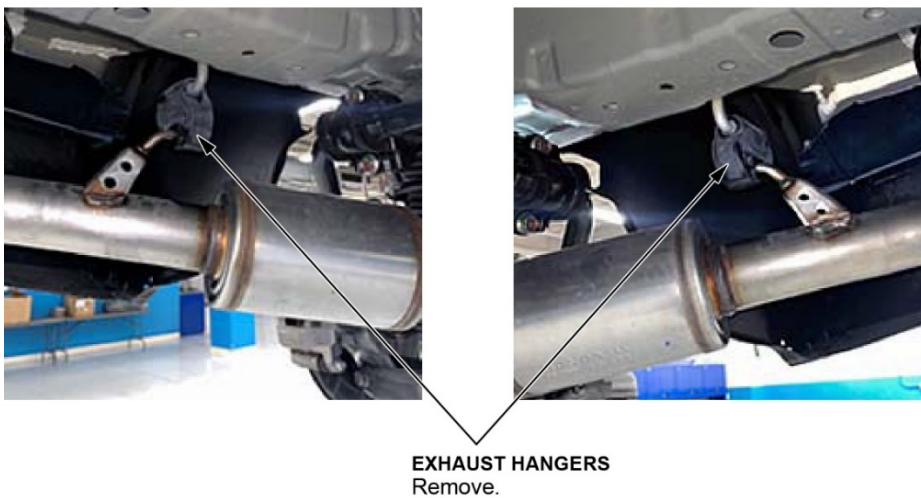
18. For vehicles with dual exhaust only, remove the rear exhaust hangers on the left and right sides.

DUAL EXHAUST ONLY

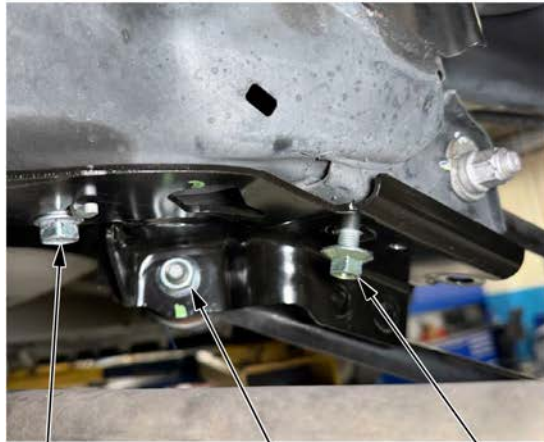
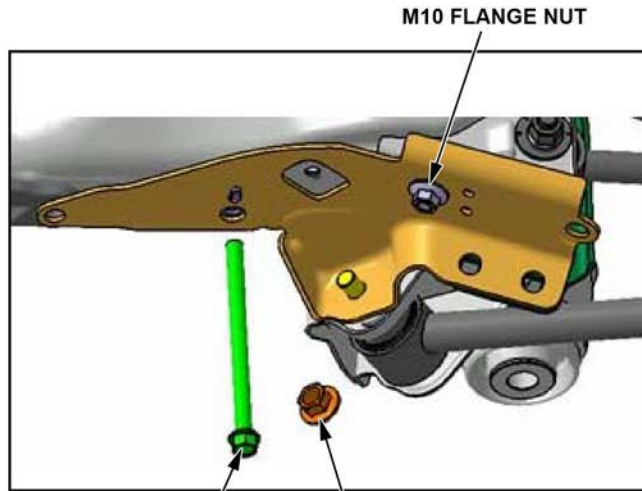
19. Install the lower stiffener bracket to the subframe. Loosely install the **12 mm** flange nut to the lower arm A bracket flange bolt, then install the **10x135 mm** flange bolt through the collar and into the upper stiffener plate.

10 x 135 FLANGE BOLT 12 mm FLANGE NUT Loosely install. M10 FLANGE BOLT

M10 FLANGE NUT
10 x 135 FLANGE BOLT 12 mm FLANGE NUT Loosely install.

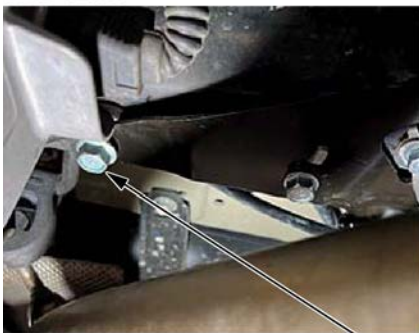
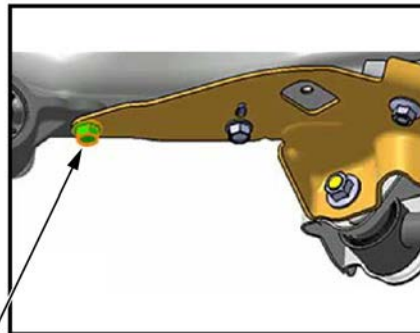
Install the **10x30 mm** flange bolt into the subframe until. Do not tighten to final torque at this time.

10 x 30 FLANGE BOLT

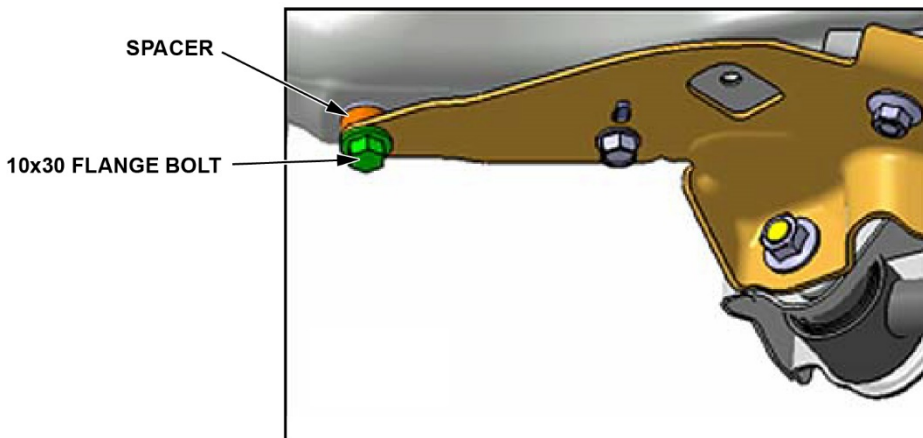
Install the spacer between the lower stiffener and front subframe cross member, then install the **8x30 mm** flange bolt into the rivet nut that was installed earlier. **Do not** tighten to final torque at this time.

SPACER
10x30 FLANGE BOLT

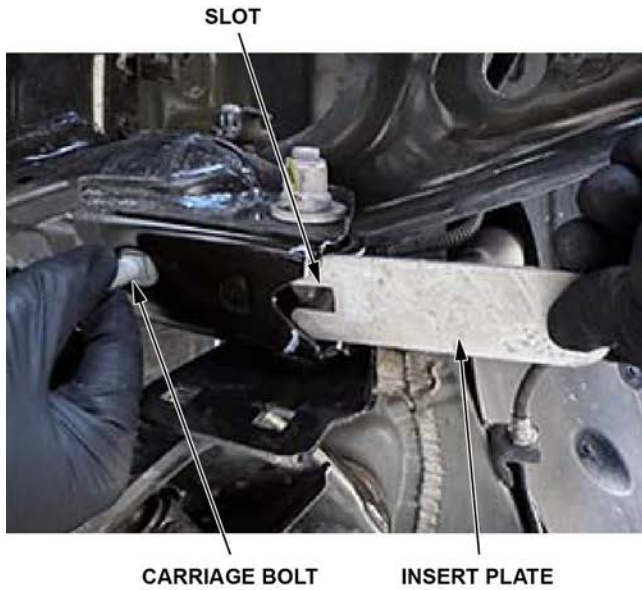
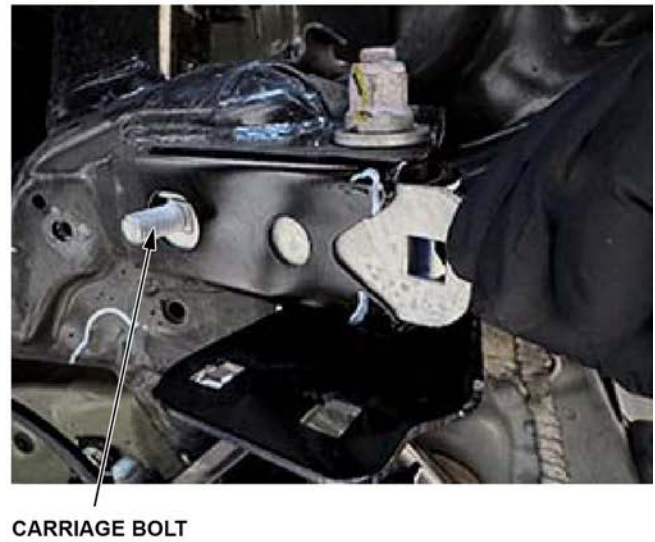
22. Push up slightly on the carriage bolt so it sticks up through the lower control arm bracket, then slide the insert plate above the lower control arm bracket so that the square slot of the plate engages with the square head of the carriage bolt (rotating the carriage bolt slightly may help with engagement).

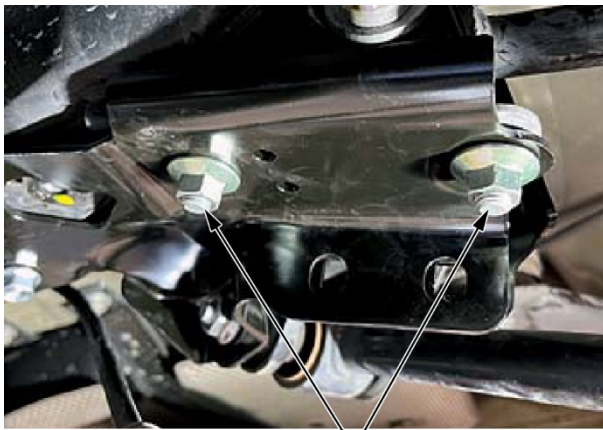
23. Secure the insert plate to the lower stiffener with **10x22 mm** carriage bolts and **10 mm** flange nuts and tighten until snug.

**10x30 CARRIAGE BOLTS
WITH 10mm FLANGE NUTS**

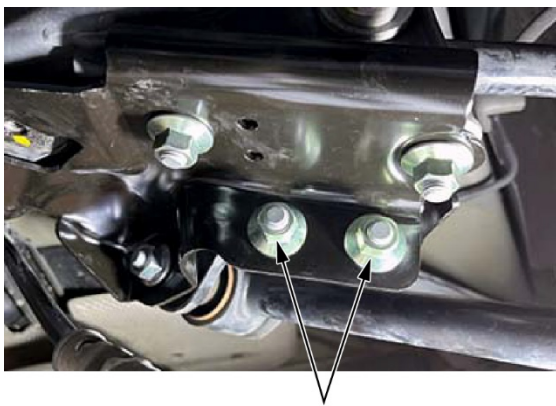
24. Secure the upper stiffener to the lower stiffener with two **10x22 mm** carriage bolts and two **10 mm** flange nuts.
NOTE: Make sure the square head of the carriage bolt is seated in the square hole in the upper stiffener plate.

**10x30 CARRIAGE BOLTS
WITH 10mm FLANGE NUTS**

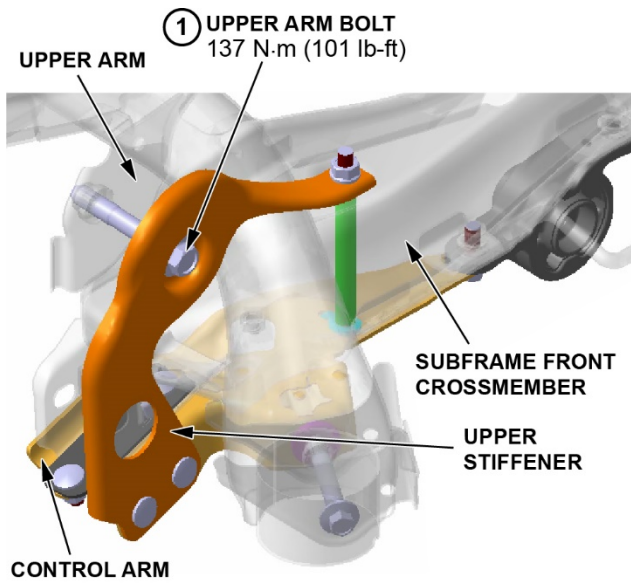
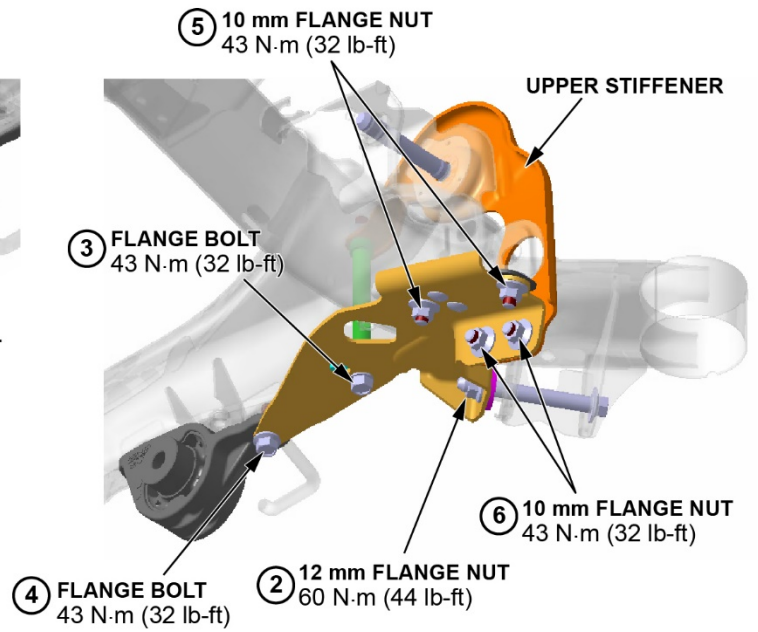
25. Load the suspension with the vehicle's weight, then torque all bolts to specification in the following sequence (Repeat for both sides):

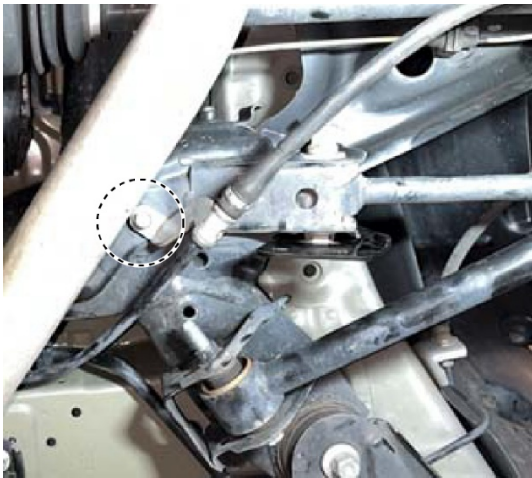
Install the parking brake wire bracket and bolt, then torque to **21 N·m (15 lb-ft)**.

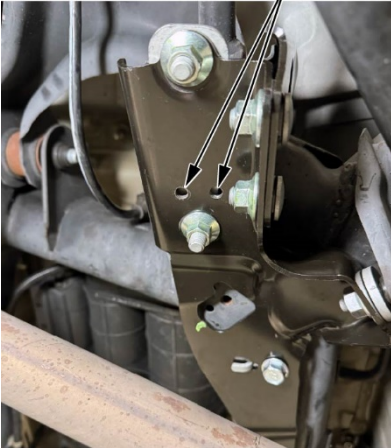
27. Using the punched holes in the lower stiffener as a guide, drill two **5 mm** holes through the subframe control arm bracket and the inserted plate.

5 mm HOLES

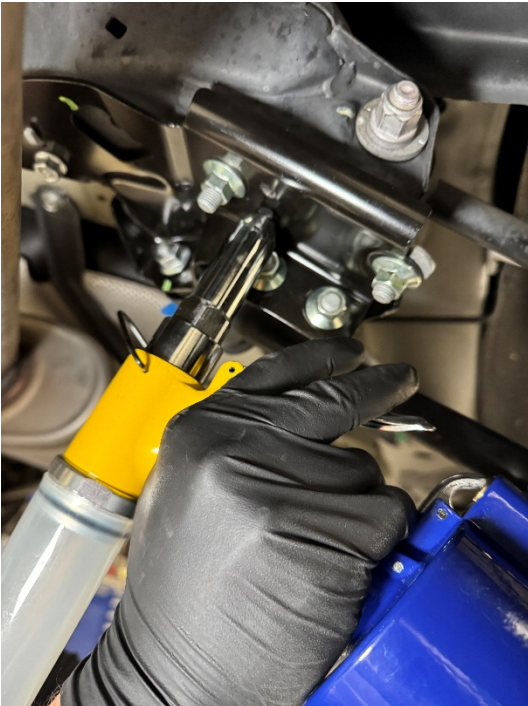
28. Install the rivets provided into each of the drilled holes.

NOTE: Make sure the rivet flange is fully seated against the lower stiffener bracket prior to setting the rivet.

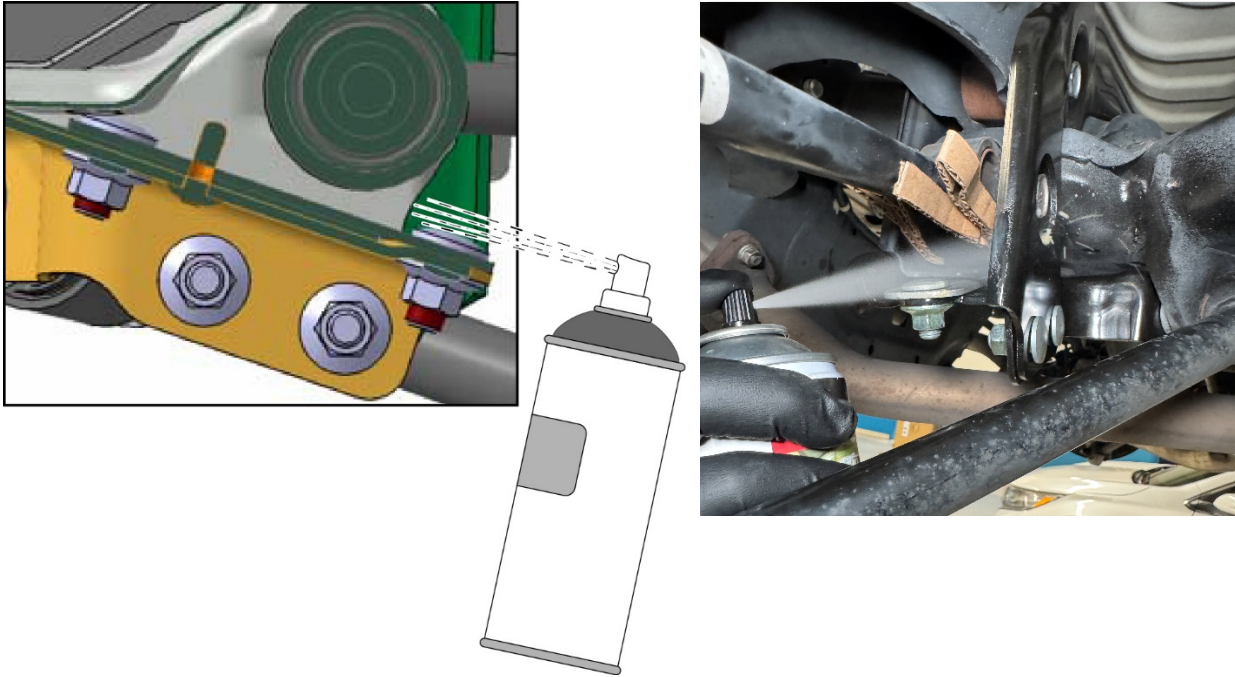
29. Install the cardboard masking to protect the rubber bushing, then apply additional anti-corrosion wax around the rivet area.

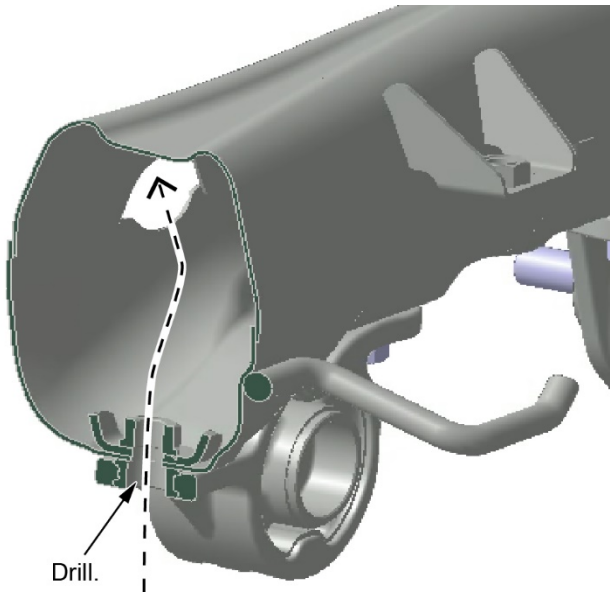
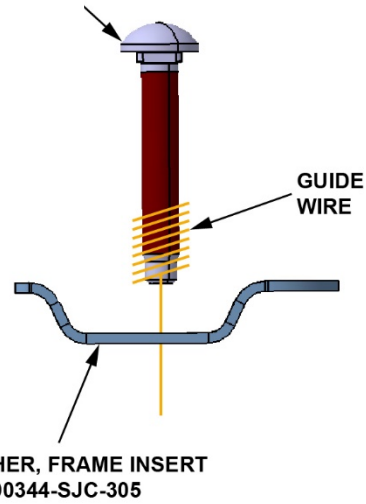
1. Drill a **12mm** hole through the existing weld nut.

NOTE: If bolt is broken, remove or drill out the bolt, then drill through the existing weld nut.

BOLT SPECIAL 10x62
P/N: 90324-SJC-305

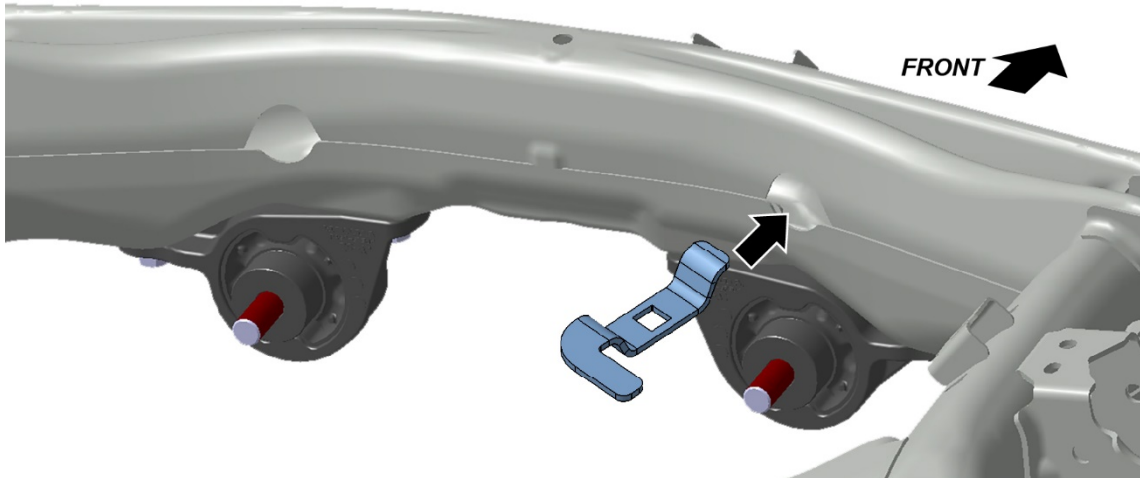
- When inserting the washer in the RIGHT SIDE, insert the short side first (after passing the guide wire through the 12 mm hole).

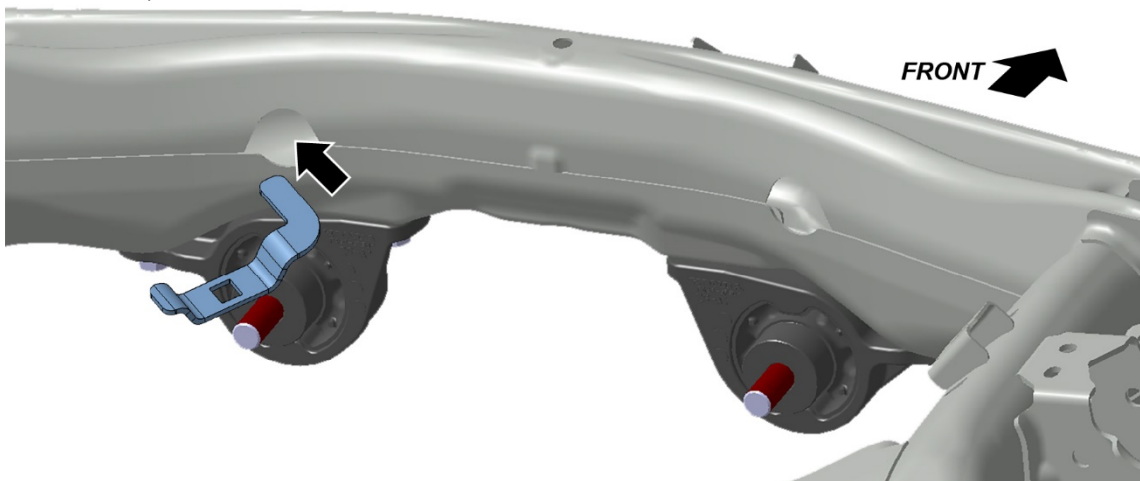
- When inserting the washer in the LEFT SIDE, insert the long end first (after passing the guide wire through the 12 mm hole)

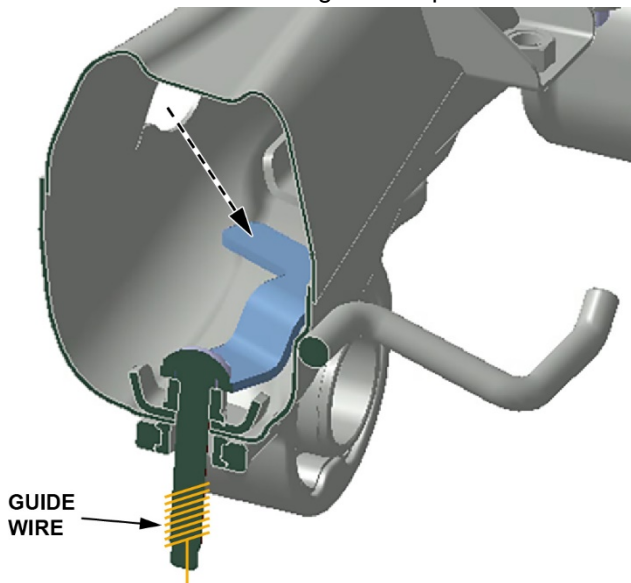
5. Gently feed the washer and carriage bolt through the cross-member access hole. Continue to pull the guide wire downwards until the carriage bolt is pulled down through weld nut and is exposed through the differential mount area.

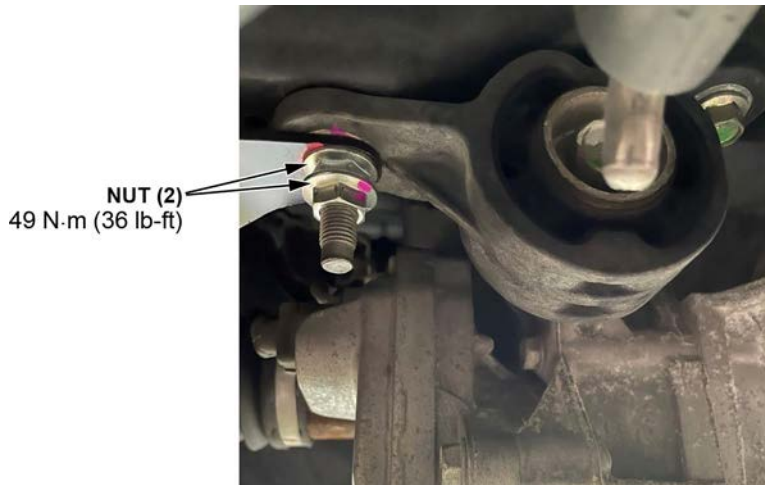
6. Rotate the carriage bolt while pulling downwards to engage the square anti-rotation feature into the washer, then remove the guide wire.
7. Replace the old **M10** bolt with the **M10** flange nut (P/N: 94050-10000) and torque to **49 N.m (36 lb-ft)**. Install a second **M10** flange nut as a lock-nut and torque to **49 N.m (36 lb-ft)**.

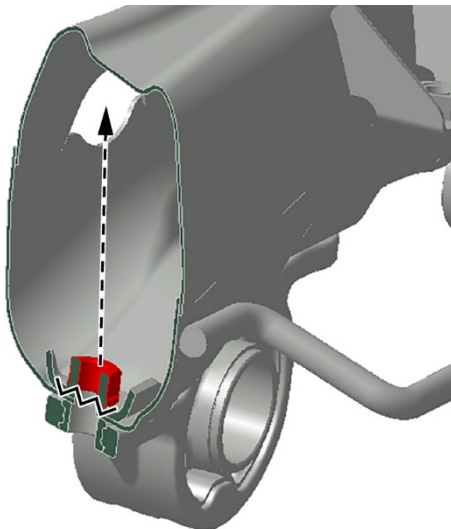
1. Remove the broken weld nut from the subframe.

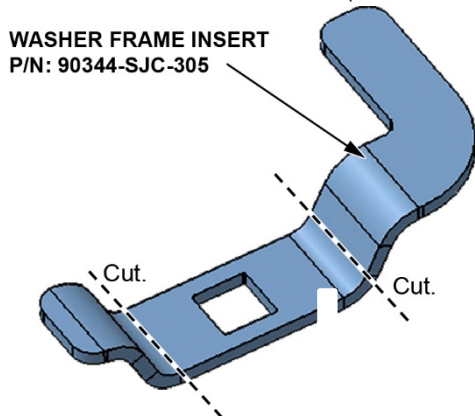
2. Continue with the repair procedure through step 24.
3. Cut the washer frame insert (P/N: 90344-SJC-305) as shown.

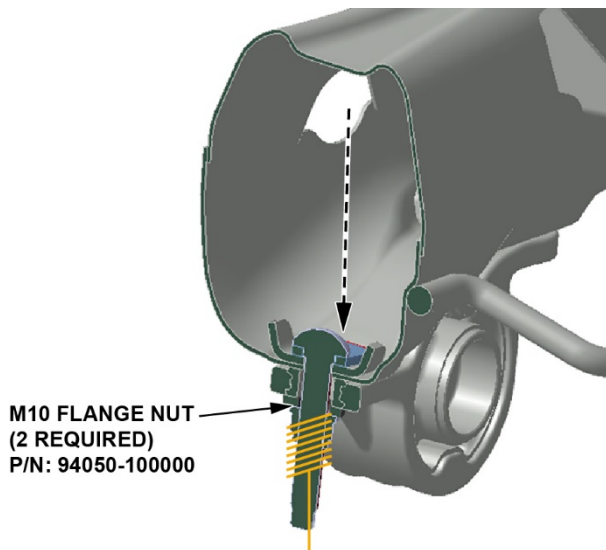
5. Pass the guide wire through the modified washer and thread it onto the carriage bolt (P/N: 90324-SJC-305).

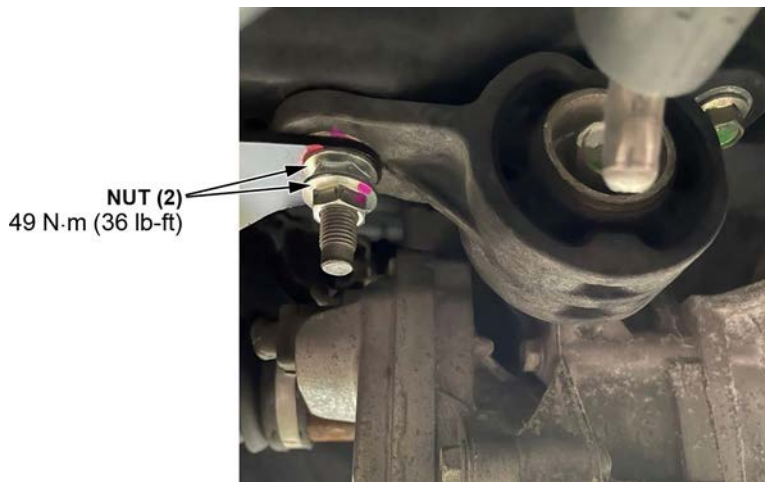
6. Gently feed the washer and carriage bolt through the crossmember access hole. Continue to pull the guide wire downwards until carriage bolt is pulled down through weld nut and is exposed through the differential mount area.
7. Rotate the carriage bolt while pulling downwards to engage square anti-rotation feature into the washer, then remove the guide wire.
8. Replace the old **M10** bolt with the M10 flange nut (P/N: 94050-10000) and torque to **49 N.m (36 lb-ft)**. Install a second **M10** flange nut as a lock-nut and torque to **49 N.m (36 lb-ft)**.

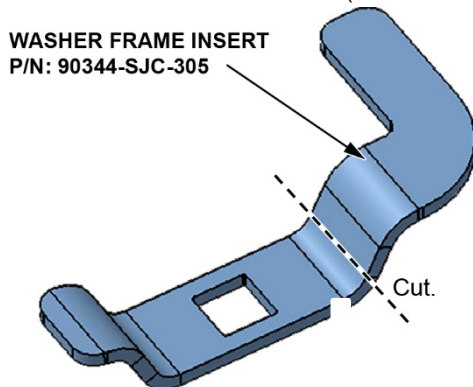
1. Cut the washer frame insert (P/N: 90344-SJC-305) as shown.

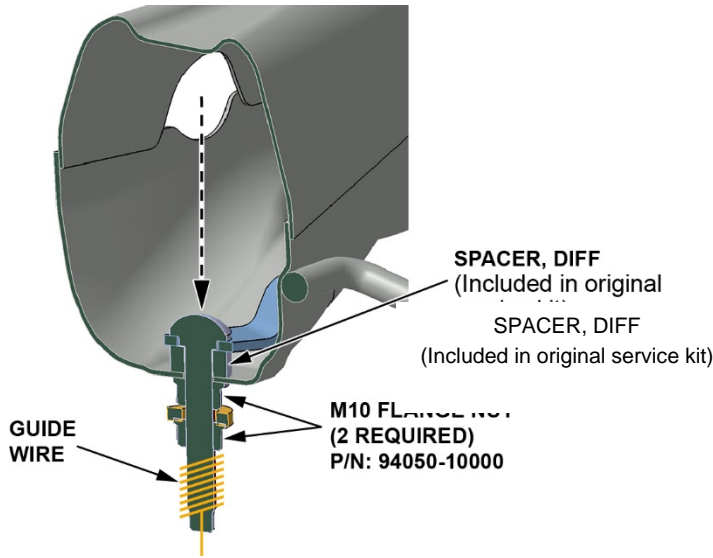
2. Feed the guide wire upward through the existing subframe hole and out through the access hole in rear side of front crossmember.

3. Pass the guide wire through the differential spacer (supplied with original service kit) and the cut washer frame insert and thread it onto the carriage bolt (P/N: 90324-SJC-305).
4. Gently feed the differential spacer, washer and the carriage bolt through the crossmember access hole. Continue to pull the guide wire downwards until the carriage bolt is pulled down through the hole in the subframe crossmember.
5. Rotate the carriage bolt while pulling downwards to engage the square anti-rotation feature into the washer, then remove the guide wire.
6. Torque the **M10** flange nut (P/N: 94050-10000) to **49 N.m (36 lb-ft)**.
7. Continue with the repair procedure through step 24.
8. Discard the **M8** flange bolt. Replace it with the **M10** flange nut (P/N: 94050-10000). Install to the carriage bolt and torque to **49 N.m (36 lb-ft)**.

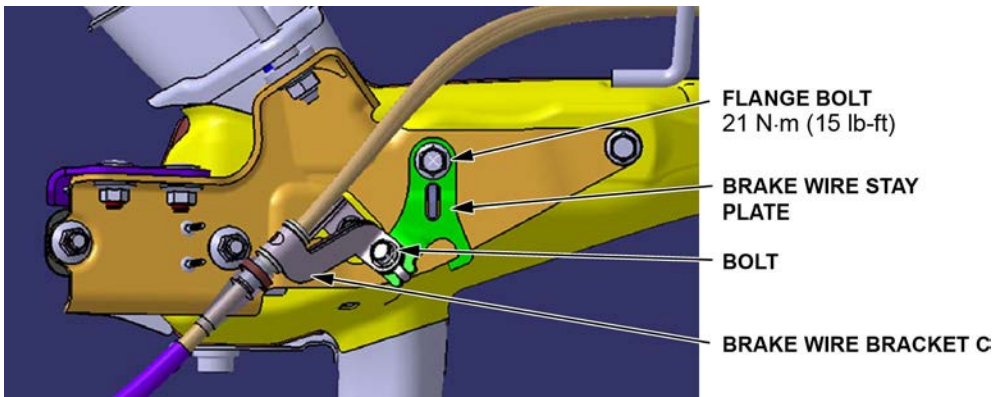
3. Install the parking brake wire stay plate to the lower stiffener with the flange bolt and torque to **21 N·m (15 lb-ft)**.

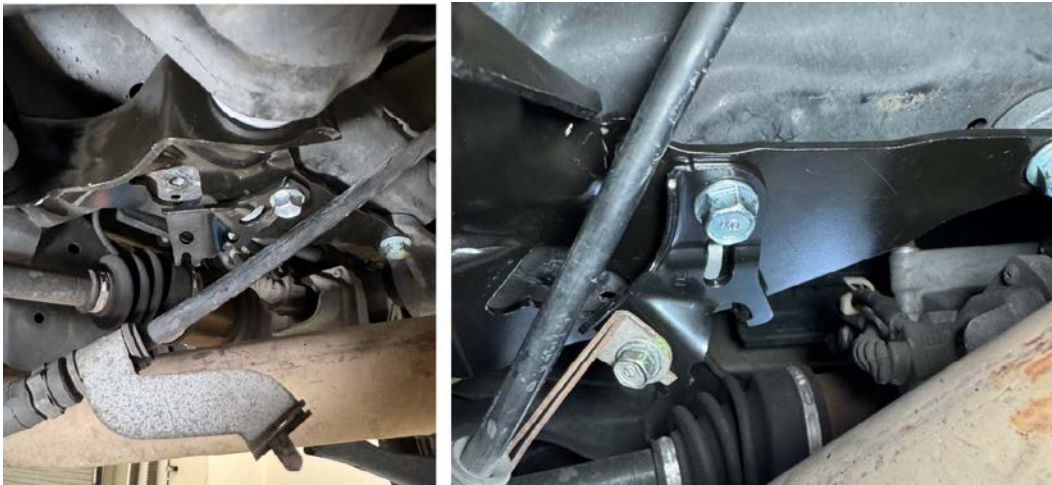
4. Install the new brake wire bracket C onto the parking brake wire.
5. Secure the brake wire bracket C to the brake wire stay plate with the bolt and nut provided.

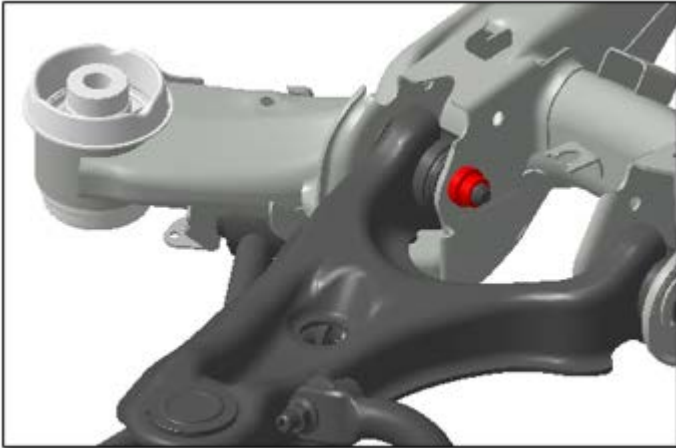
During the removal of the upper arm front bolt, the weld nut may get damaged or become completely separated from the rear subframe. Remove the weld nut from the subframe, then clean and inspect the subframe's surface. Once complete, replace the damaged weld nut with the flange nut (P/N: 90215-TGV-A00) and torque to specification following the procedure outlined in step 25 of the REPAIR PROCEDURE.

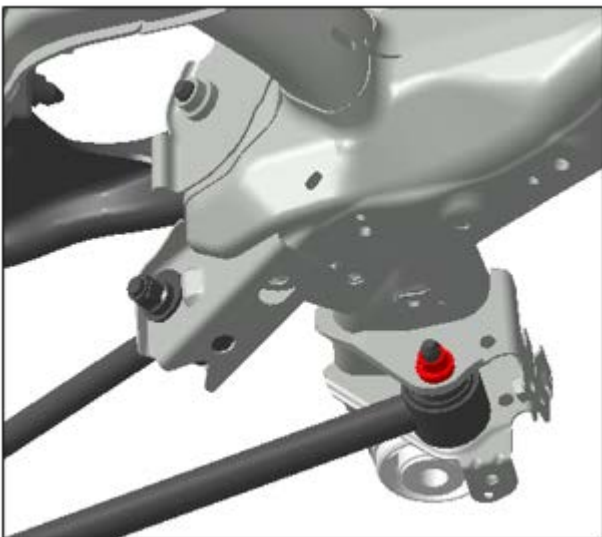
During the removal of the lower arm A bolt, the weld nut may get damaged or become completely separated from the rear subframe. Remove the weld nut from the subframe, then clean and inspect the subframe's surface. Once complete, replace the damaged weld nut with the flange nut (P/N: 90213-3T1-000) then torque to specification as outlined in step 14 of the REPAIR PROCEDURE.
