**June 15, 2026**

Version 2

**Safety Recall: 2016–23 Multi-Model Rear Subframe Reinforcement****Supersedes version 1 to revise the information at:**

Install the rear subframe reinforcement kit.

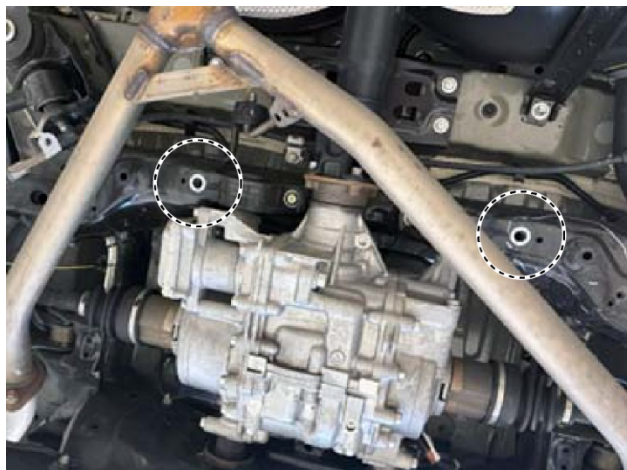
Remove and discard the rear differential outboard mounting bolts on both sides of the front crossmember.

NOTE: If these bolts do not come out, or the weld nuts or threads are damaged, refer to [Procedures A1-A2](#) in the REAR FRAME REINFORCEMENT KIT – SUPPLEMENTAL REPAIRS section at the end of this bulletin.

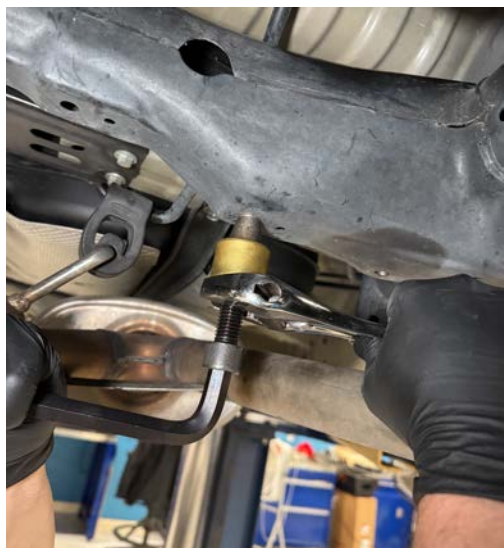
Install **M8** rivet nuts (see the [Using the Rivet Nut Installation Tool](#) Job Aid) into the locations shown, in the underside of the front crossmember portion of the rear subframe.

NOTE: If the mounting holes in the subframe are too corroded to hold the rivet nuts, refer to [Procedure A3](#) in the REAR FRAME REINFORCEMENT KIT – SUPPLEMENTAL REPAIRS section at the end of this bulletin.

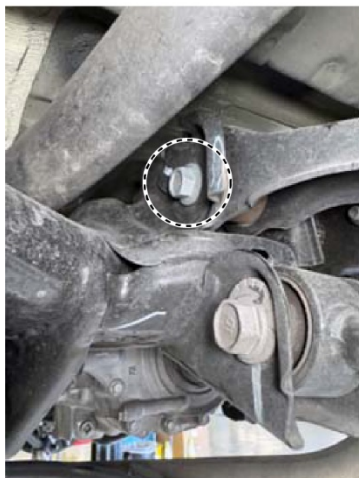
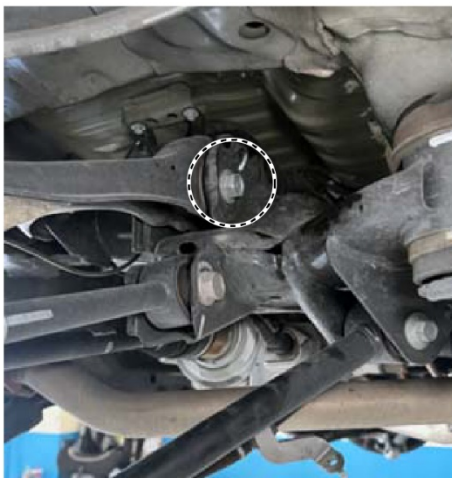
6.1 Clean the upper arm front bracket area and front cross member upper area.

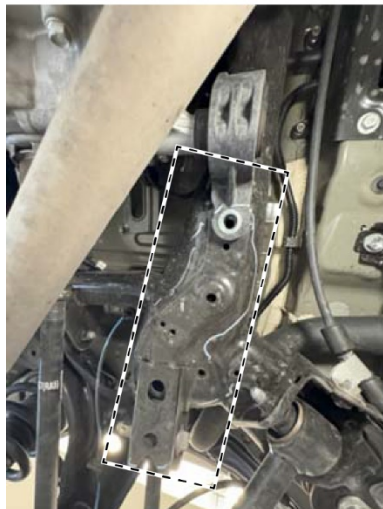
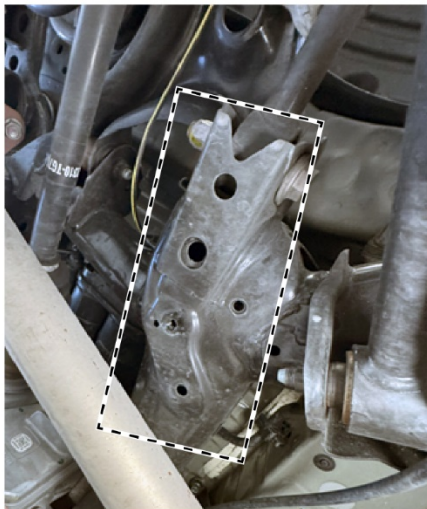
6.2 Clean the control arm bracket area, lower arm rear bracket face, and the front cross member lower differential mount area (2WD only).

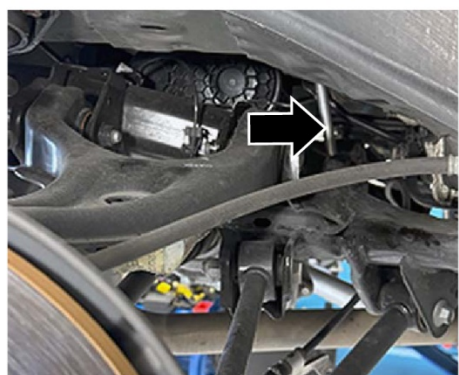
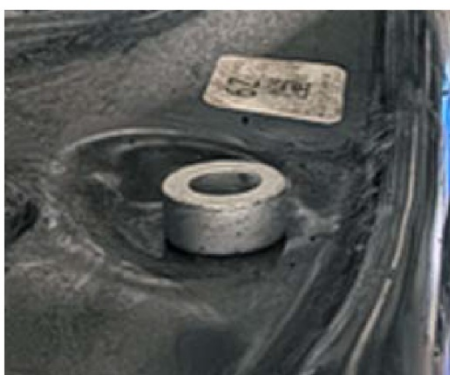
Install the collar into the hole in the top of the subframe front crossmember, just inboard from the upper arm mount.

- 7.1 Insert the collar (1) into the top of the crossmember and ensure the head sits flush with the top of the crossmember.  
NOTE: If there is not enough clearance to insert the collar into the subframe hole, see step 7.2 for additional information.

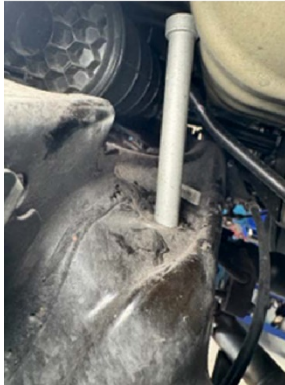
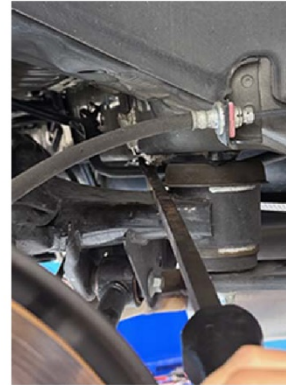
7.2 If there is not enough clearance to slide the collar into the hole, loosen the forward mounting bolt for the rear crossmember and use a pry bar to force the subframe down for more clearance. Once the collar is installed, install a new subframe mounting bolt and torque it to **132 N·m (97 lb-ft)**.

NOTE: **Do not** remove both forward subframe mounting bolts at the same time or an alignment will be required.

**REAR CROSSMEMBER  
MOUNTING BOLT -  
FORWARD LOCATION**  
132 N·m (97 lb-ft)  
Replace.

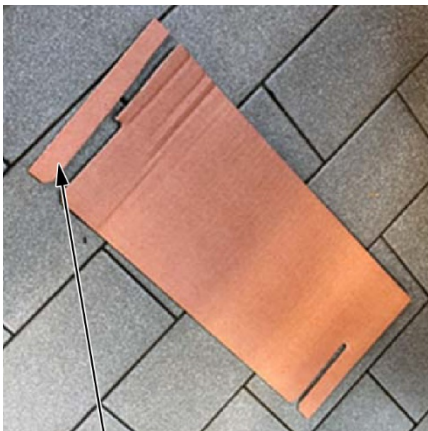
8. Make 4 cardboard masking pieces by cutting off the tabs of the cardboard parts box inserts and then fold the pieces into thirds in a "Z" shape as shown.

**CARDBOARD PARTS BOX**  
Cut off tabs.

Fold pieces into thirds in a "Z" shape.

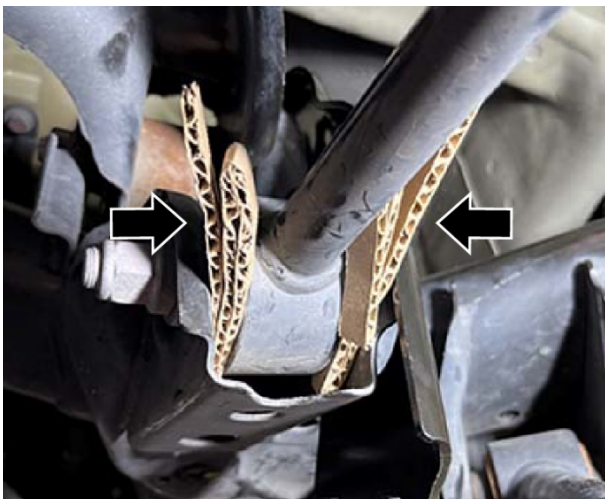
9. Insert the cardboard pieces around the control arm bushing to protect the rubber area of the bushing.

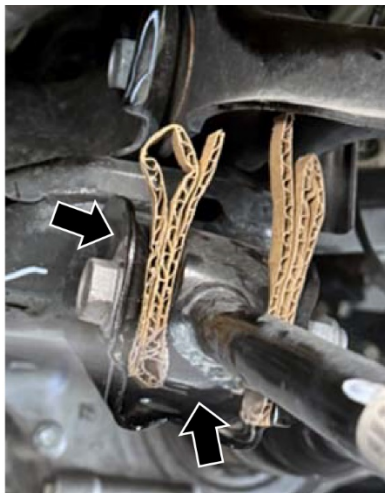
10. Apply spray wax on the inner and outer surfaces of the control arm bracket area. If overspray occurs on the stiffener bracket, wipe the surface with brake cleaner.

NOTE: Leave the cardboard in place until the final spray wax step is completed.

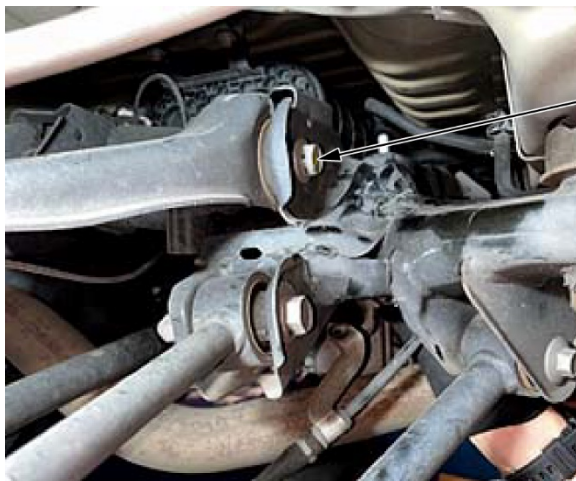
11. Remove and discard the upper arm front bolt.

NOTE: If the weld nut is damaged or becomes separated from the subframe, refer to [Procedure C](#) in the REAR FRAME REINFORCEMENT KIT – SUPPLEMENTAL REPAIRS section at the end of this bulletin.

UPPER ARM  
FRONT BOLT  
Replace.

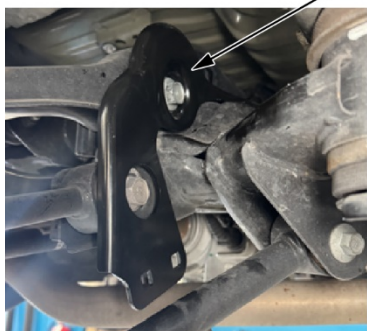
12. Install the stiffener bracket to the subframe using a new **14x90 mm** flange bolt. Snug the bolt but **do not** tighten to final torque.

**14 x 90 FLANGE BOLT**  
Snug bolt, do not  
tighten to final torque.  
Replace.

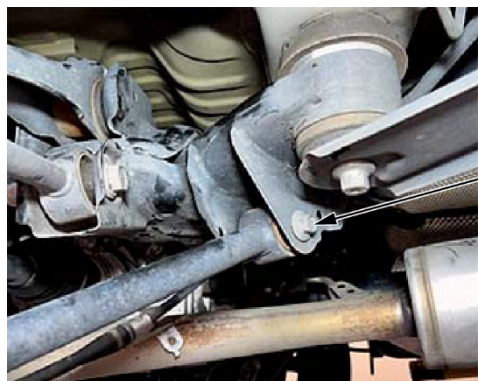
13. Remove and discard the lower arm A bolt.

NOTE: If the weld nut is damaged or becomes separated from the subframe, refer to [Procedure D](#) in the REAR FRAME REINFORCEMENT KIT – SUPPLEMENTAL REPAIRS section at the end of this bulletin.

LOWER ARM  
"A" BOLT

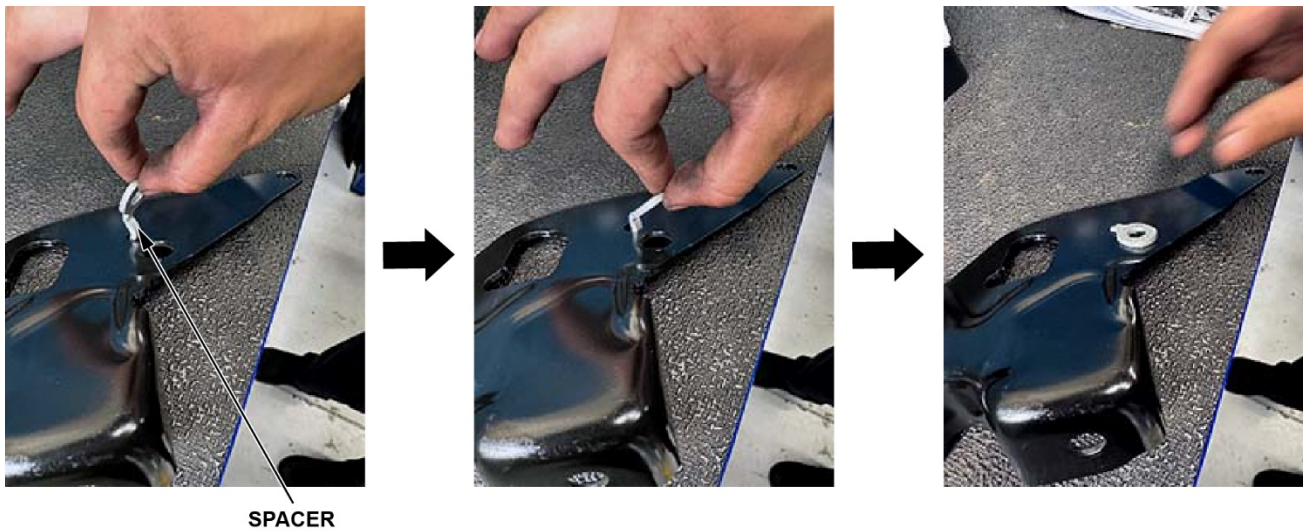
16. Insert the spacer into the lower stiffener bracket.

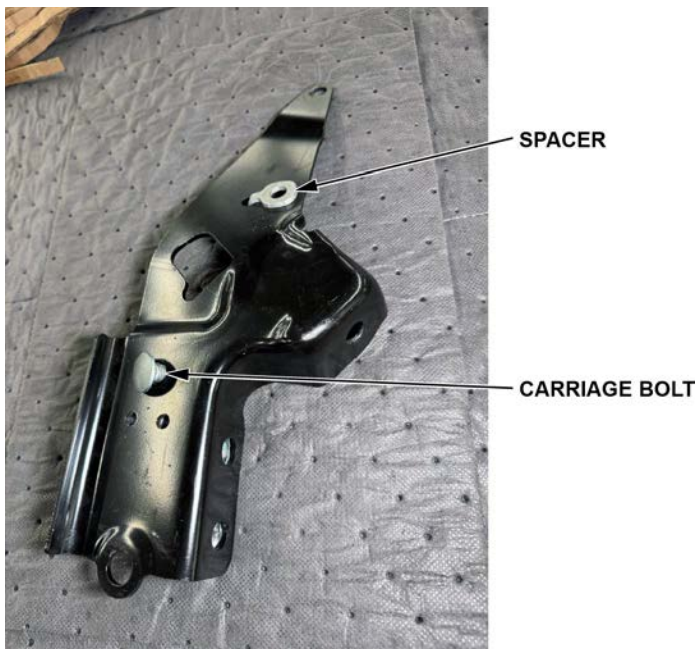
17. Place a carriage bolt in the lower stiffener in the location shown, then loosely put a flange nut on the underside to keep it in place during installation.

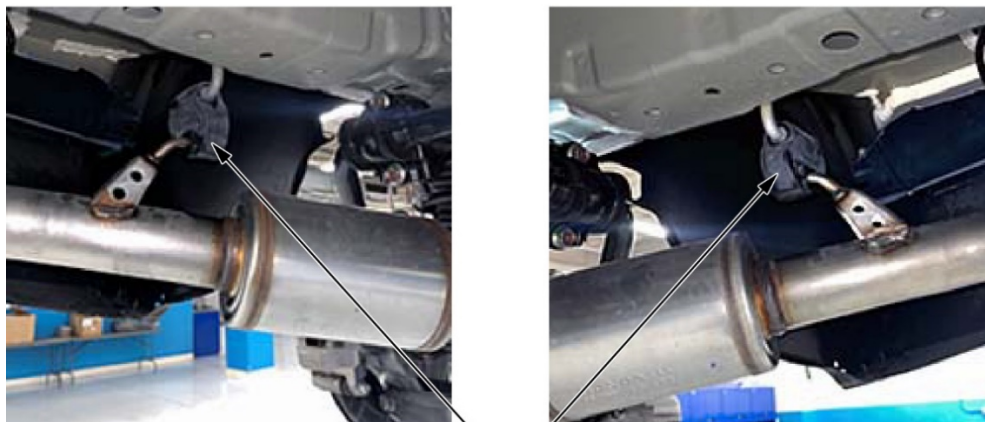
18. For vehicles with dual exhaust only, remove the rear exhaust hangers on the left and right sides.

**EXHAUST HANGERS**  
Remove.

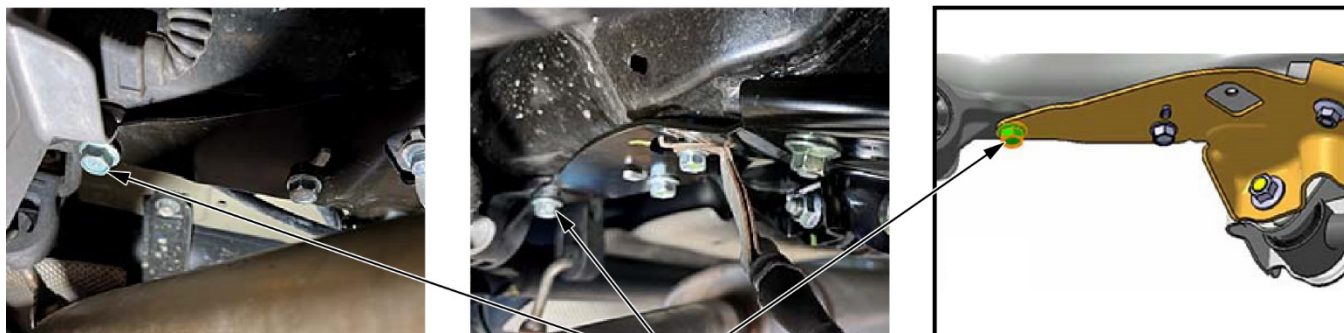
Install the **10x30 mm** flange bolt into the subframe until. Do not tighten to final torque at this time.

**10 x 30 FLANGE BOLT**

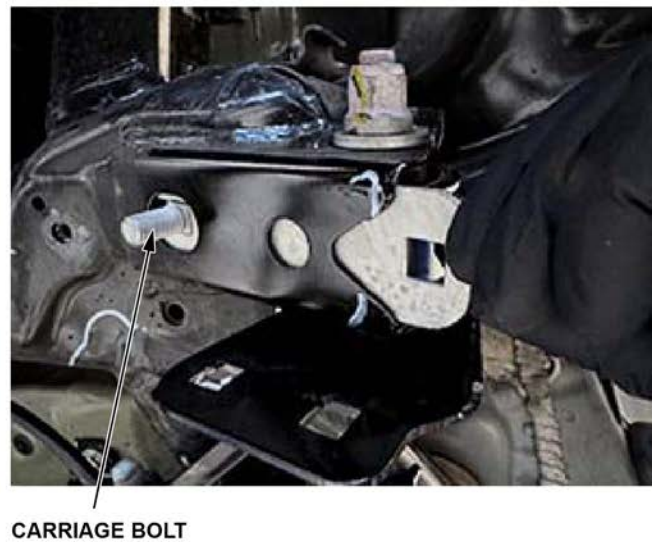
22. Push up slightly on the carriage bolt so it sticks up through the lower control arm bracket, then slide the insert plate above the lower control arm bracket so that the square slot of the plate engages with the square head of the carriage bolt (rotating the carriage bolt slightly may help with engagement).

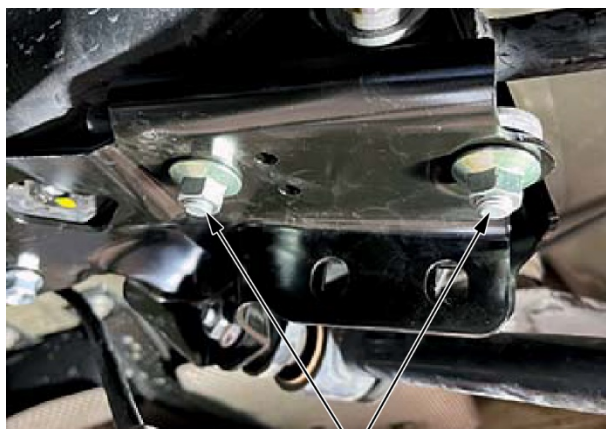
23. Secure the insert plate to the lower stiffener with **10x22 mm** carriage bolts and a **10 mm** flange nuts and tighten until snug.

**10x30 CARRIAGE BOLTS  
WITH 10mm FLANGE NUTS**

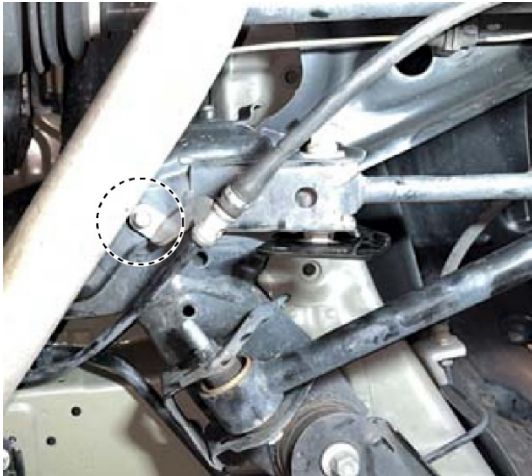
26. Reinstall the parking brake cable bracket and bolt and torque to **21 N·m (15 lb-ft)**.

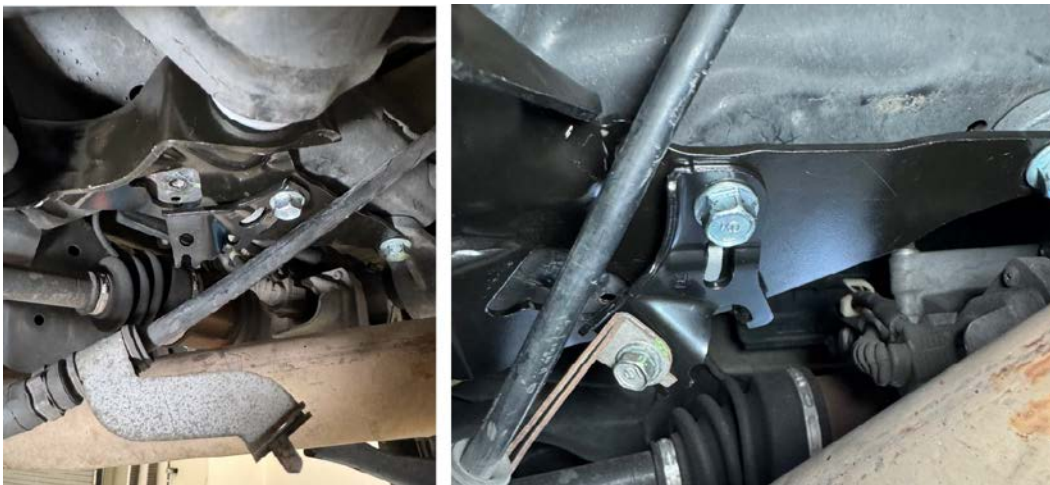
4. Install the new brake wire bracket C onto the parking brake wire.
5. Secure the brake wire bracket C to the brake wire stay plate with the included bolt and nut.

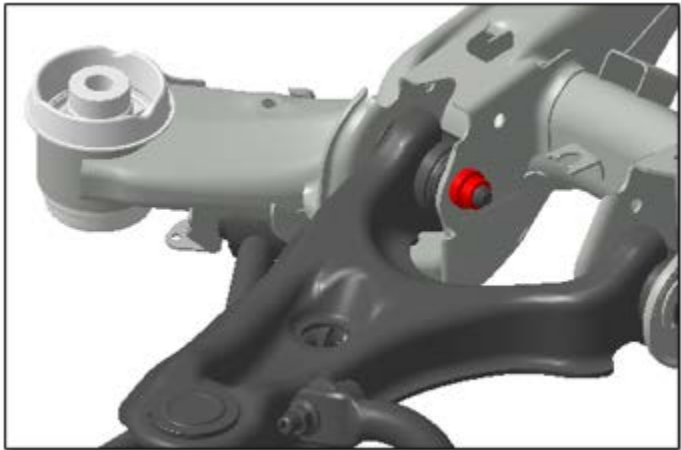
**Procedure C - Upper Arm Front Bolt Removal**

During the removal of the upper arm front bolt, the weld nut may get damaged or become completely separated from the rear subframe. Remove the weld nut from the subframe, then clean and inspect the subframe's surface. Once complete, replace the damaged weld nut with the flange nut (P/N: 90215-TGV-A00) and torque to specification following the procedure outlined in step 13 of the REPAIR PROCEDURE.

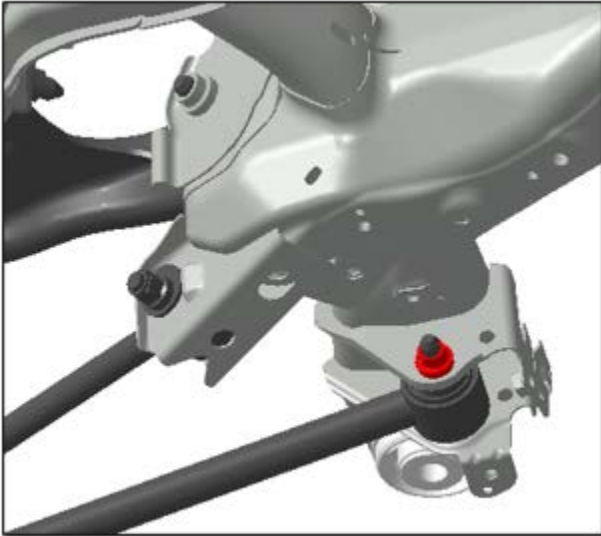
#### Procedure D - Lower Arm A Bolt Removal

During the removal of the upper arm A bolt, the weld nut may get damaged or become completely separated from the rear subframe. Remove the weld nut from the subframe, then clean and inspect the subframe's surface. Once complete, replace the damaged weld nut with the flange nut (P/N: 90213-3T1-000) then torque to specification as outlined in step 15 of the REPAIR PROCEDURE.
